City of Franklin Stormwater Inspection Report

Site or Project Name Muddy Brook Manor, Section 1

COF Project Number #1234 Date of Inspection 11/07/2014

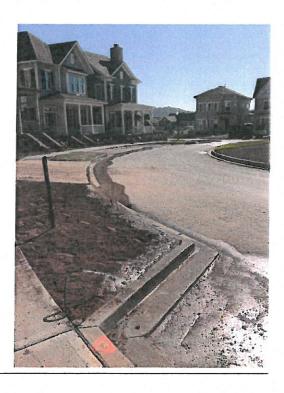
Photo

-Lot 22 irrigation system was flowing across bare soil, into Sycamore Lane, and into a catch basin.
