CONCEPTUAL ENGINEERING REPORT

**Robinson Lake Dam
Franklin, Tennessee**

City of Franklin

December 8, 2017

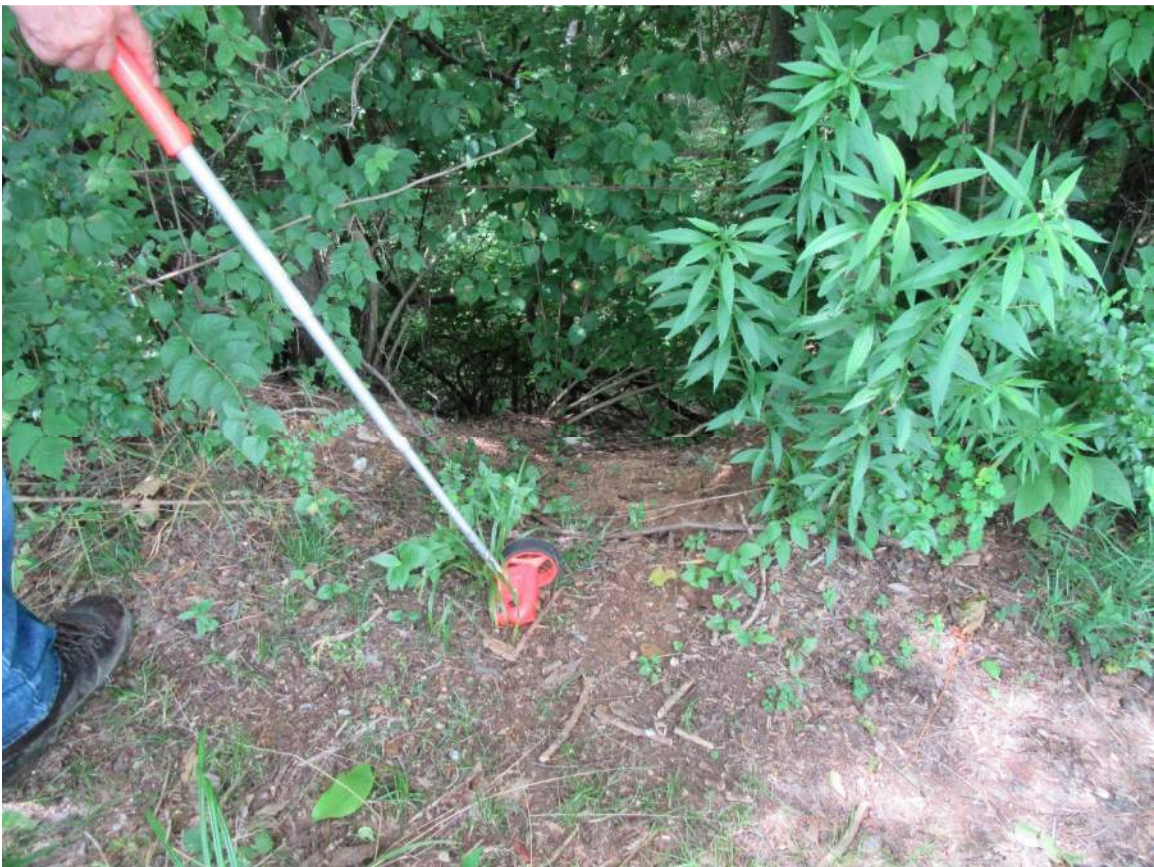
Photo No. 4: Erosion on crest due to possible overtopping.

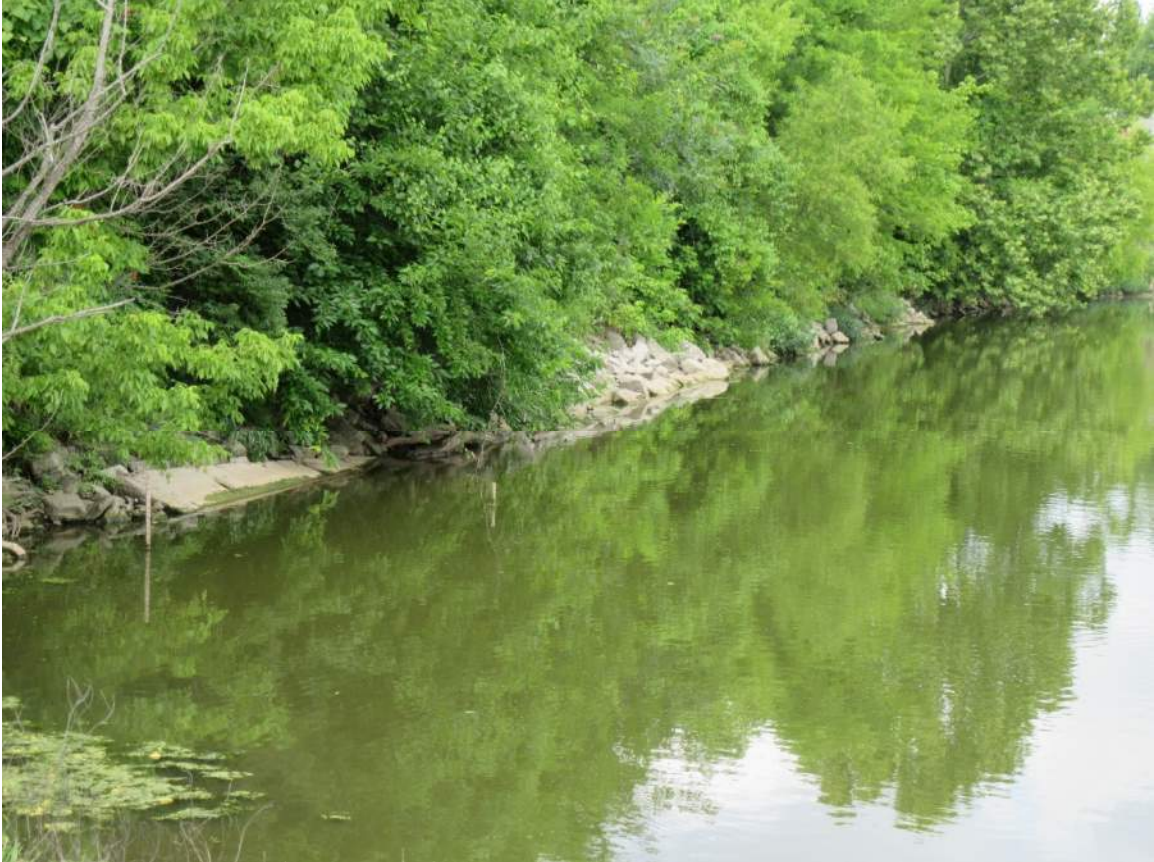
Photo No. 7: Riprap present on portions of upstream slope.

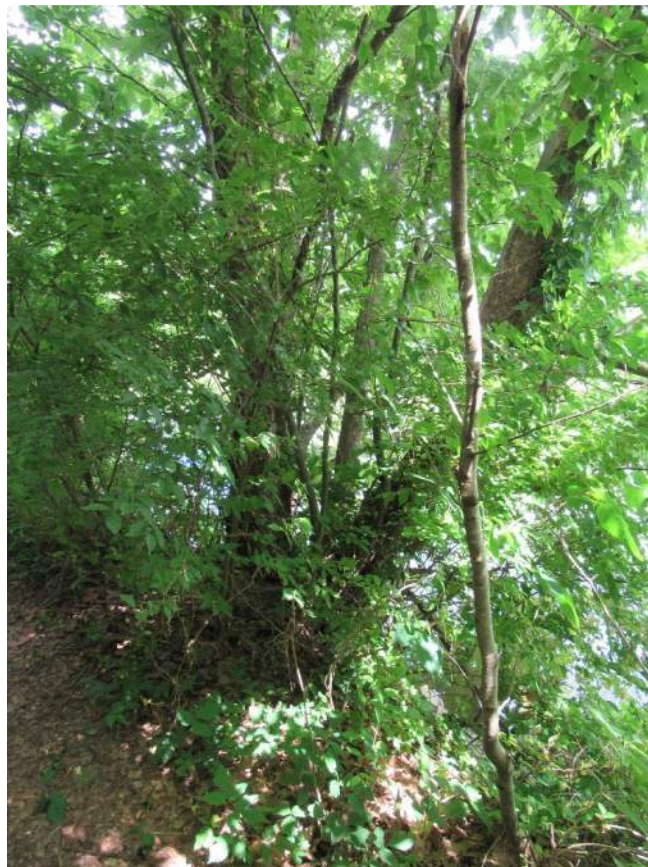
Photo No. 8: Trees on upstream slope.

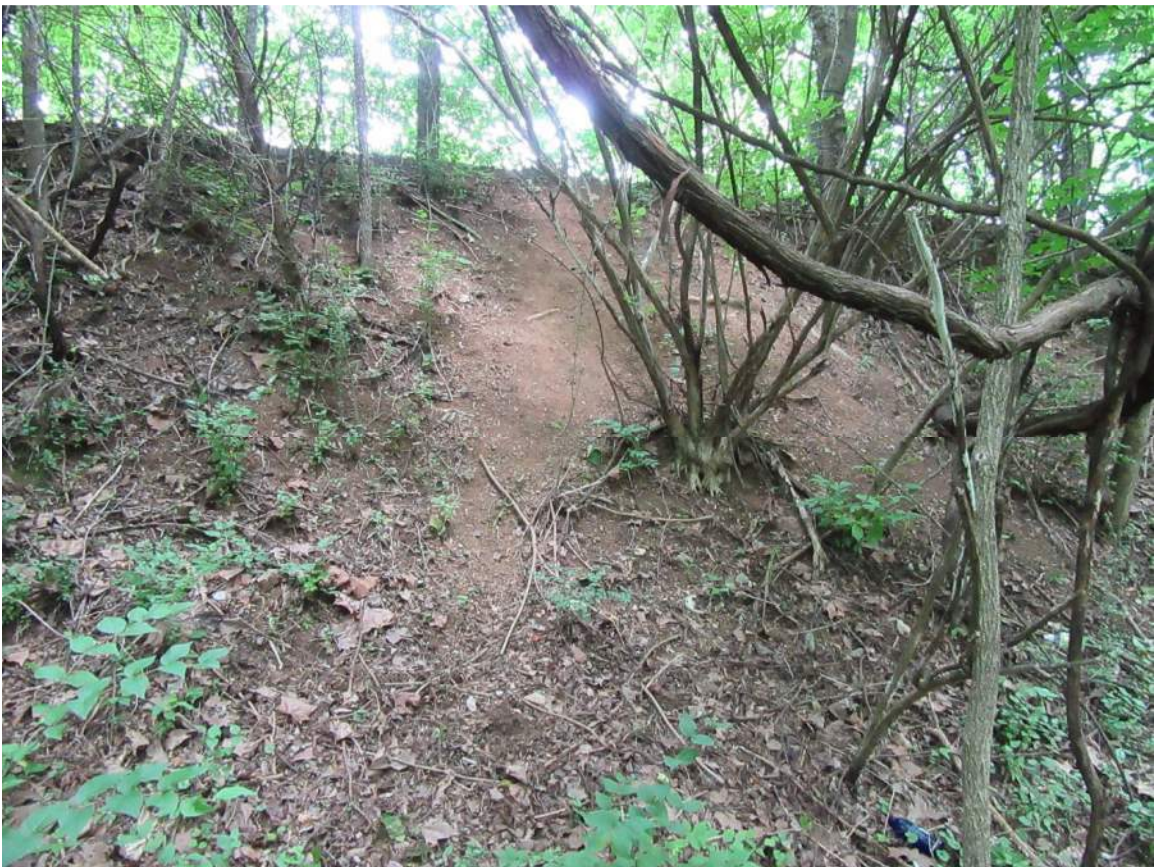
Photo No. 12: Erosion on downstream slope due to possible overtopping.

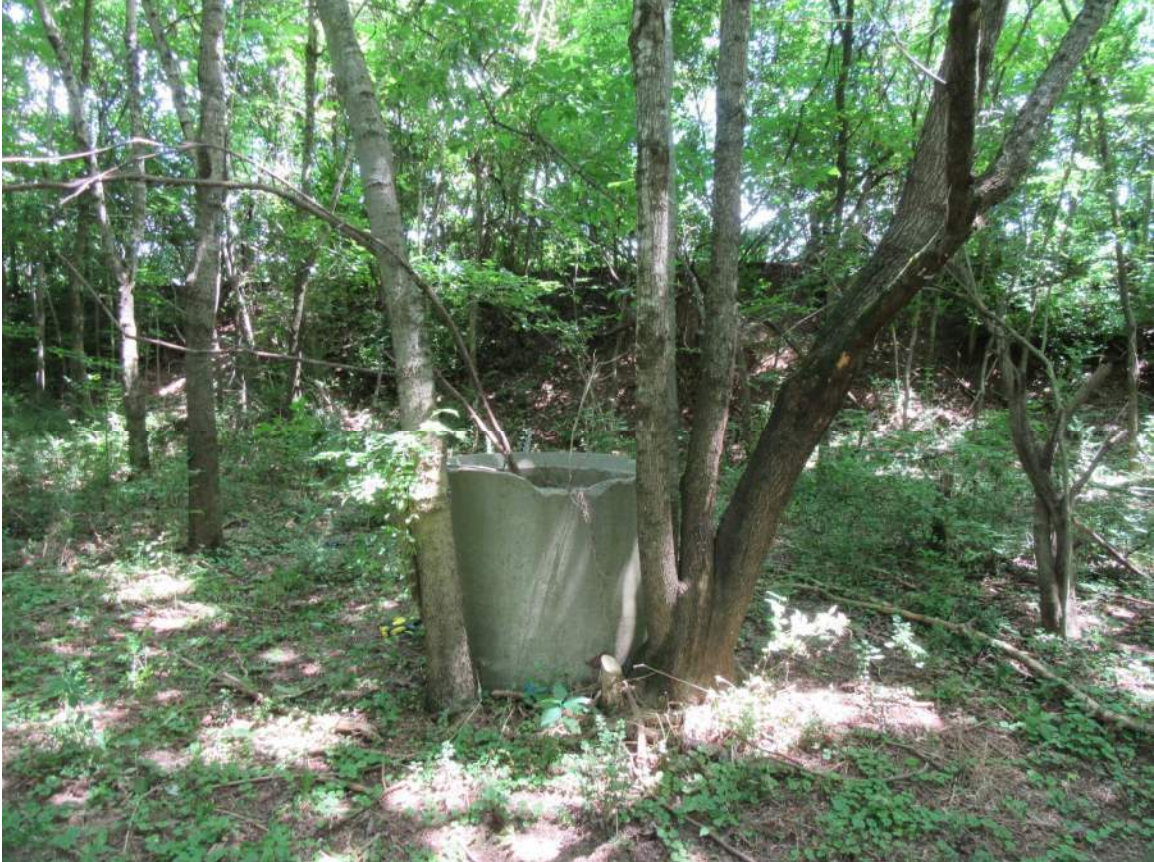
During the previous site visit, the CDM Smith representatives observed a vertical 36-inch-diameter, 12-foot-long reinforced concrete pipe extending 8 feet below ground surface (ft-bgs) just beyond the downstream slope of the dam. We believe this pipe may be a remnant of the original primary spillway, but the bottom of the pipe had 3 feet of sediment, and no outlet pipes were observed.

Photo No. 13: 36-inch-diameter RCP pipe downstream of dam.

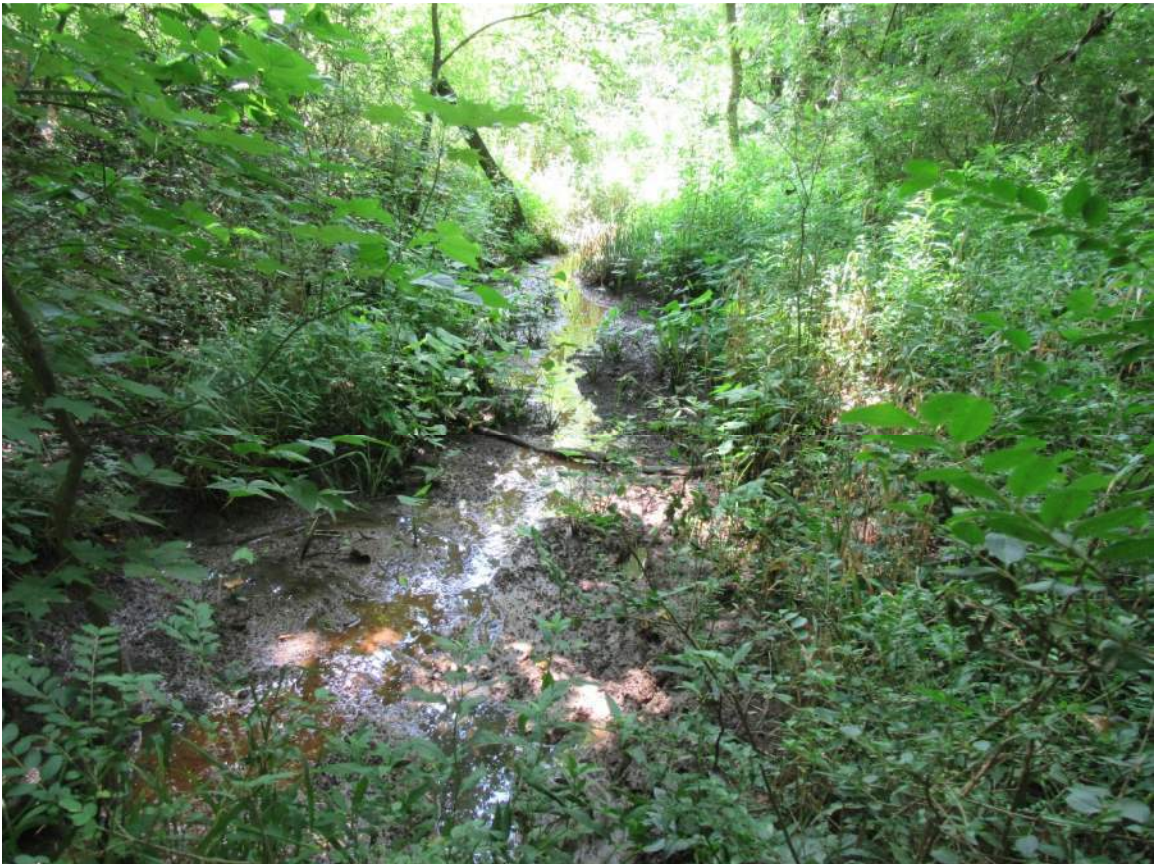
Photo No. 14: Seepage downstream of RCP pipe.

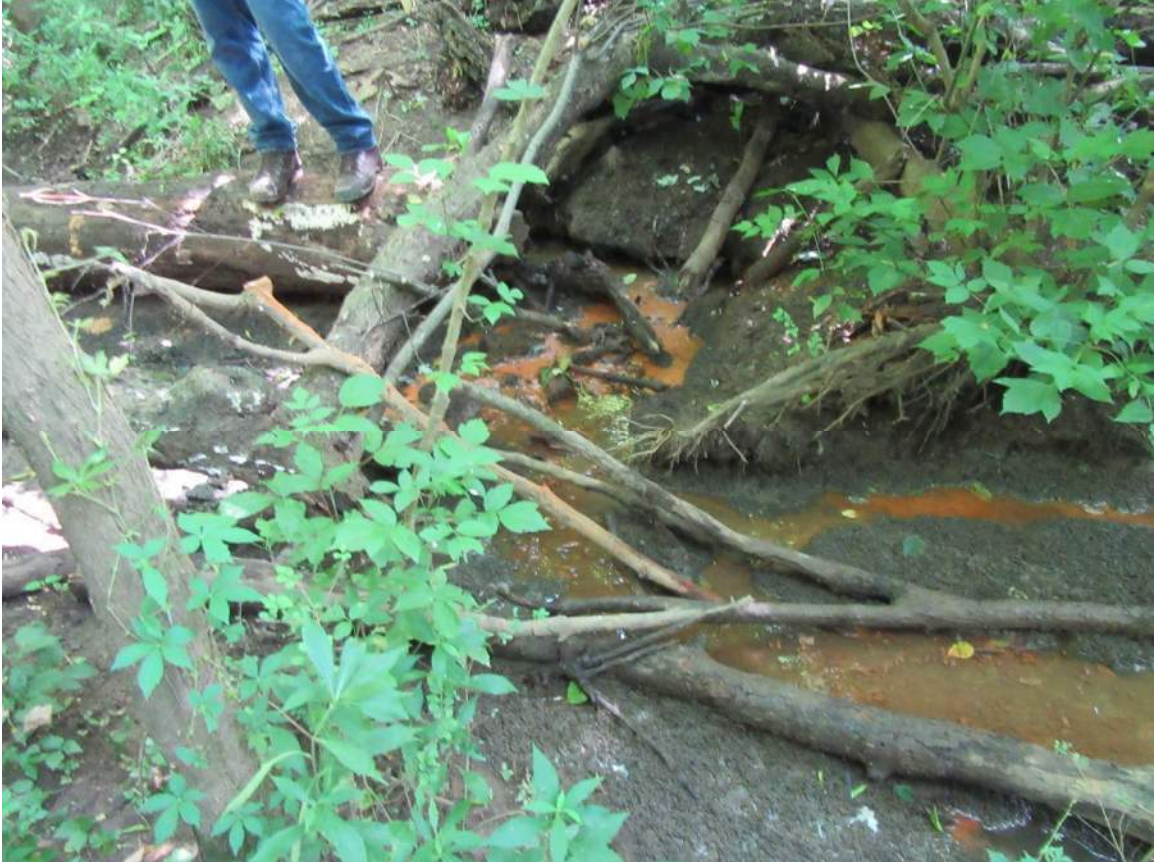
Photo No. 15: Seepage downstream of RCP pipe.

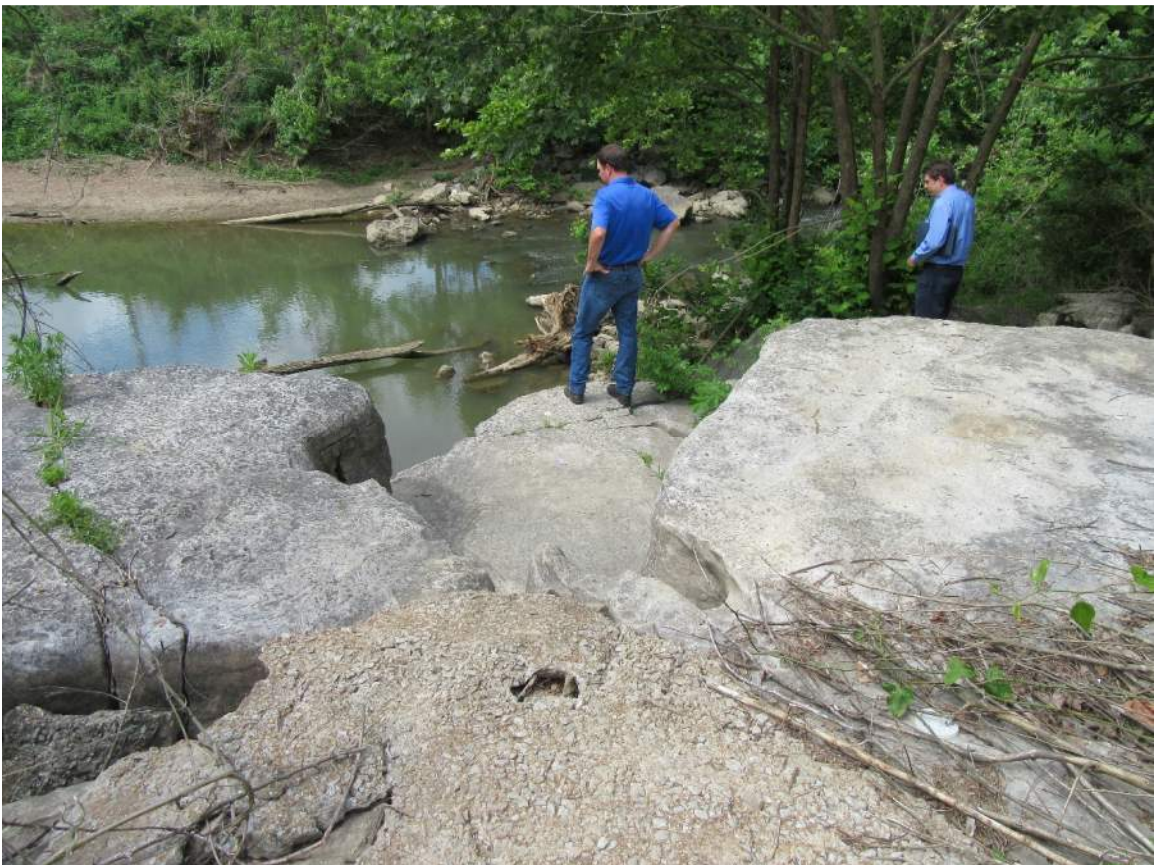
At the end of the auxiliary spillway, it was noted that seepage was flowing through the limestone face at the 15-foot-high drop-off down to the river. In addition, seepage was flowing from the river bank to the left of the limestone face. Total seepage flow was about 100 to 200 gallons per minute. There was erosion in the seepage area, but the seepage flow appeared to be clear.

Photo No. 20: Bedrock drop-off at downstream end of spillway discharge channel.

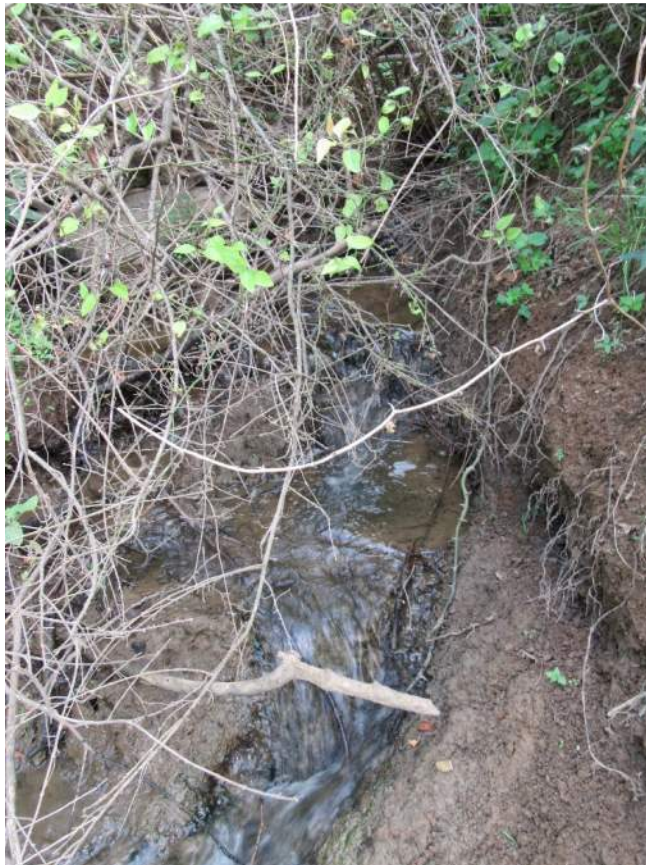
Photo No. 22: Seepage to left of spillway.

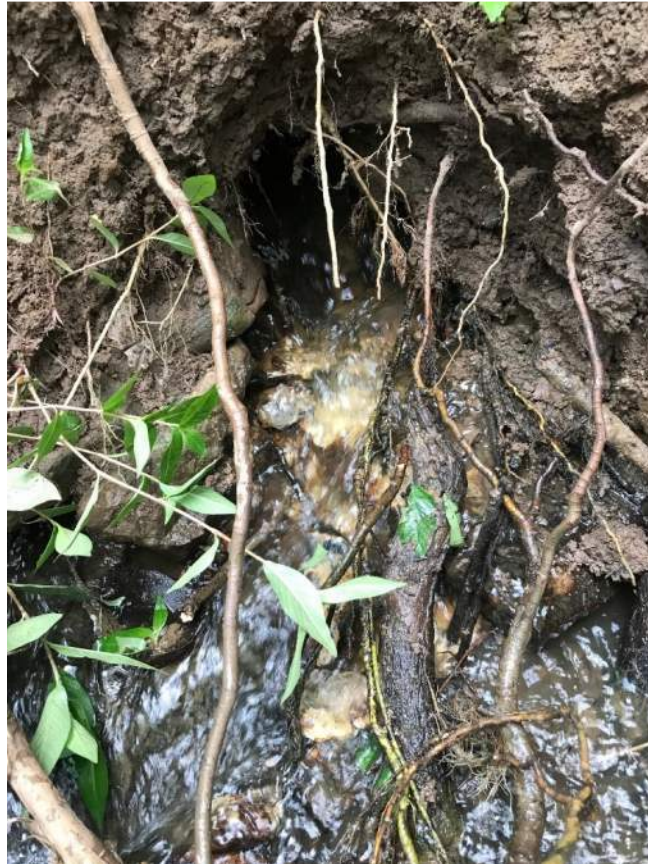
Photo No. 23: Seepage to left of spillway.
