**Goose Creek Inn Wastewater Treatment Plant
NPDES Permit # TN0060216, Williamson County
Compliance Evaluation Inspection Photo Summary**

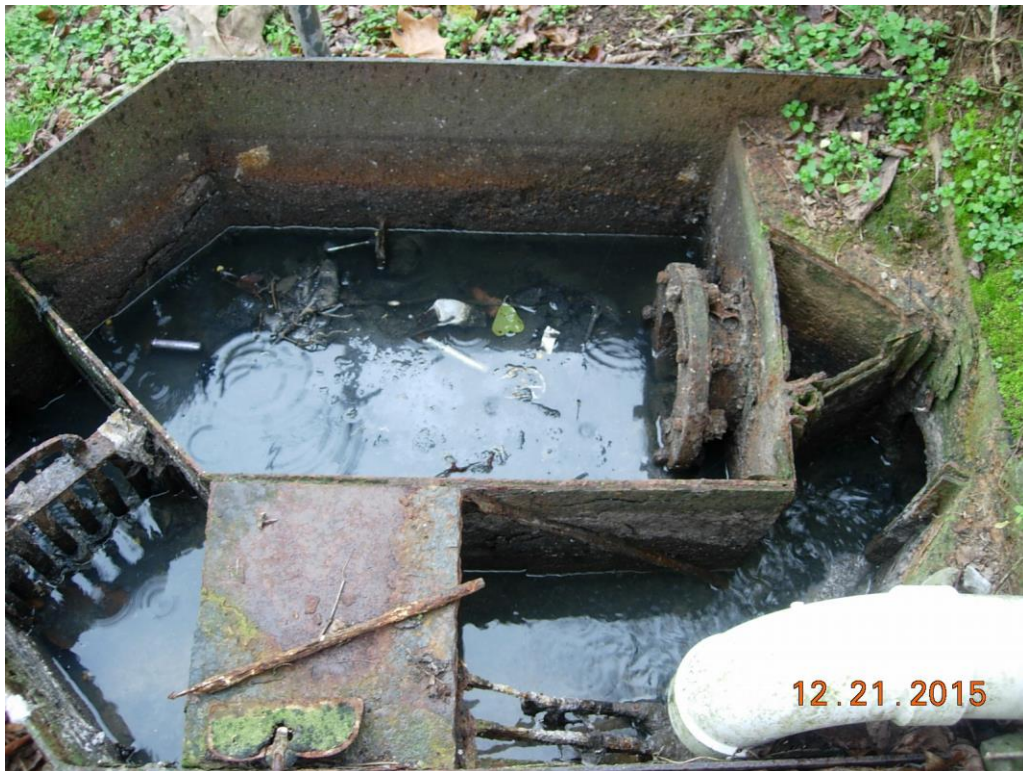
Influent bar screens showing severe corrosion, bar screens breaking apart & ineffective screening of raw wastewater

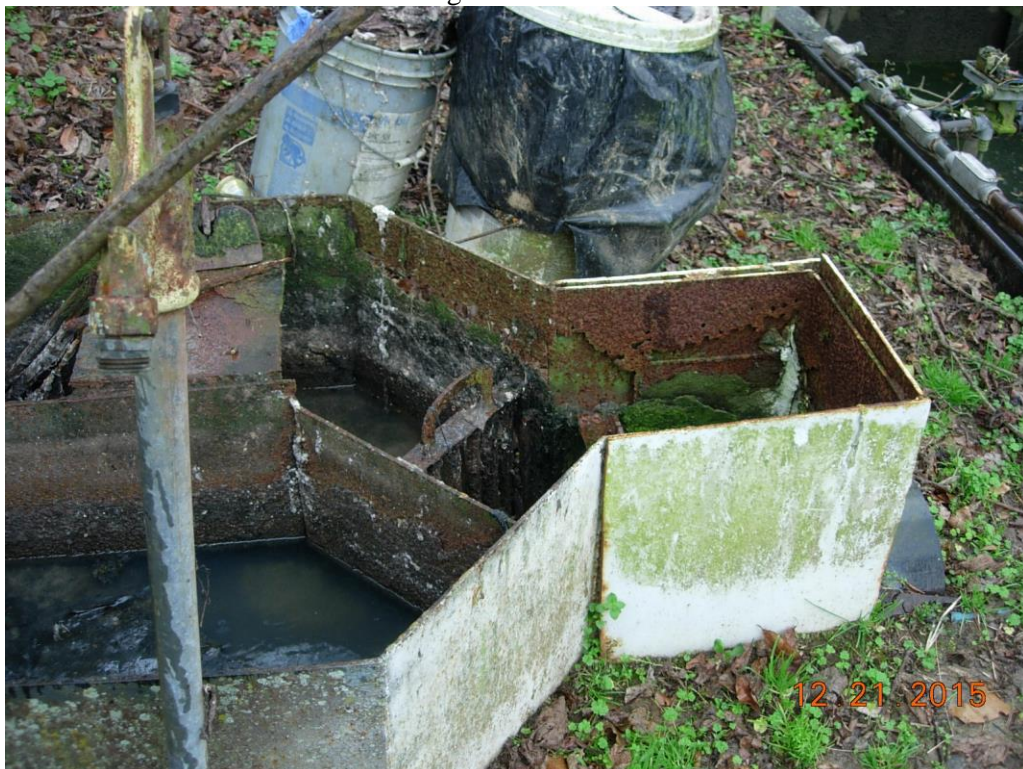
Severe corrosion of bar screen structure & metal walls breaking apart

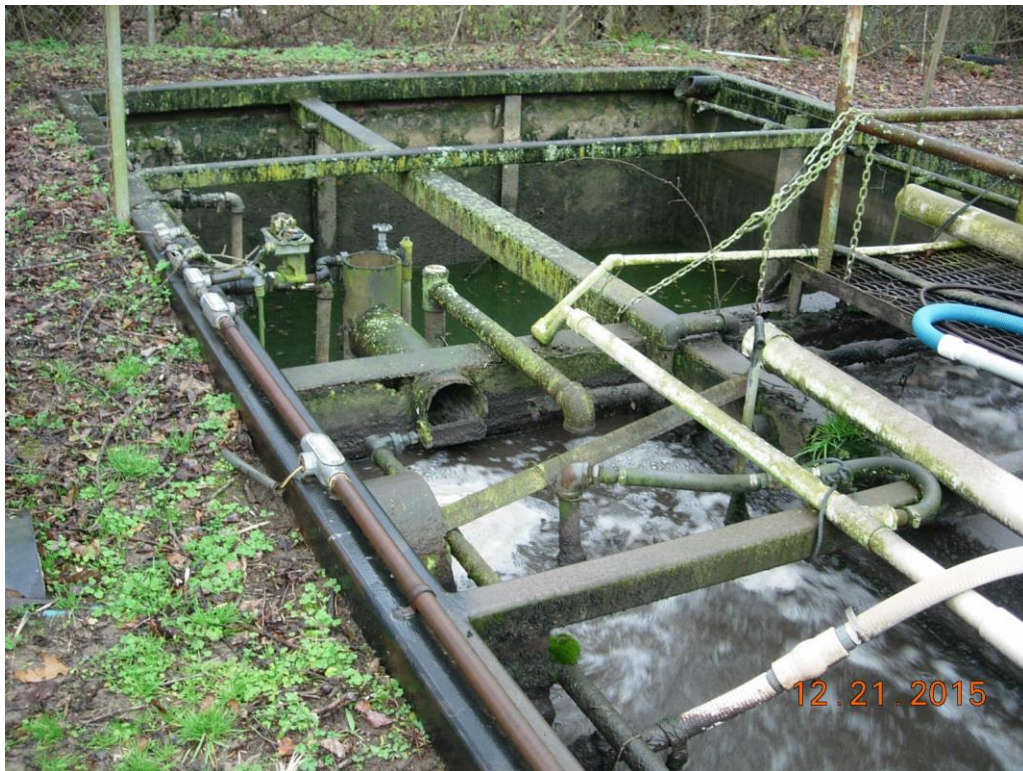
Deteriorated condition of structures, piping & wiring, makeshift repairs & replacement of metal piping with PVC and flexible hoses

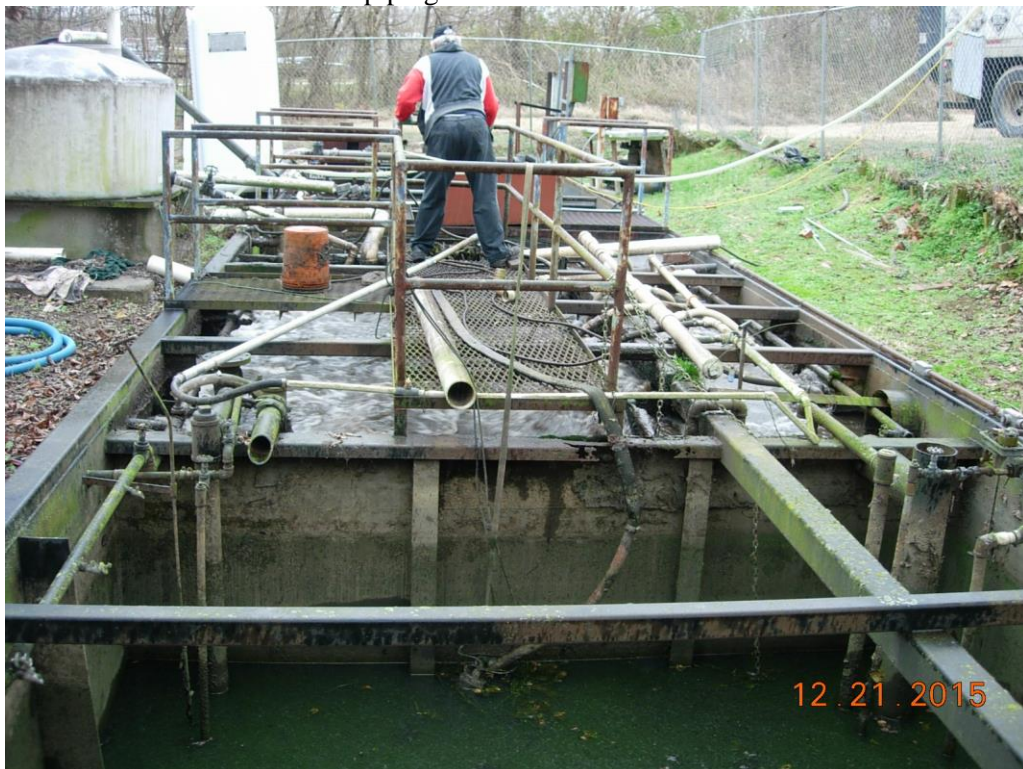
Digester & aeration basin, deteriorated/corroded metal structures & makeshift repairs of piping

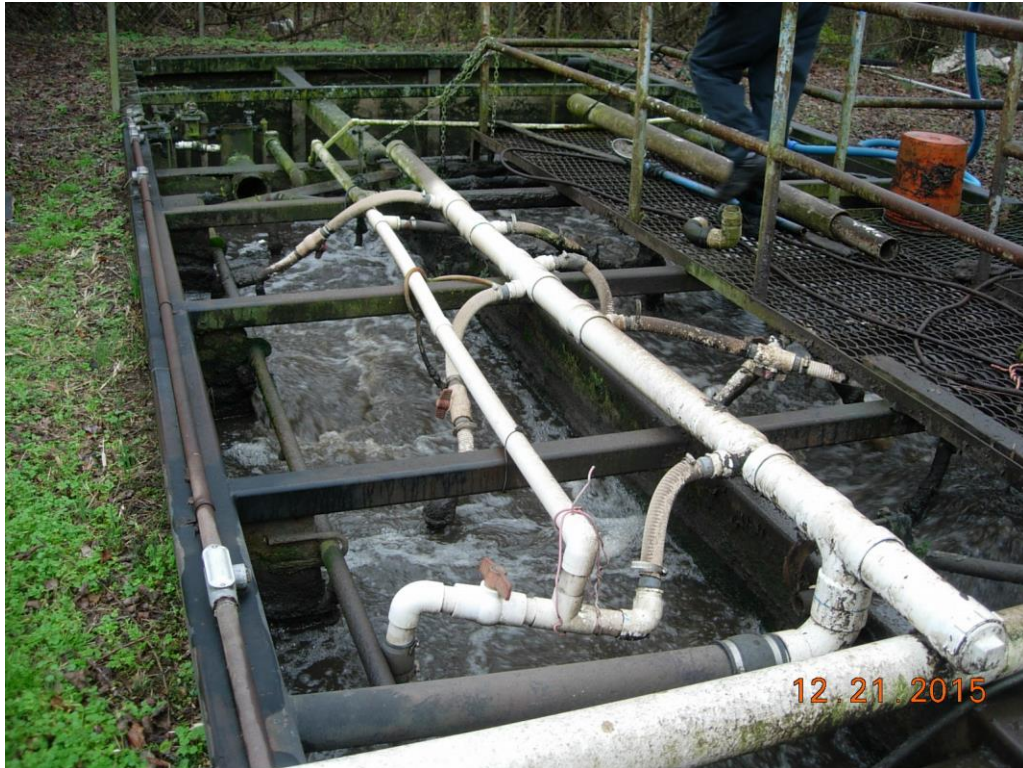
Aeration basin, PVC pipe & flexible hose replacing corroded & un-useable aeration lines

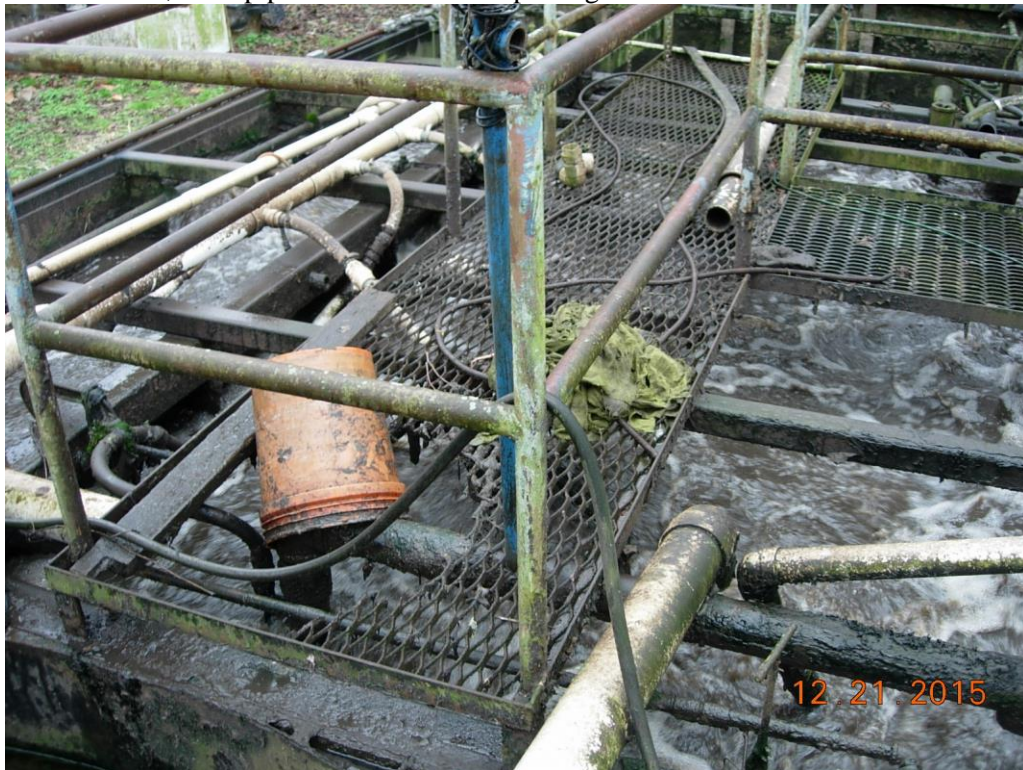
Aeration basin walkway corroded through around return sludge line, return sludge line covered with plastic bucket, rock & 2 x 4 on bucket & wedged under hand rails is used to hold bucket in place

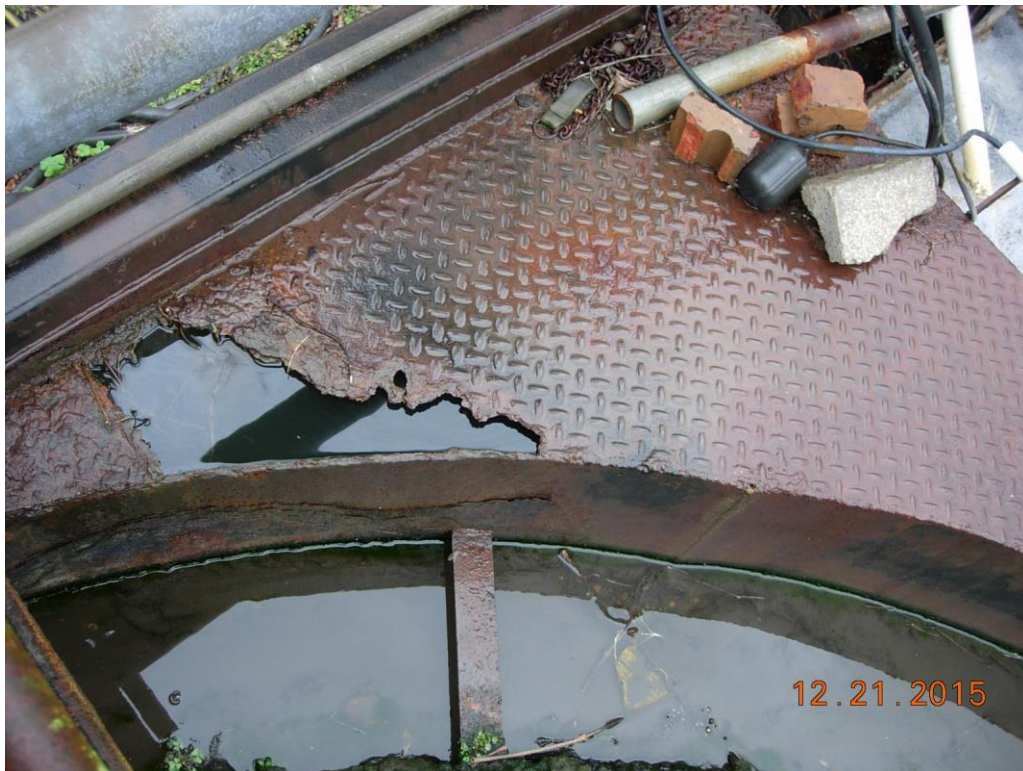
Severely corroded clarifier structure with hole in decking & with metal flaking off of weir trough

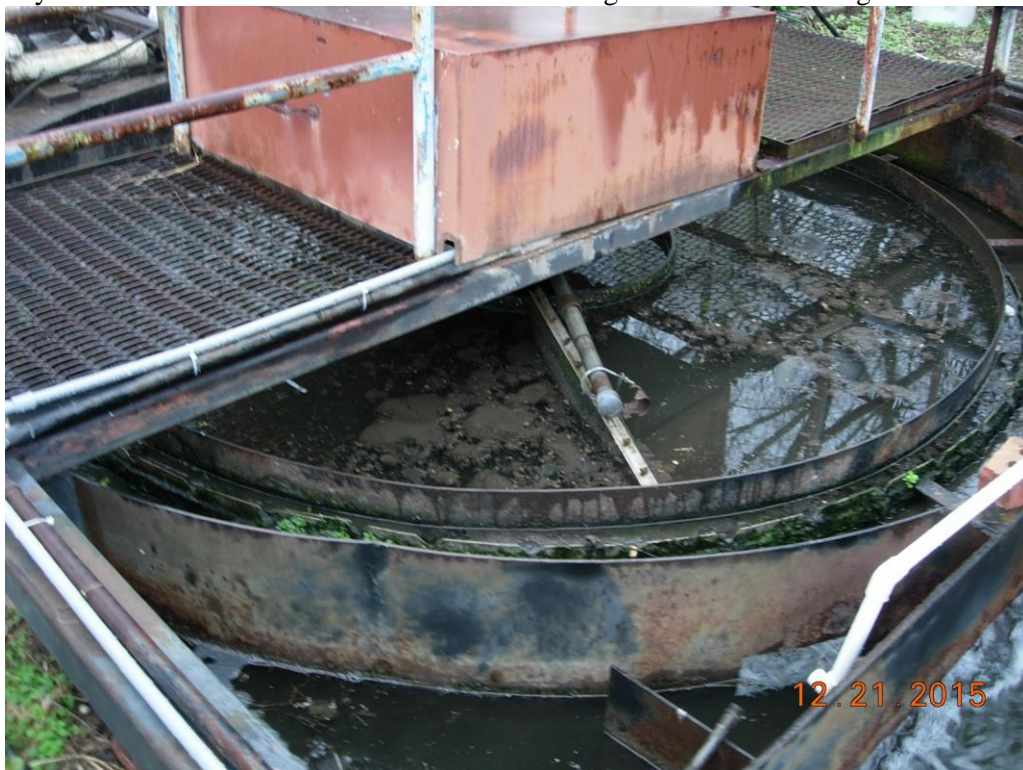
Rising solids in clarifier due to clogged sludge return line & inadequate treatment,
surface skimmer broken & ineffective

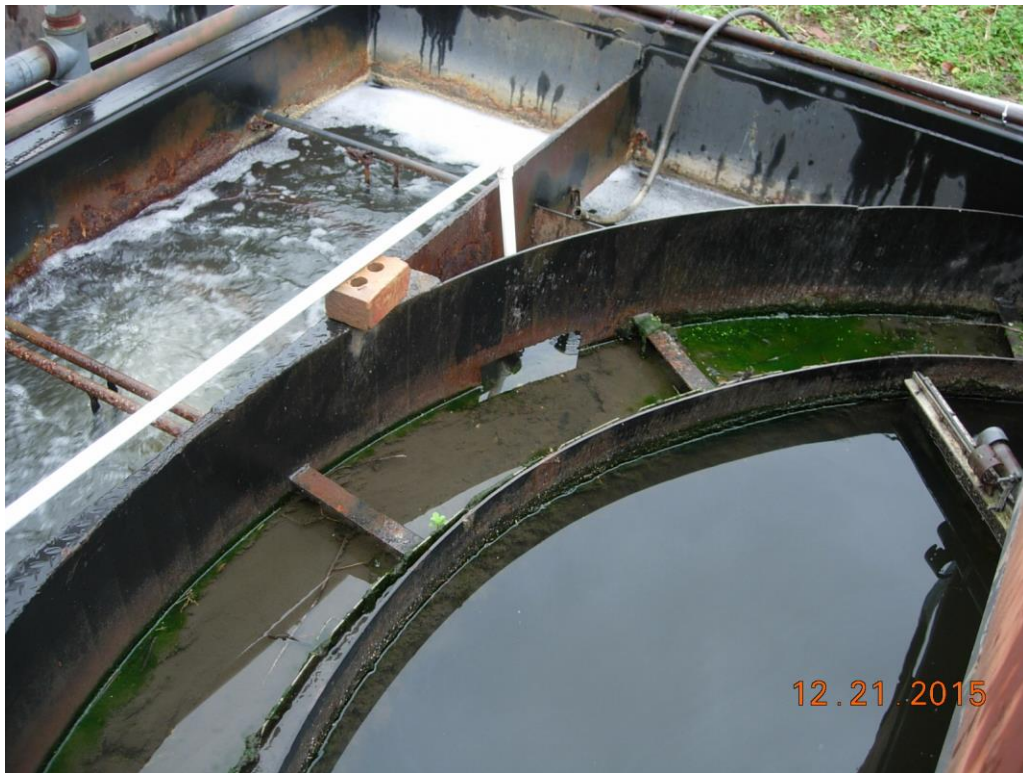
Clarifier with solids exiting weir trough

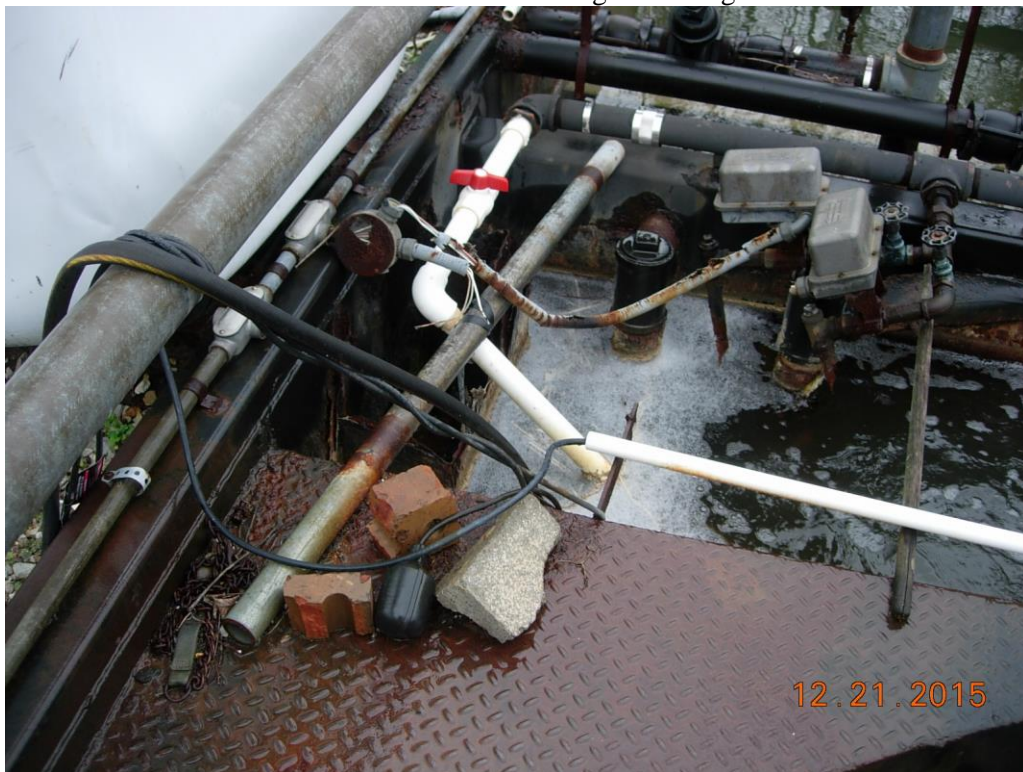
Corroded pipes broken off, emergency overflow weir box severely corroded, piping held up with broom handle & galvanized pipe, wiring deteriorated, extension cords run across basin

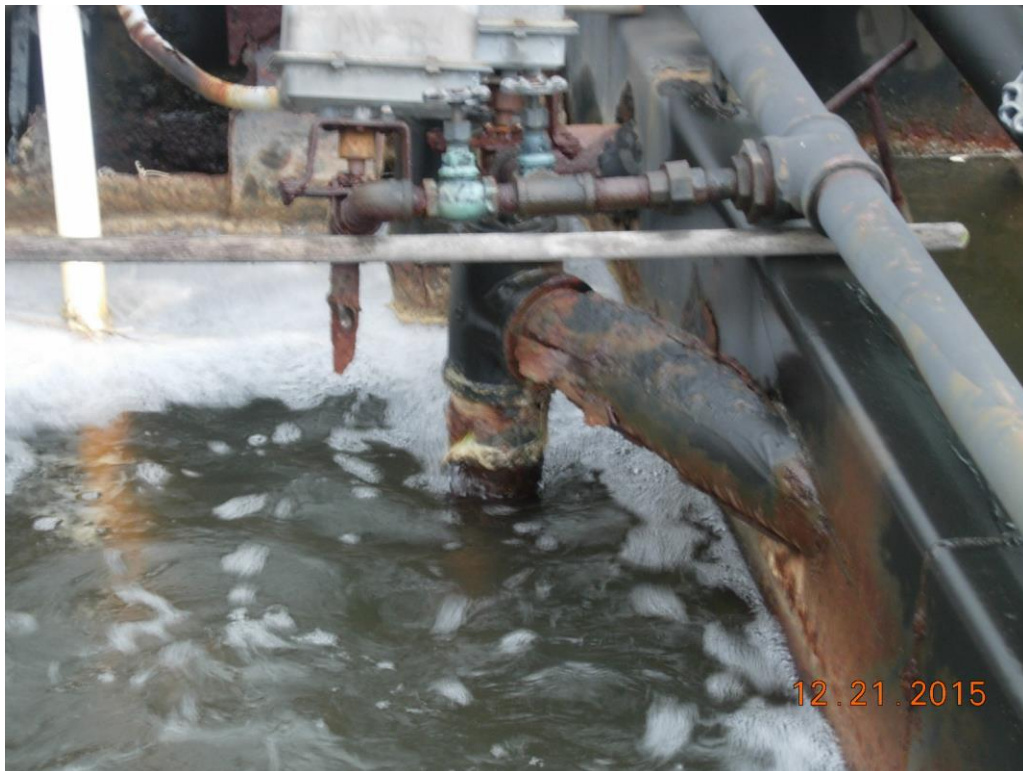
Corroded, broken piping, broom handle support

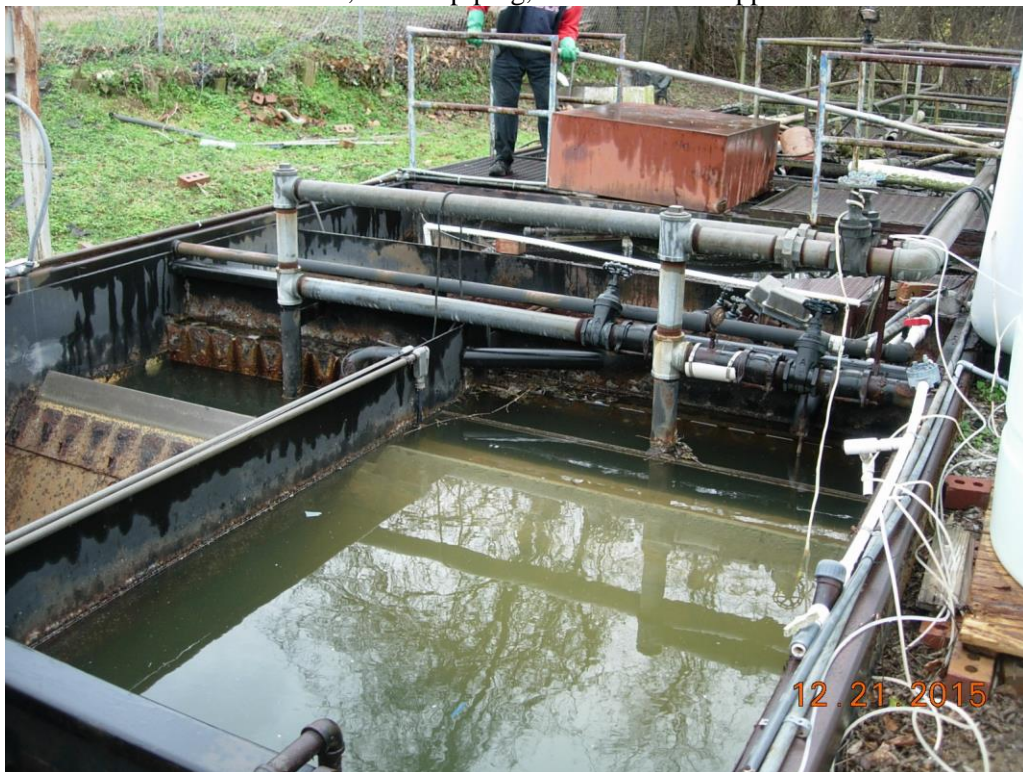
Corroded filter structure & weir troughs, & chlorine feed lines

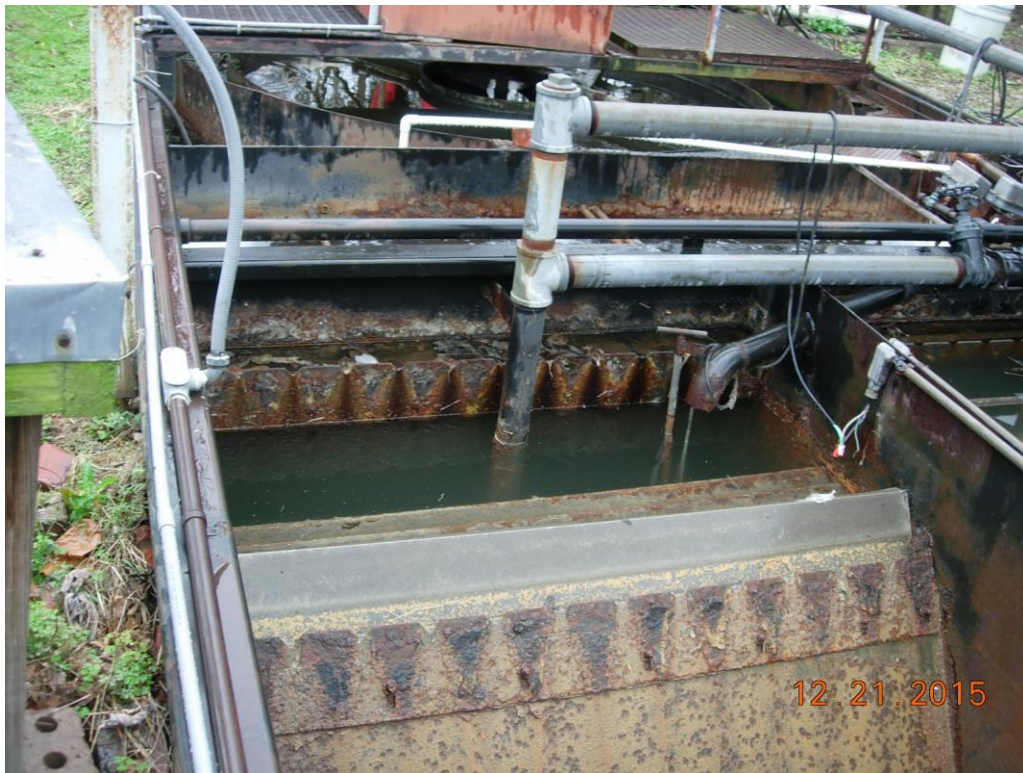
Corroded second filter structure & weir trough

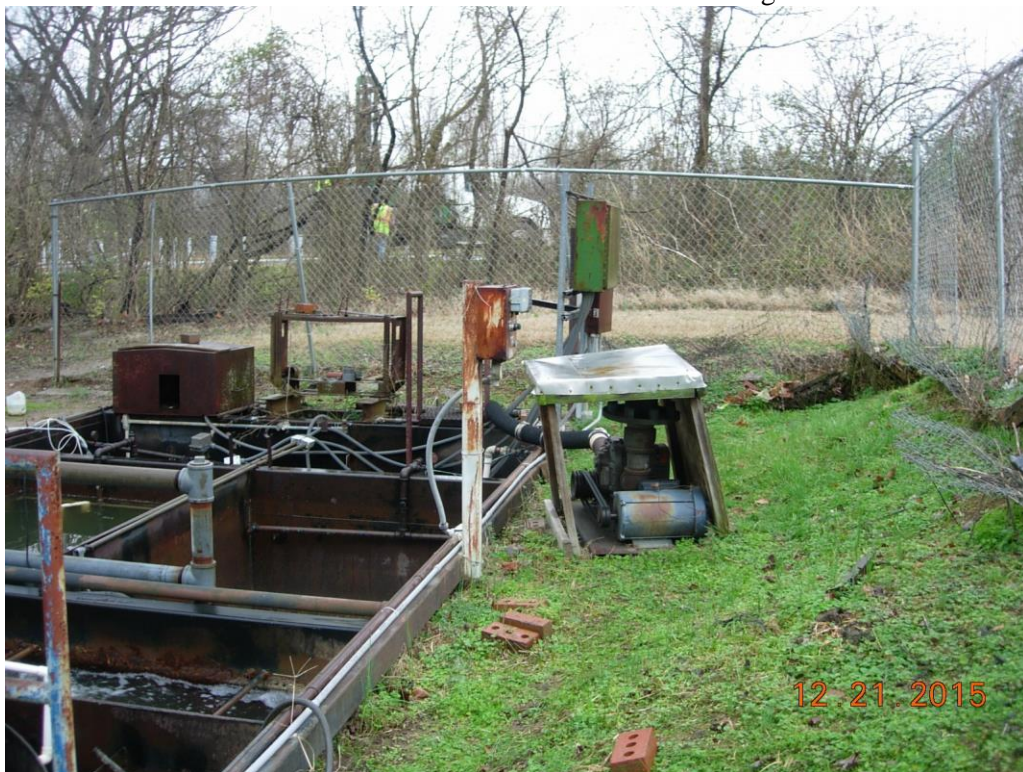
Single blower motor beside plant with flexible hose connection to air lines

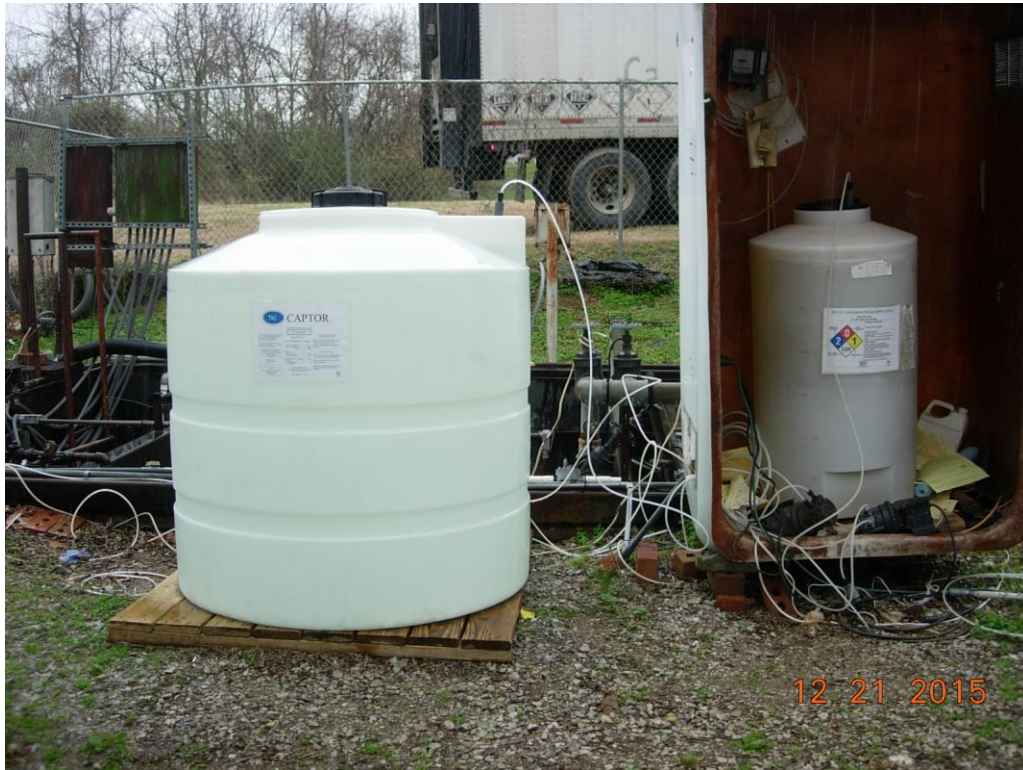
Captor de-chlorination solution tank (left) & chlorine solution tank (right)

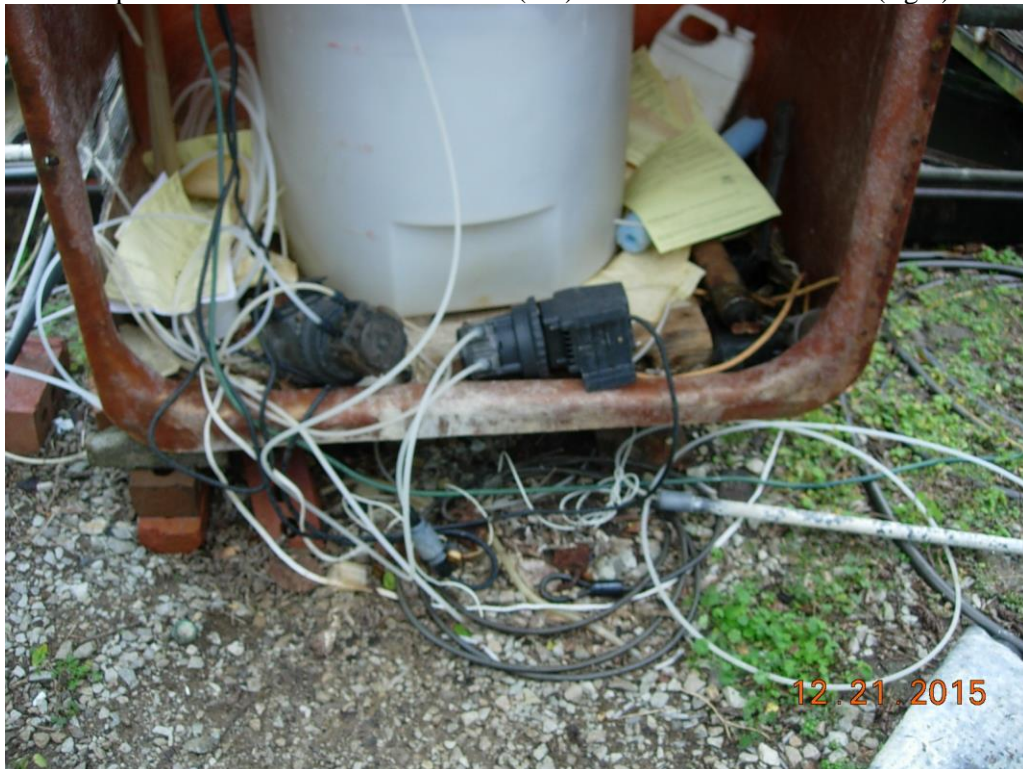
Chlorination solution & de-chlorination solution feed pumps, wiring, & feed lines

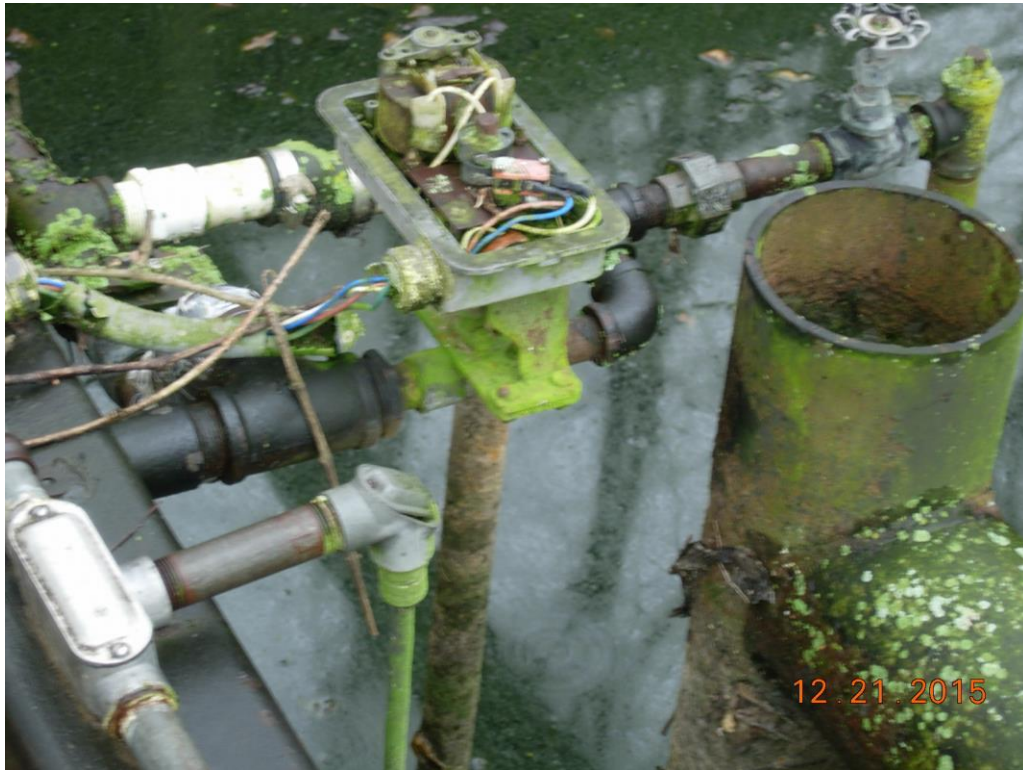
Deteriorated wiring conditions

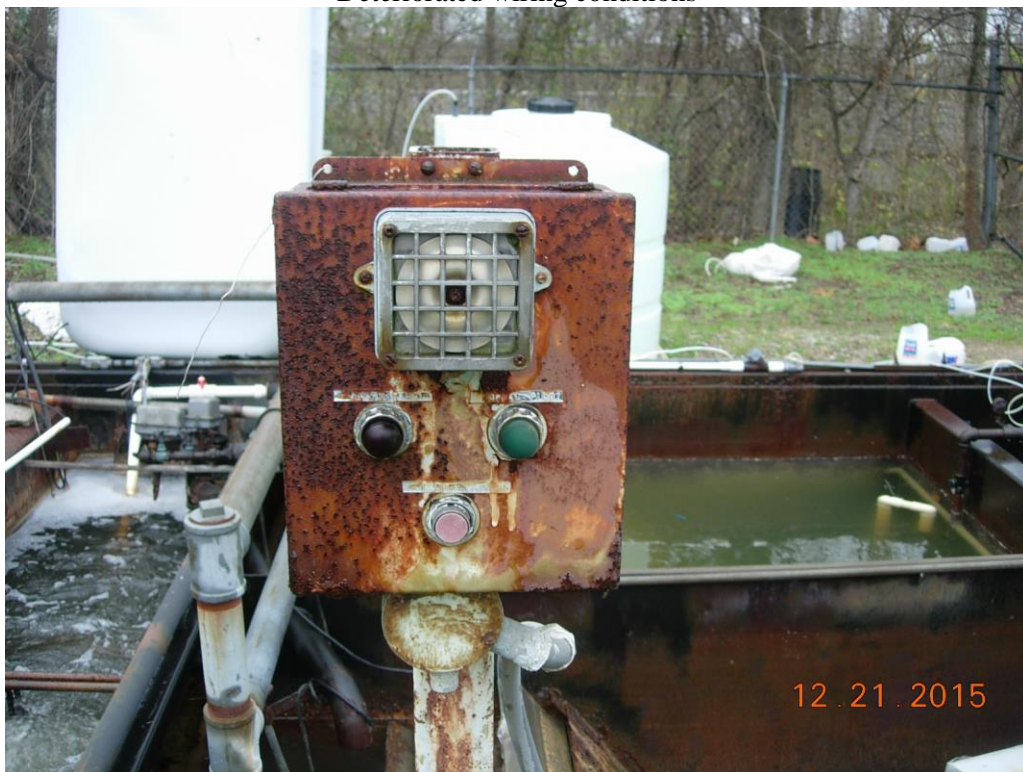
Deteriorated electrical system conditions

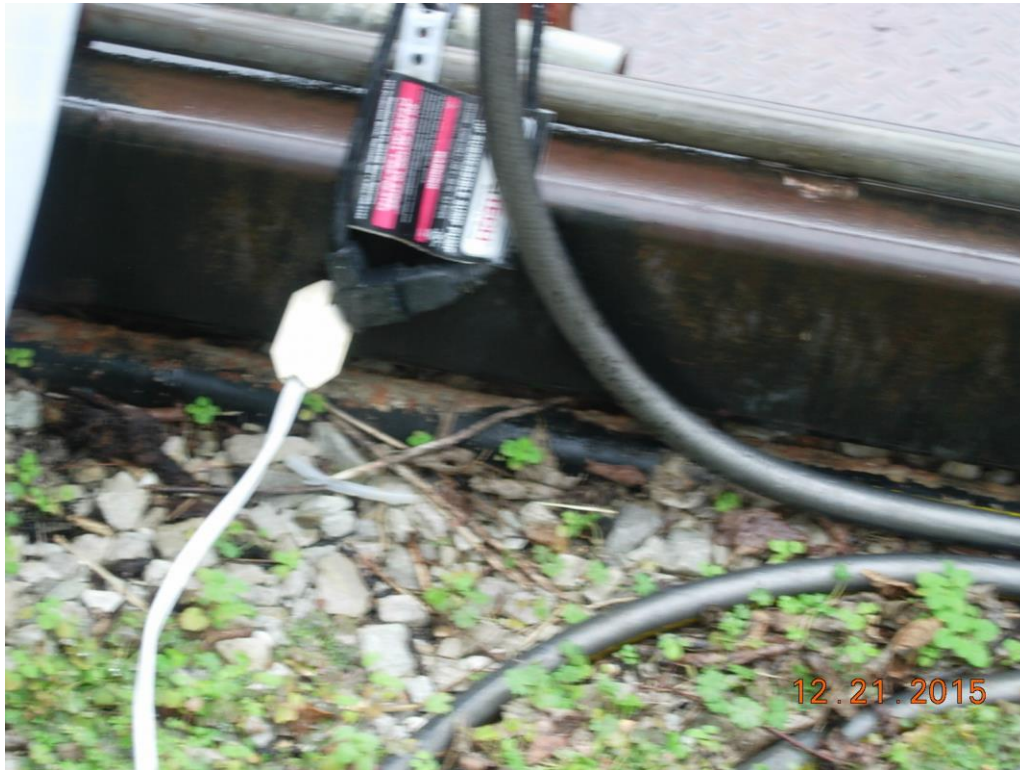
Example of extension cords used for wiring, exposed to wet weather & wastewater from treatment units

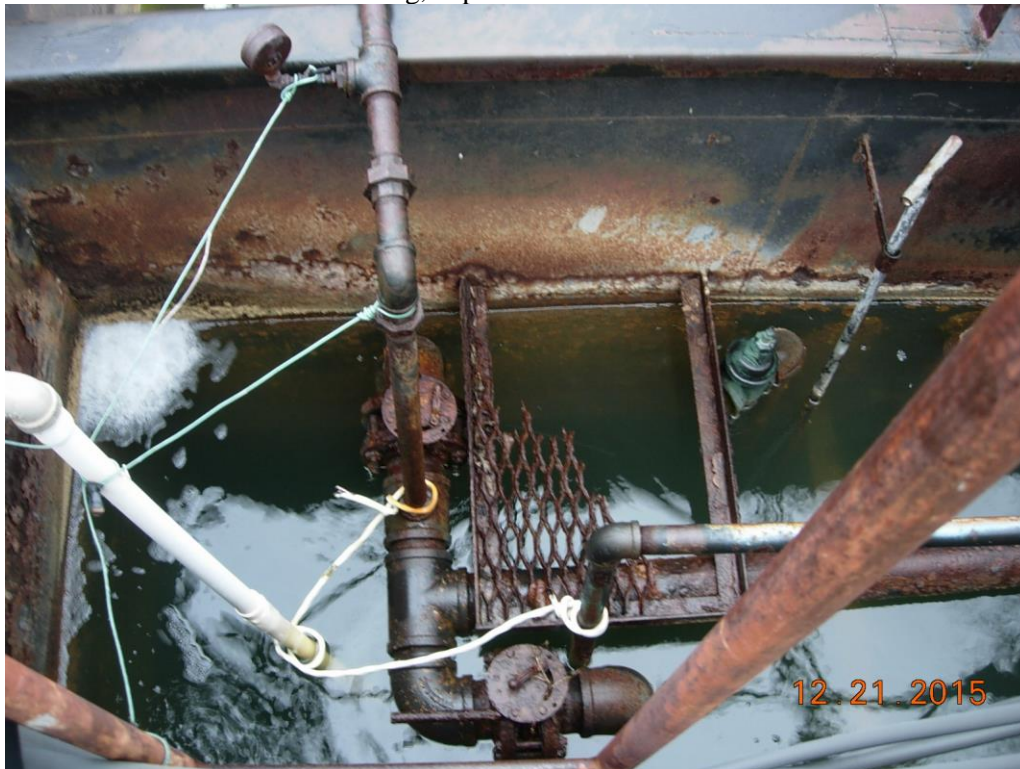
Corroded access platform & piping, makeshift piping for aeration in final effluent chamber

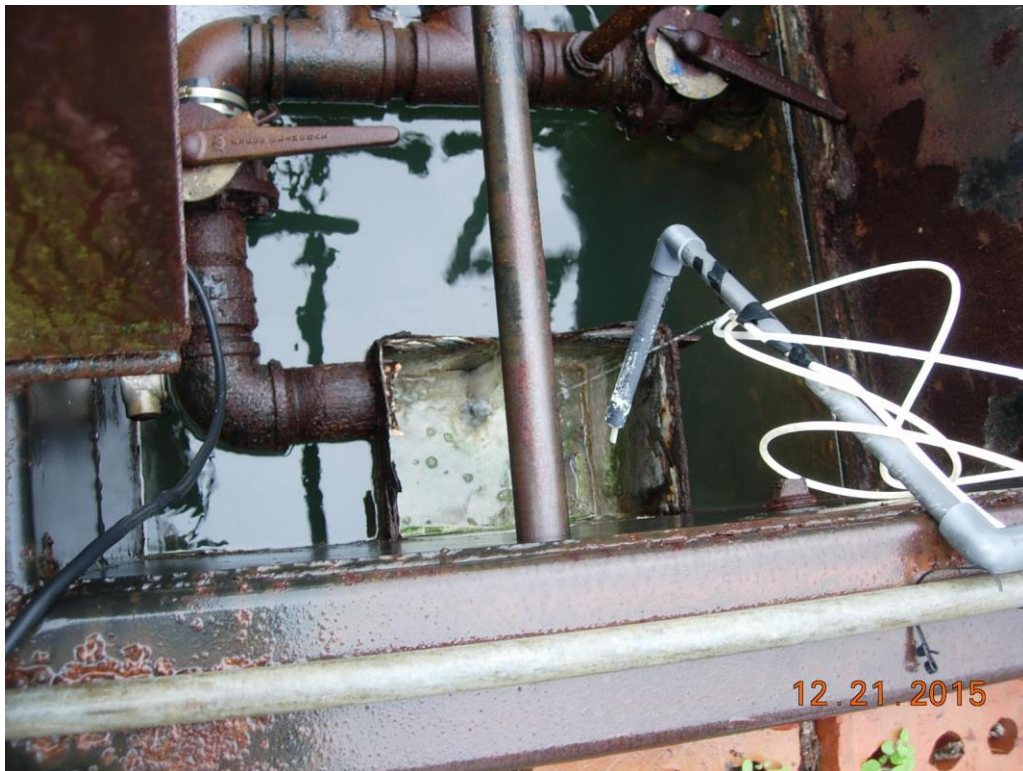
Corroded effluent weir box, Captor de-chlorination feed point, effluent discoloration in weir box

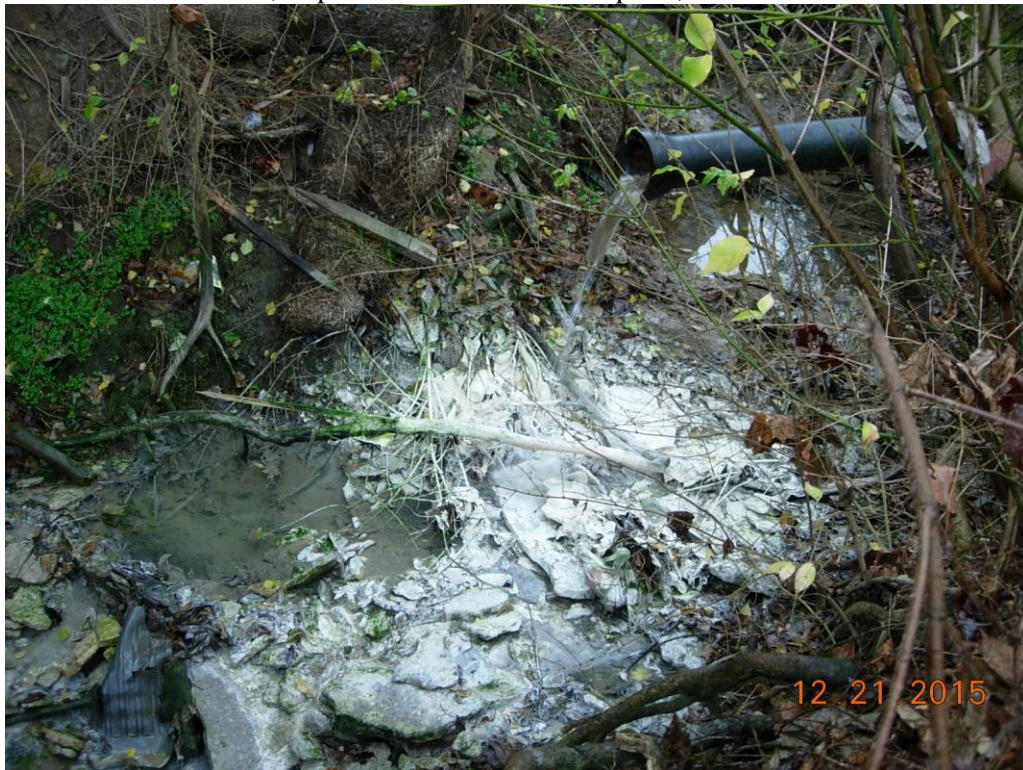
Effluent outfall pipe & discharge, cloudy/opaque effluent discharge, white precipitate & gray deposits in channel leading to receiving stream Fivemile Creek

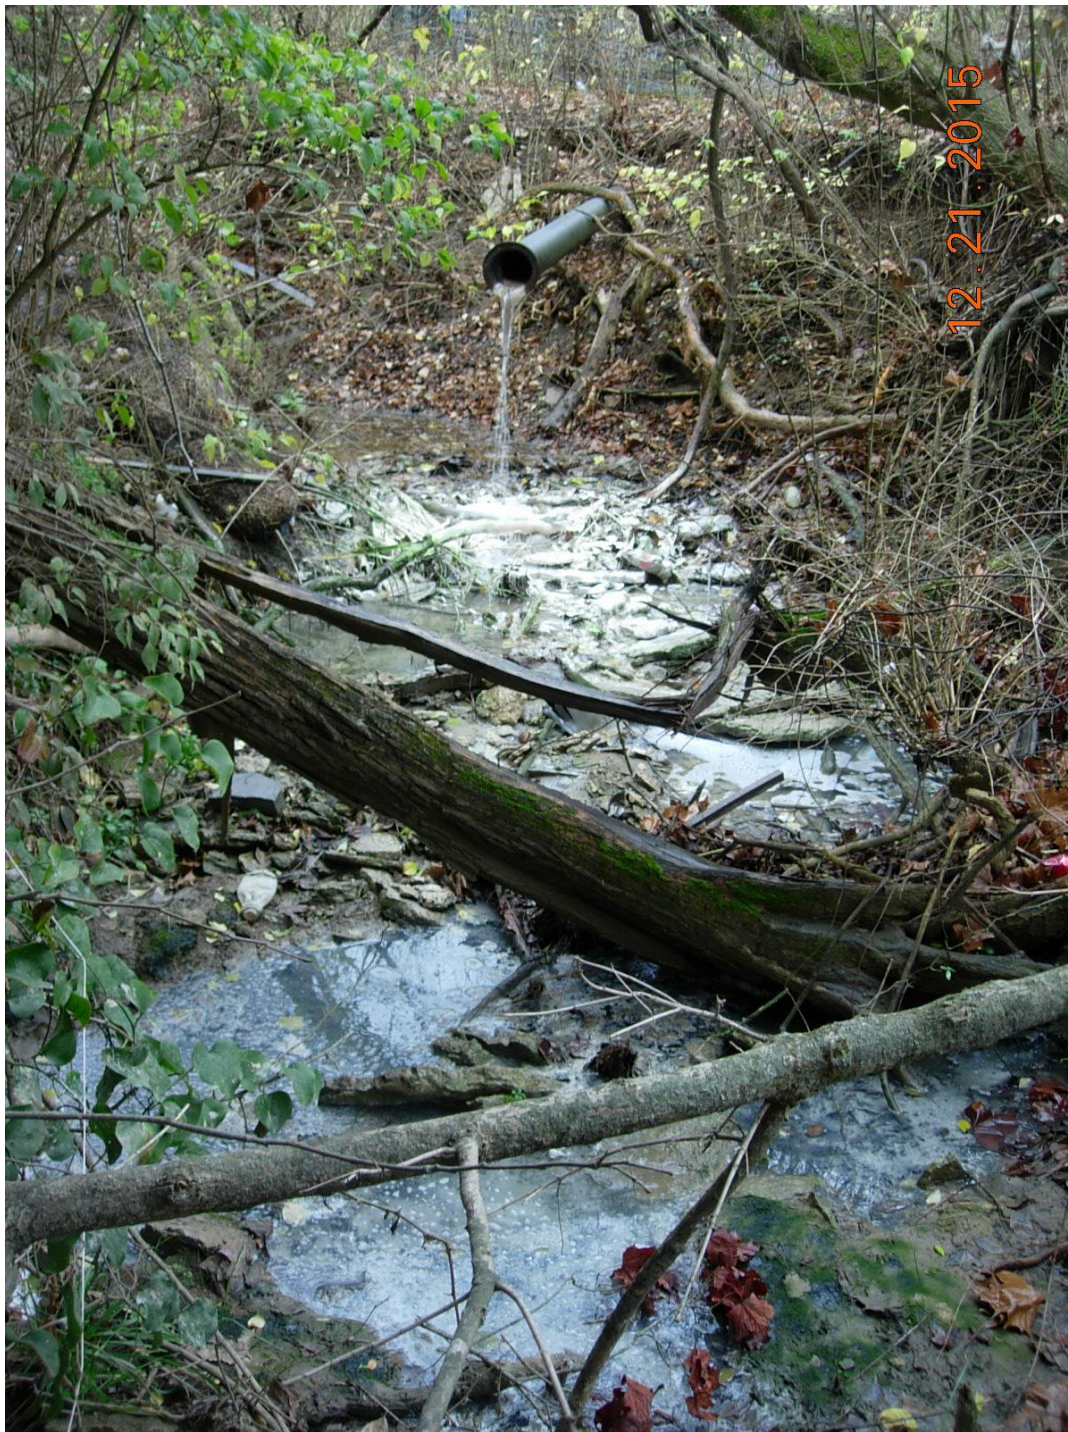
Effluent discharge pipe, cloudy/opaque effluent discharge, white & gray precipitate & deposits in channel leading into Fivemile Creek, effluent & deposits change from white to gray then to blackish color as it flows toward the stream

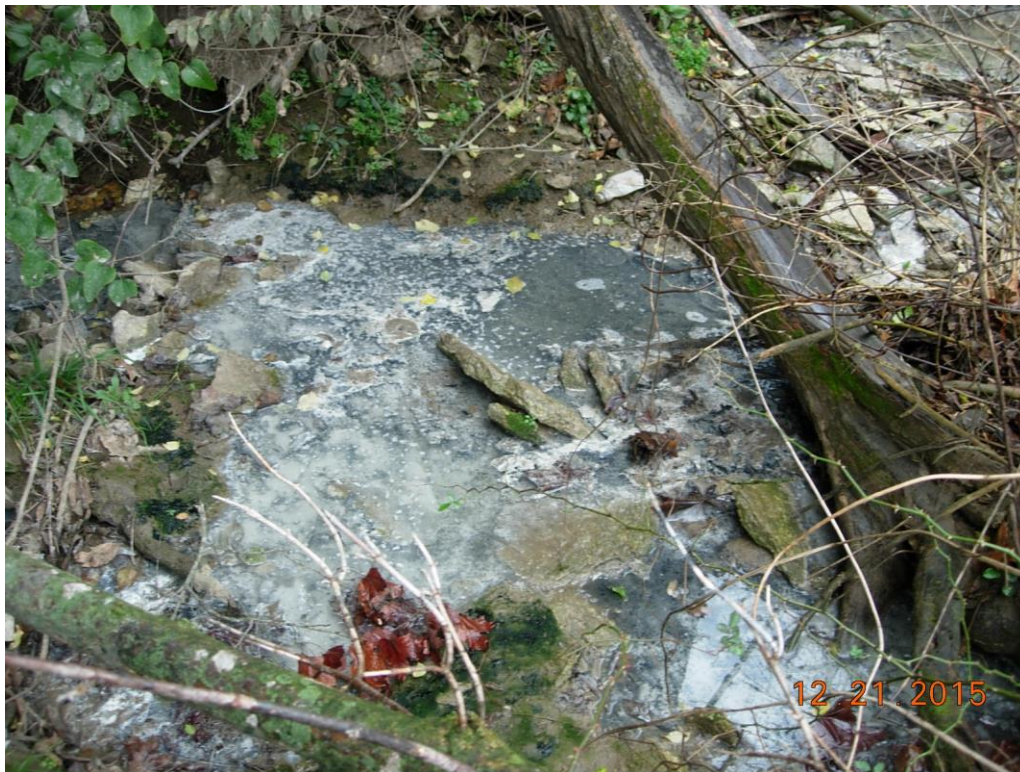
Gray precipitate & deposits in effluent flow

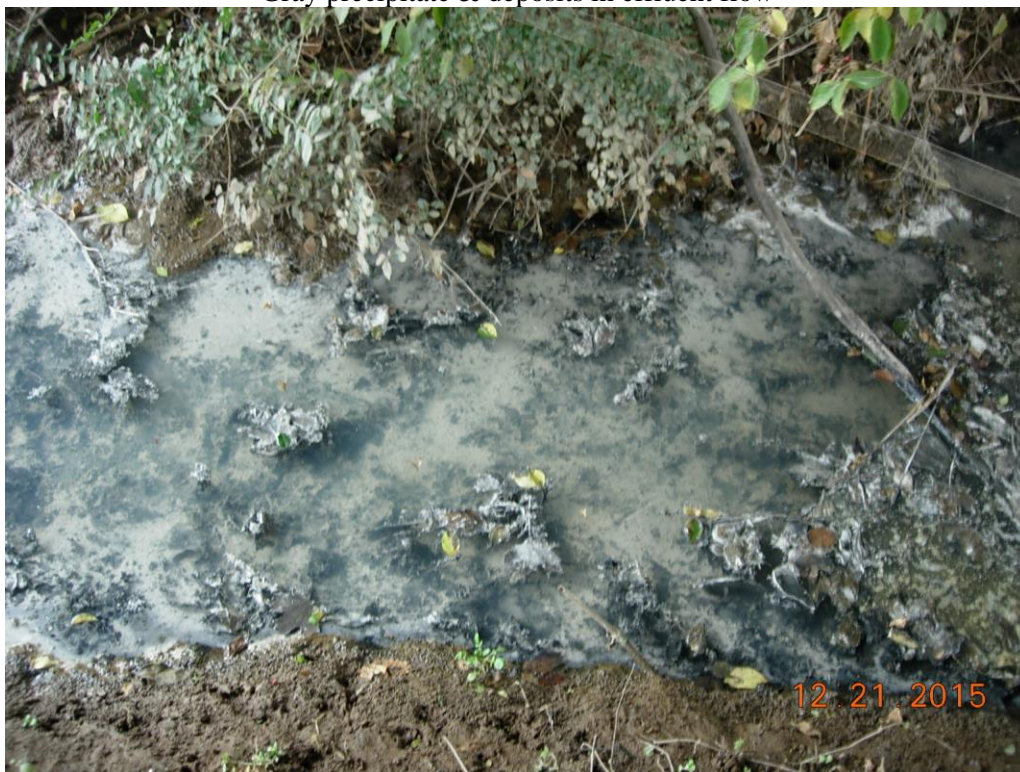
Gray & blackish precipitate & deposits in effluent flow

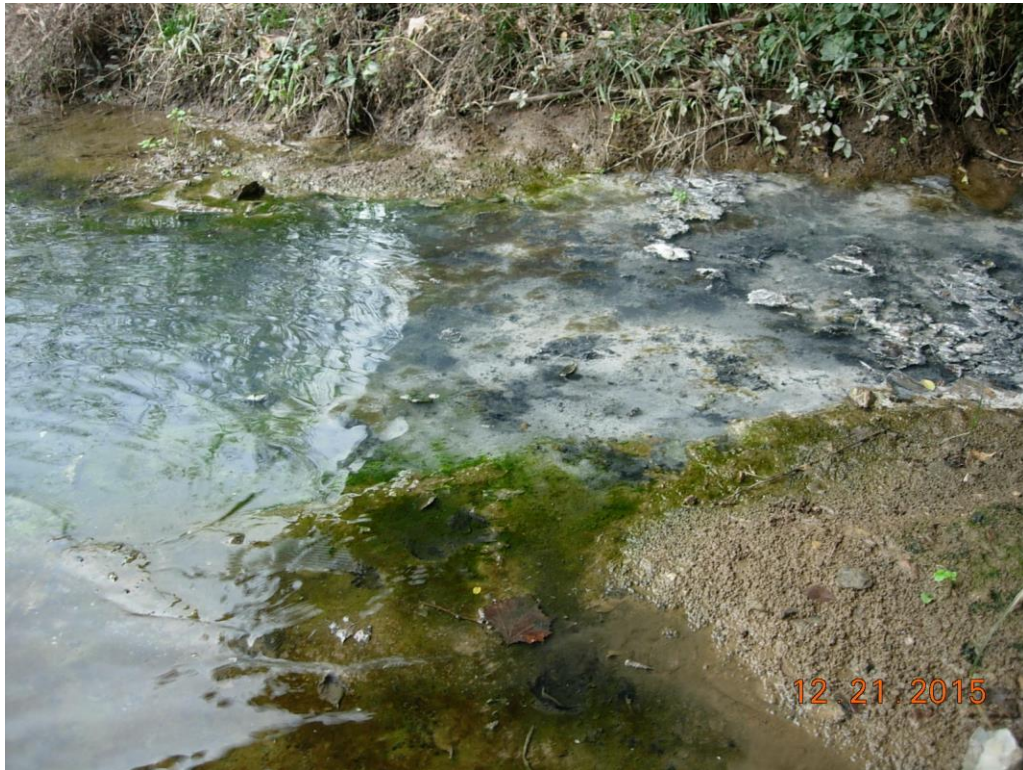
Effluent flow entering from the right into Fivemile Creek, gray & blackish precipitate & deposits

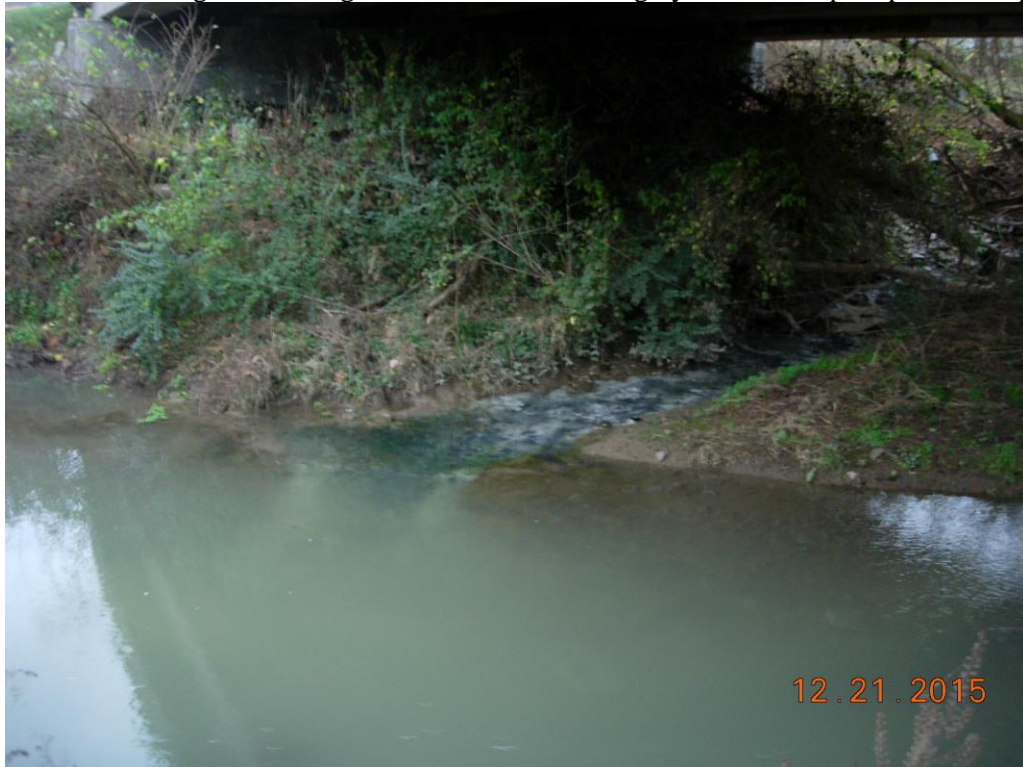
Effluent flow entering Fivemile Creek, showing gray & blackish precipitate & deposits, & discoloration of the receiving stream
