## Memorandum

*Subject: Preliminary Assessment of Robinson Lake Dam*  
*Franklin, Tennessee*

CDM Smith was engaged by the City of Franklin to perform a preliminary assessment of Robinson Lake Dam in Franklin, Tennessee. We understand that the City is considering acquiring the property on which the dam and lake are located. The purpose of the assessment is to identify potential dam safety deficiencies and provide recommendations for future actions.

**Robinson Lake Dam Inspection – June 12, 2017**

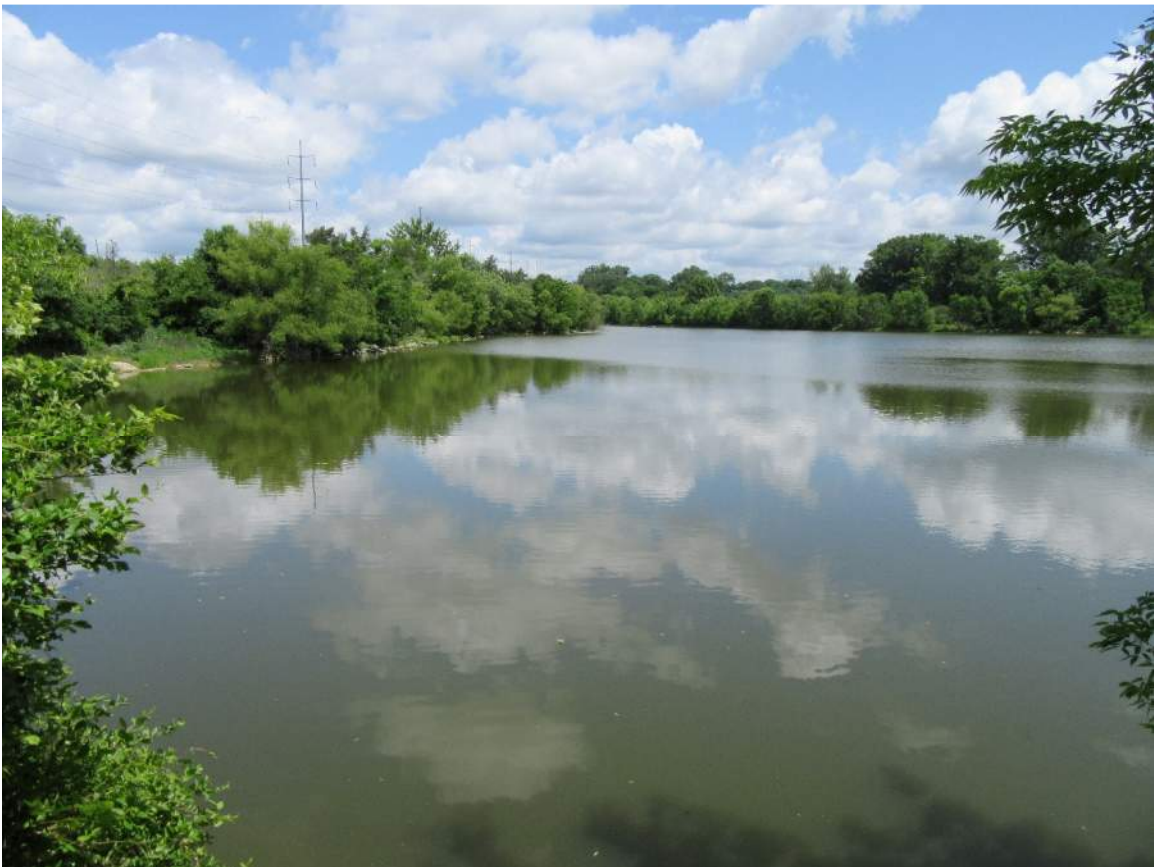
**Photo No. 1: Robinson Lake viewed from dam crest.**

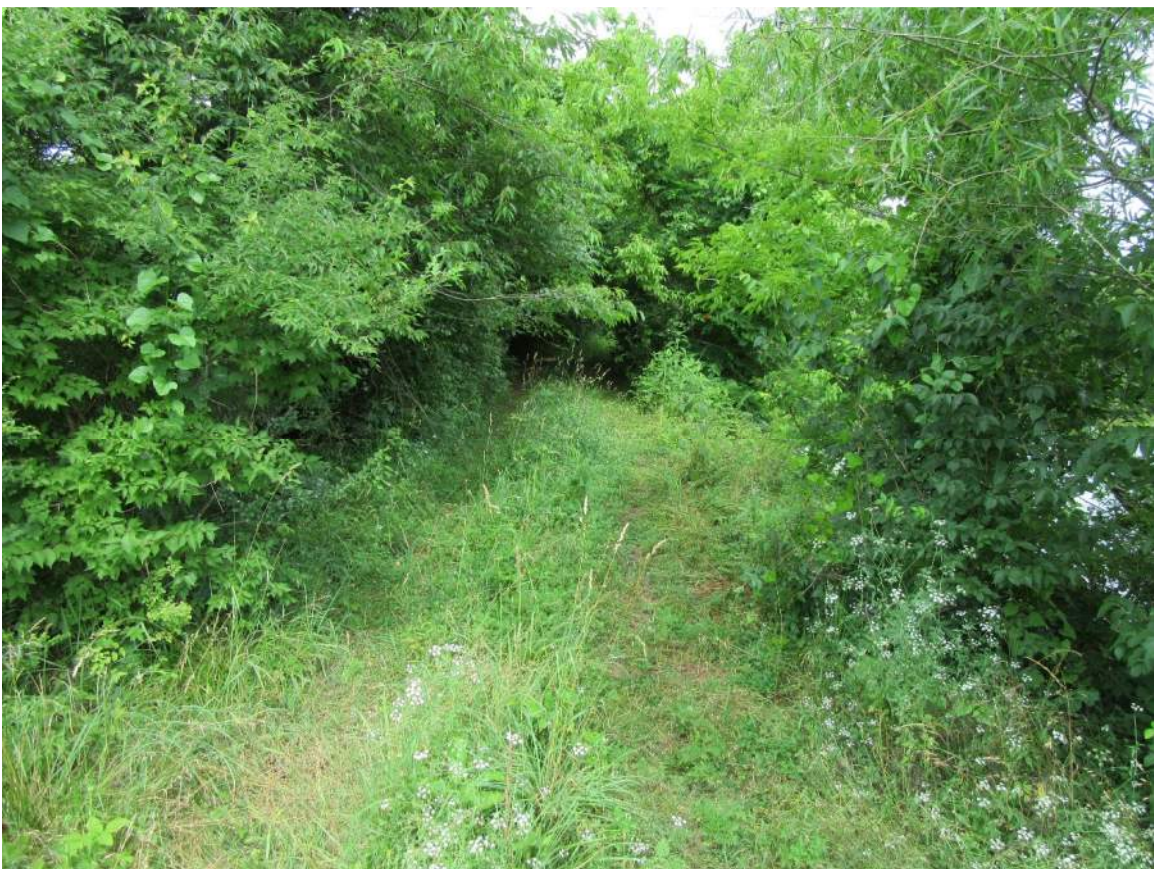
The crest is approximately 12 feet wide. The left portion is covered with tall grass and weeds, and the right portion is mostly bare with tall grass and weeds along both sides of the crest (Photos 2 and 3). There is a bare, slightly eroded area on the may be due to a previous overtopping event (Photo 4).

**Photo No. 2: Crest viewed from left abutment.**

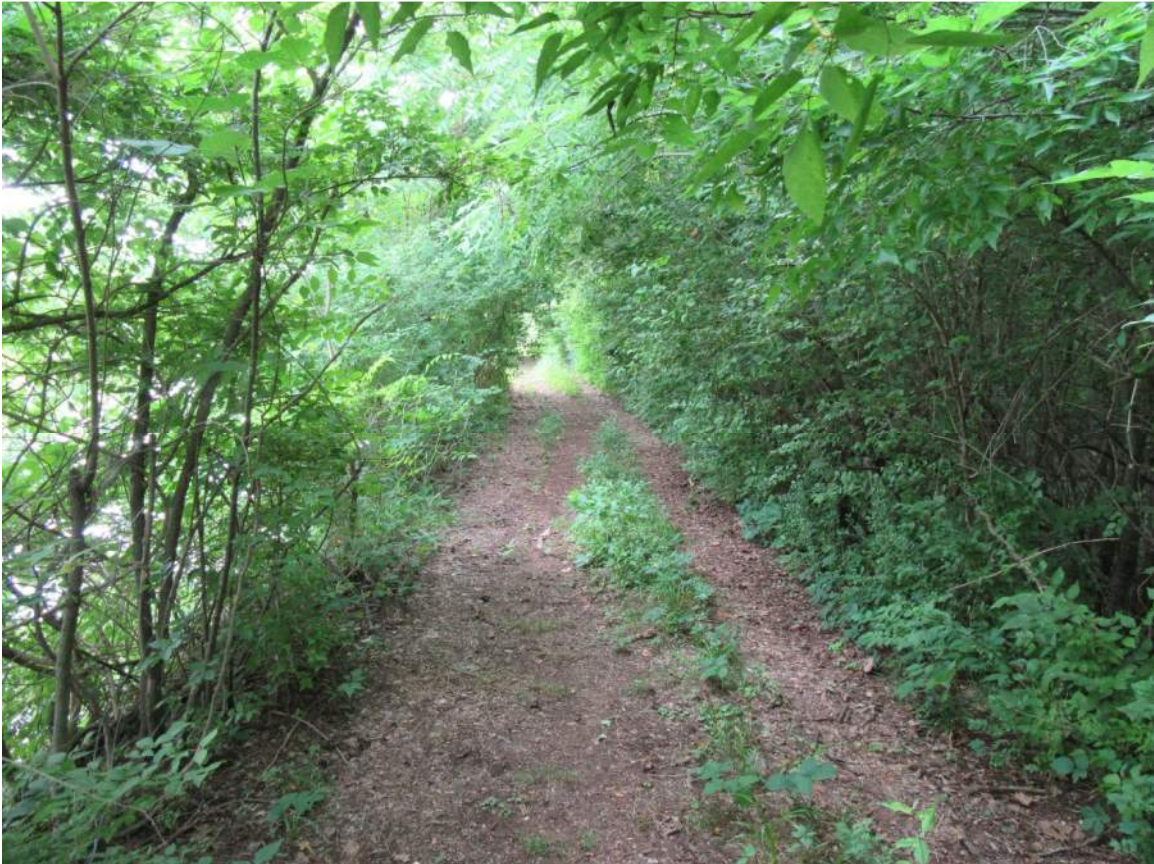
**Photo No. 3: Crest viewed from right abutment.**

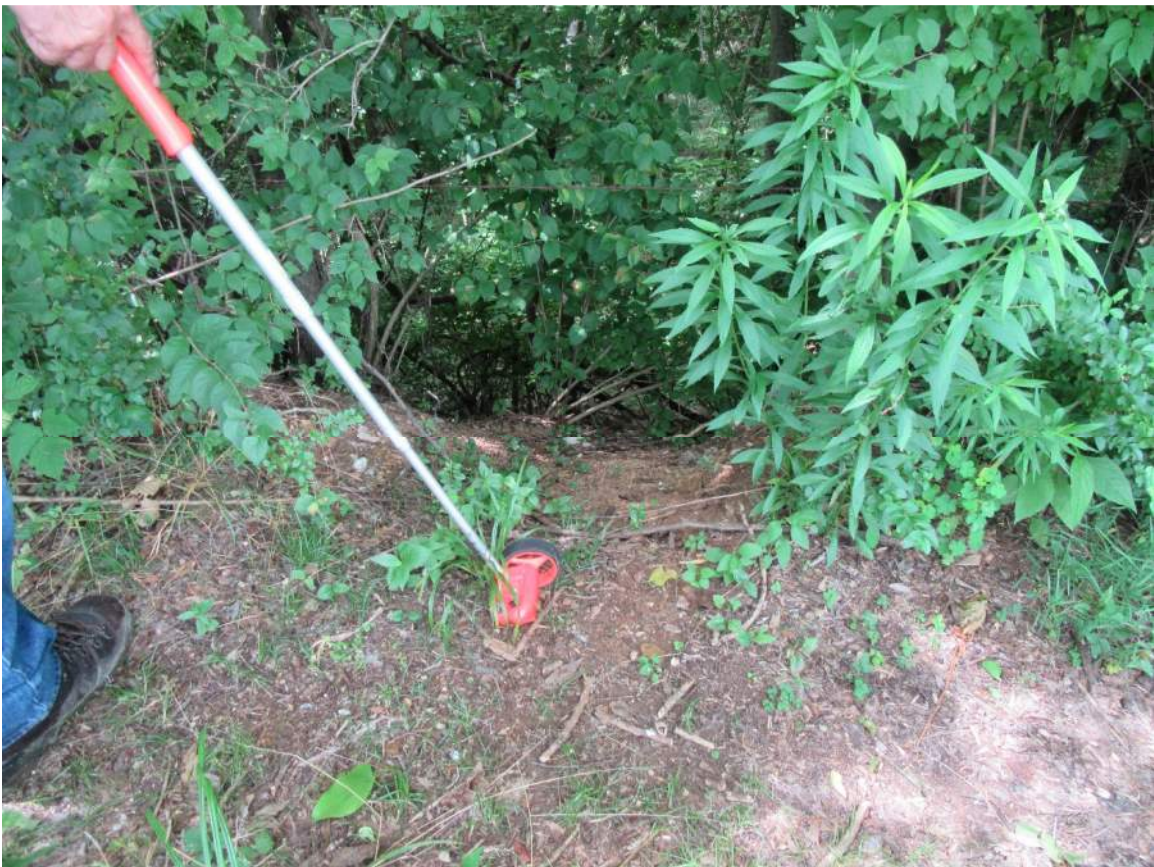
1. The slopes and downstream area are covered with large trees and heavy vegetation.
2. The upstream and downstream slopes are very steep.
3. The bare, eroded area on the crest and downstream slope may indicate previous overtopping of the dam during a flood event. If that is the case, the spillway capacity may be inadequate.

| ITEM | CONDITION | COMMENTS | MONITOR | INVESTIGATE | REPAIR |
|---|---|---|---|---|---|
| 7 | Warning Signs | Possible overtopping location observed. | <input type="checkbox"/> | <input checked="" type="checkbox"/> | <input type="checkbox"/> |

**Photo No. 4: Erosion on crest due to possible overtopping.**

1. Perform hydrologic/hydraulic analyses to evaluate the required spillway capacity for passing the design storm event without overtopping the dam.
2. Perform a geotechnical and geophysical investigation to evaluate the condition of the dam and foundation.

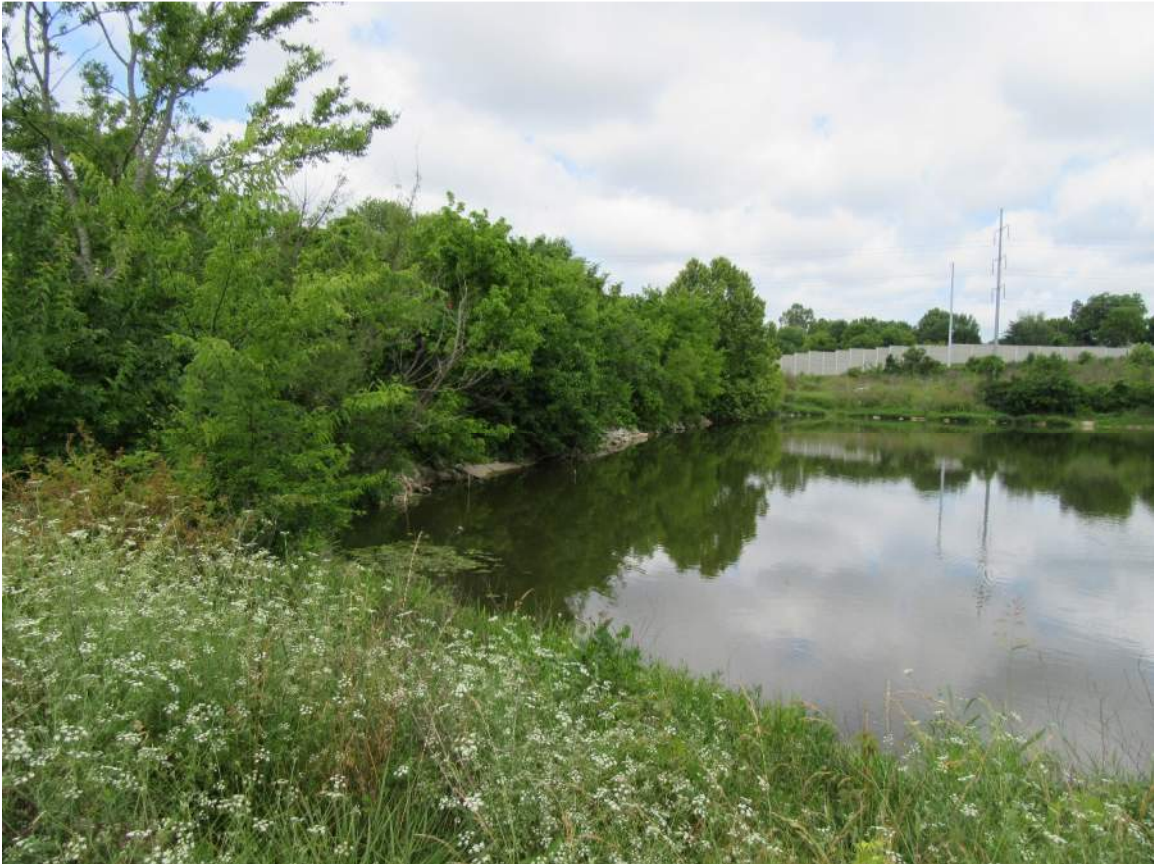
The upstream slope is covered with trees, brush, and tall weeds (Photos 5 and 6). The left portion of the slope is partially covered with riprap and concrete fragments (Photo 7). The trees are up to 12 inches in diameter (Photo 8). The slope is very steep, ranging from 1.5 horizontal to 1 vertical (1.5H:1V) to near vertical.

**Photo No. 5: Upstream slope viewed from left abutment.**

- a. Removal of all trees, root balls, and other vegetation.
  - b. Flattening the upstream and downstream slopes to 3H:1V. The downstream slope modification would include the installation of an internal drainage system to control seepage.

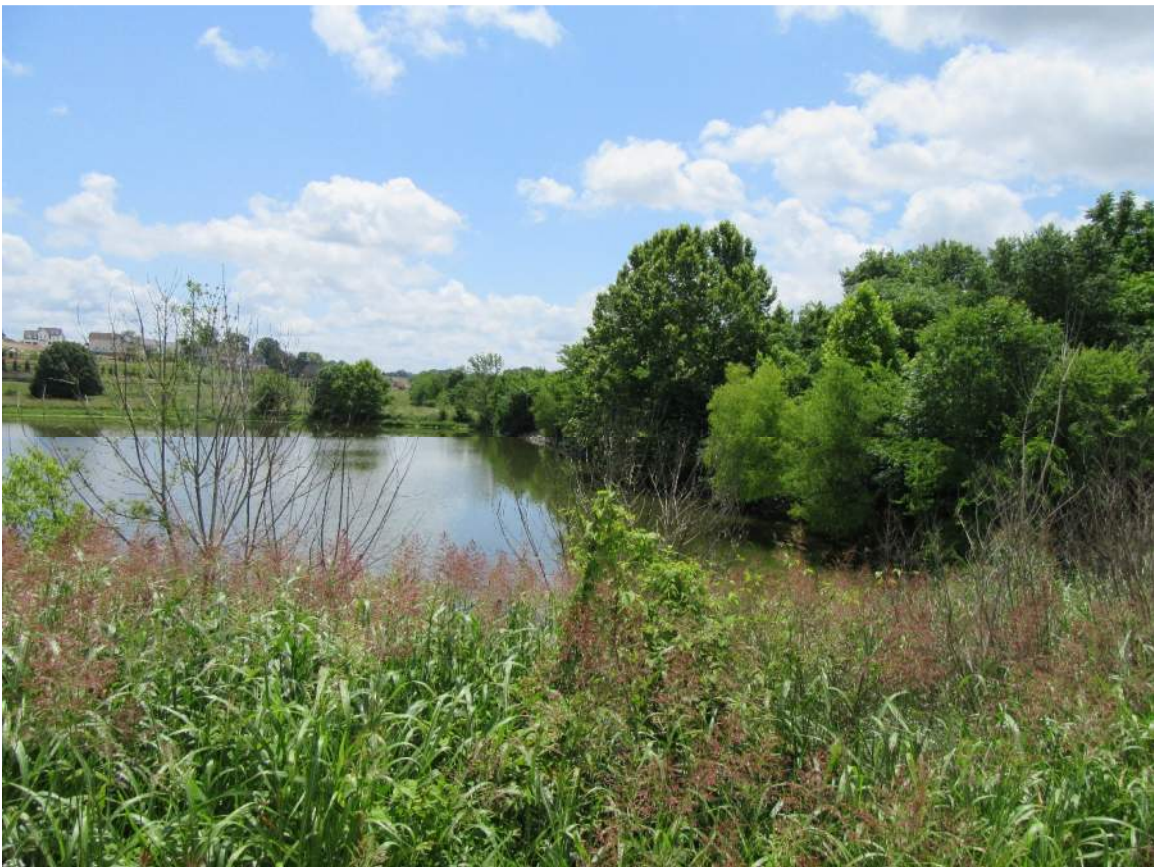
**Photo No. 6: Upstream slope viewed from right abutment.**

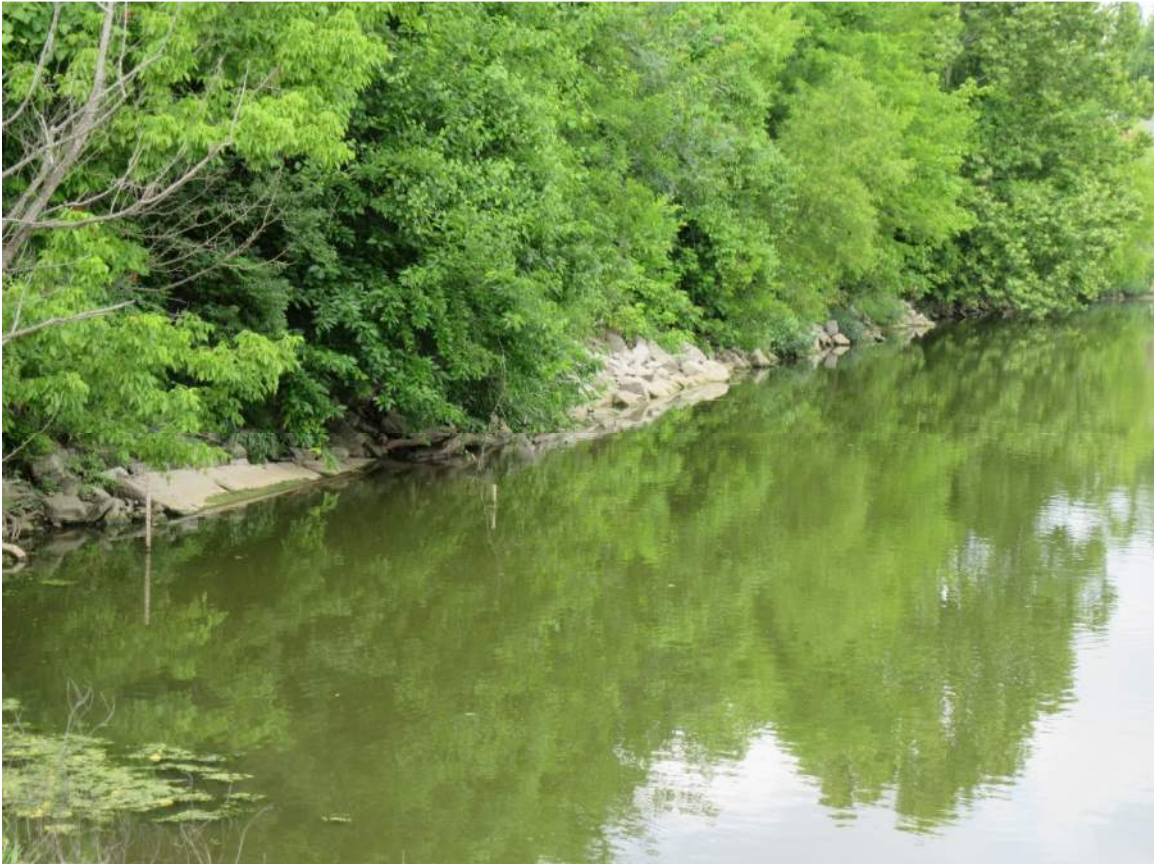
**Photo No. 7: Riprap present on portions of upstream slope.**

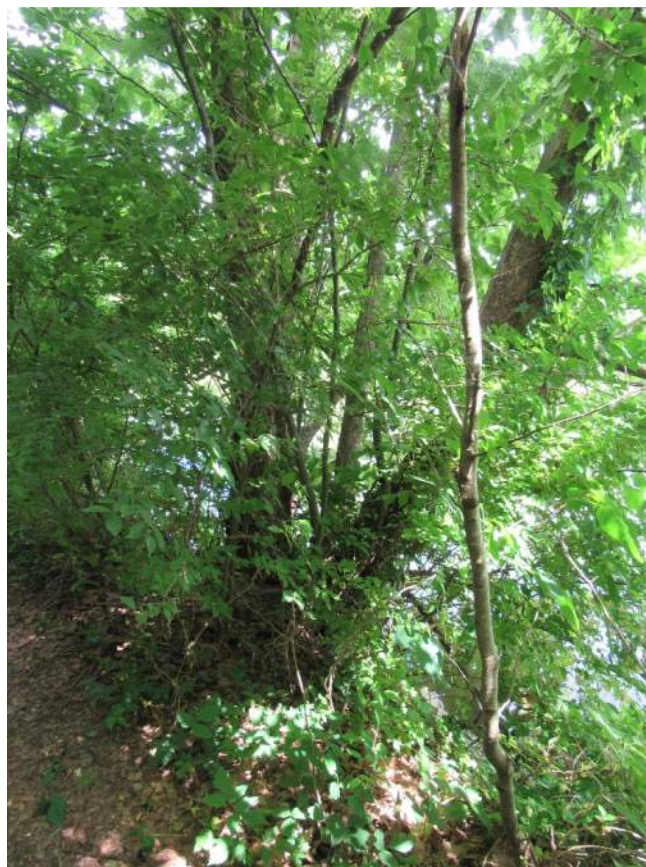
**Photo No. 8: Trees on upstream slope.**

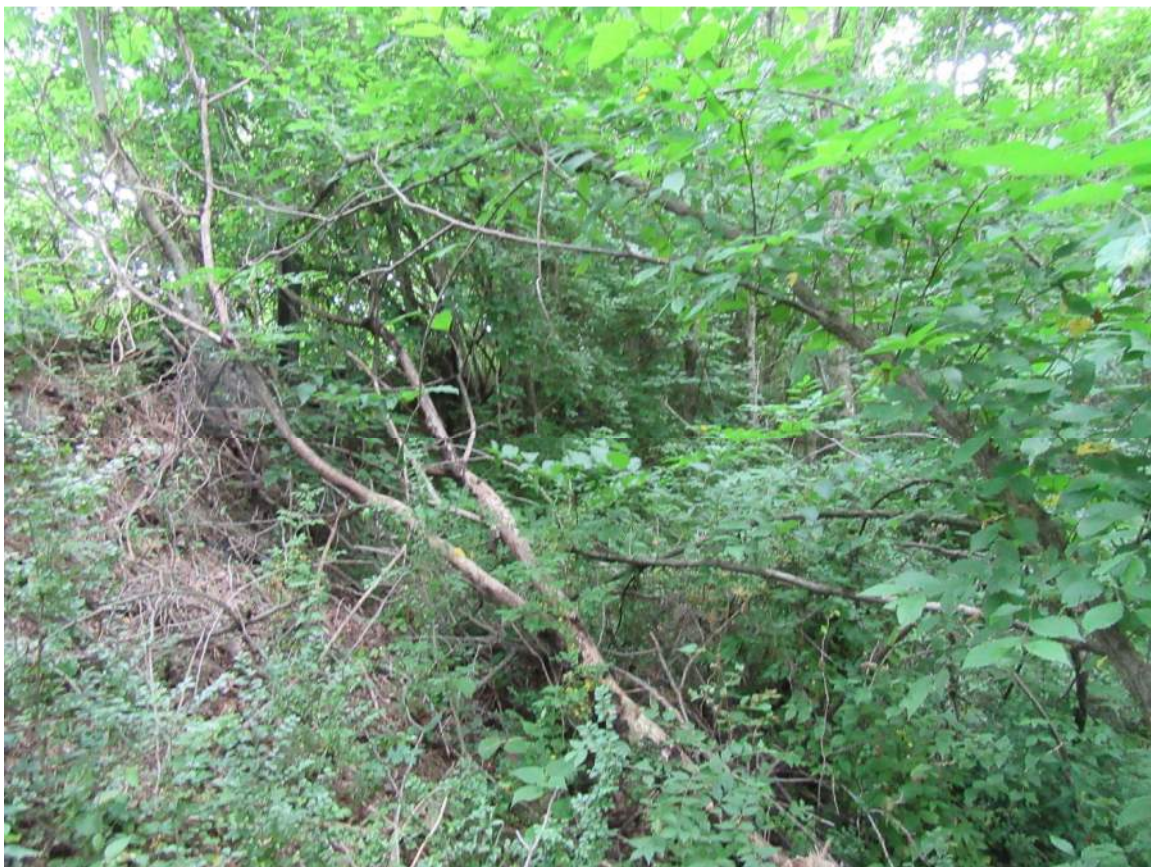
The downstream slope and downstream area are covered with leaves, vines, brush, and trees up to 12 inches in diameter (Photos 9 through 11). The downstream slope is steep, typically about 1.5H:1V. Photo 12 shows the bare, eroded area that may be due to a previous overtopping event.

**Photo No. 9: Downstream slope viewed from right abutment.**

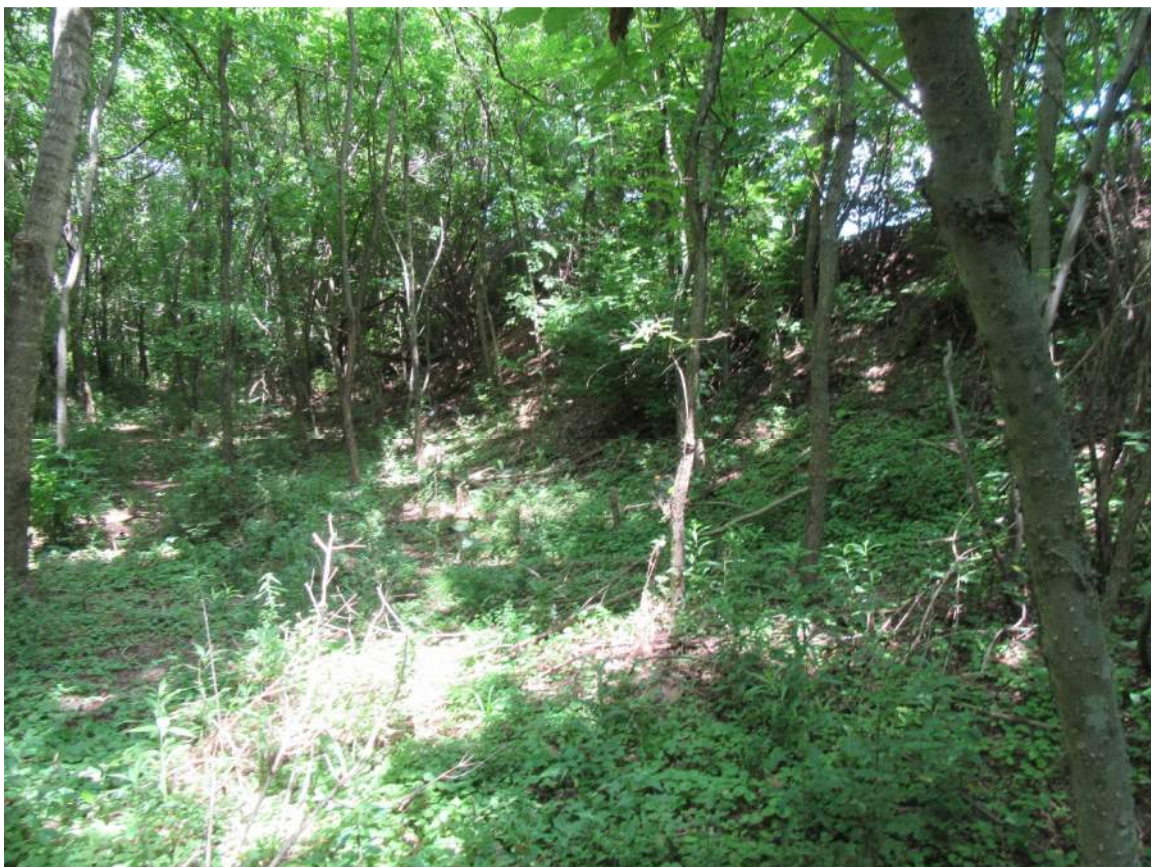
**Photo No. 10: Downstream slope and downstream area viewed from left abutment.**

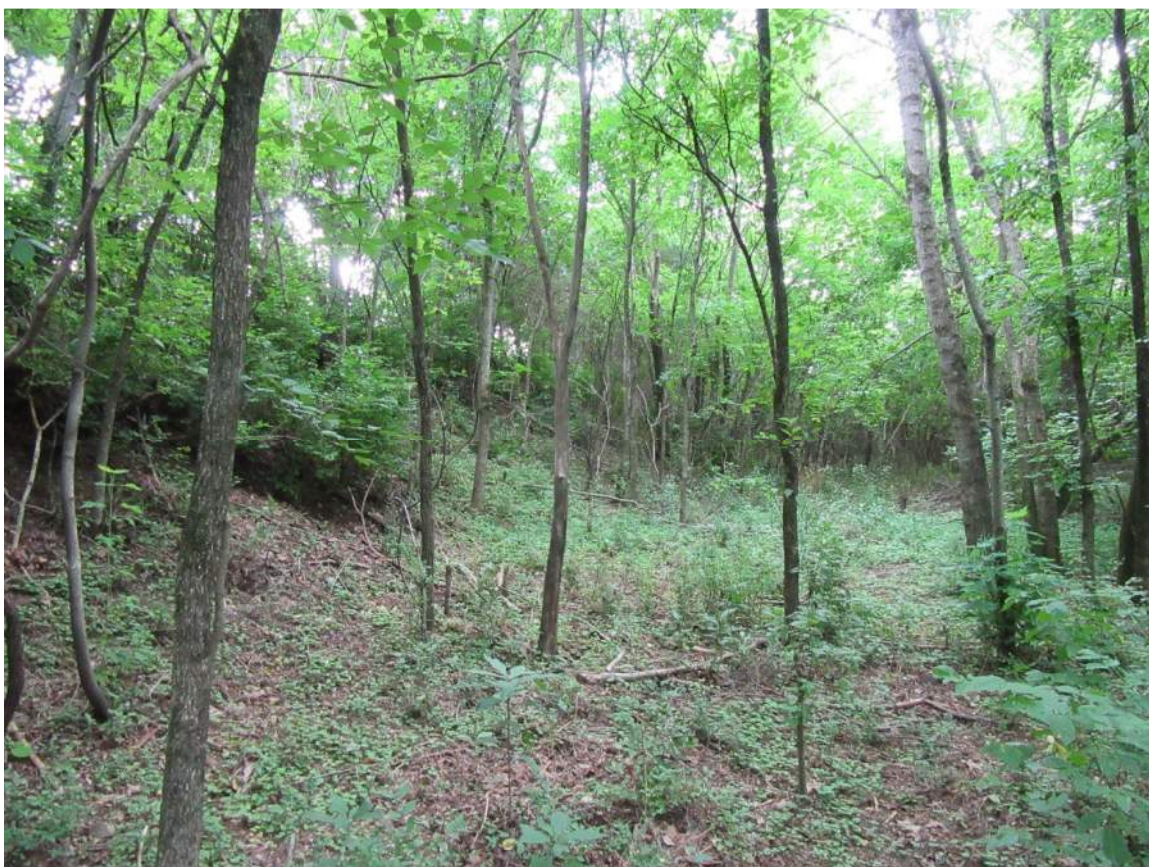
**Photo No. 11: Downstream slope and downstream area viewed from right abutment.**

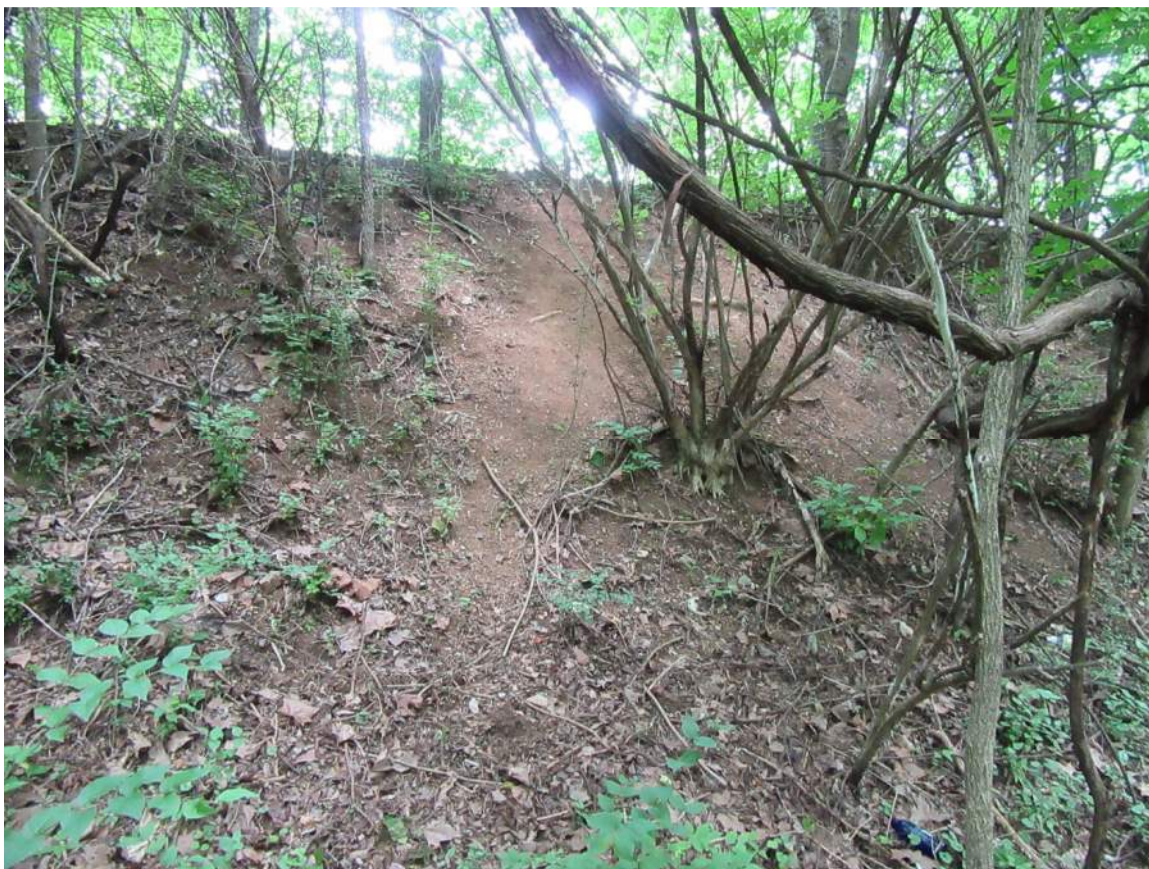
**Photo No. 12: Erosion on downstream slope due to possible overtopping.**

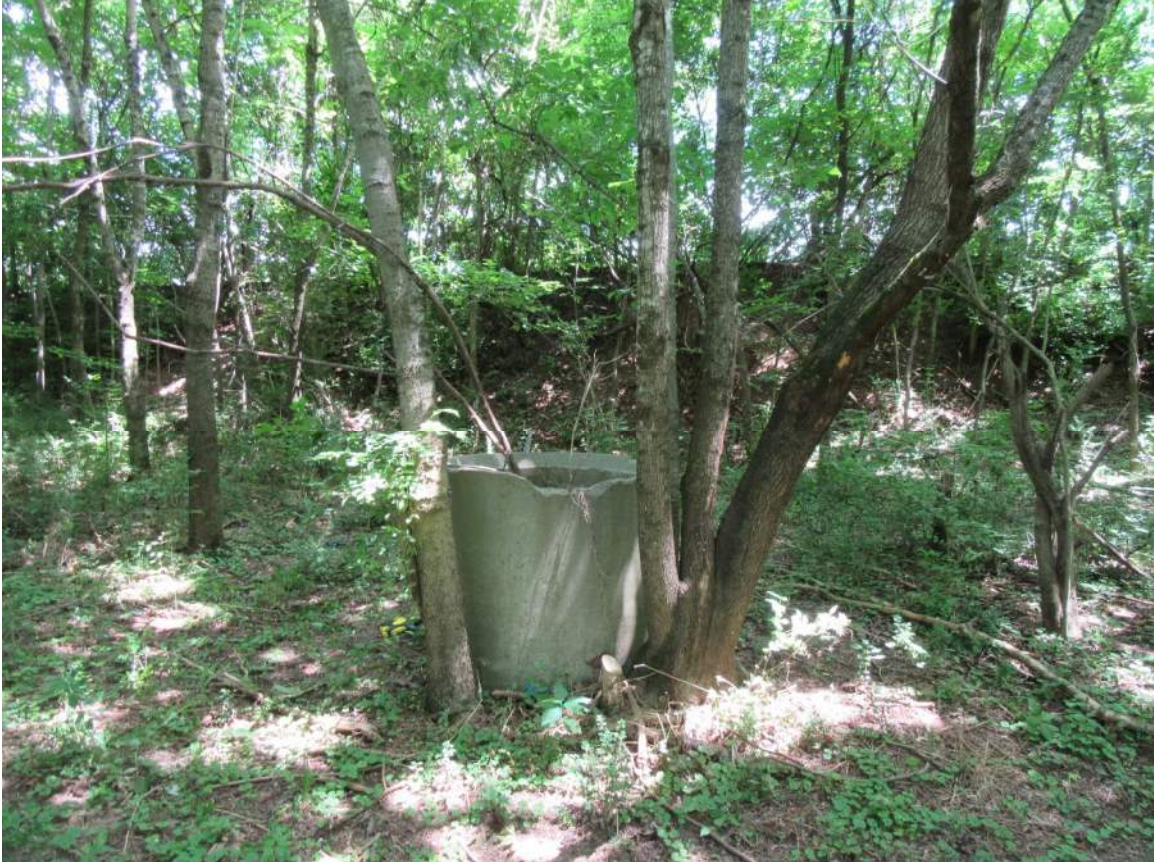
There is a vertical 36-inch-diameter RCP pipe located downstream of the dam (Photo 13). The pipe is 12 feet long and extends 8 feet below the ground surface. The bottom of the pipe has three feet of muck or sediment. No outlet pipes were observed.

| ITEM | CONDITION | COMMENTS | MONITOR | INVESTIGATE | REPAIR |
|---|---|---|---|---|---|
| <p>Additional Comments (Refer to item number if applicable):</p> <p>78. RCP pipe is 12 feet long and extends 8 feet below ground surface. The bottom has about 3 feet of muck. No outlet pipes were observed.</p> | | | | | |

**Photo No. 13: 36-inch-diameter RCP pipe downstream of dam.**

- e. Constructing a low-level outlet combined with a drop inlet spillway to serve as the principal spillway

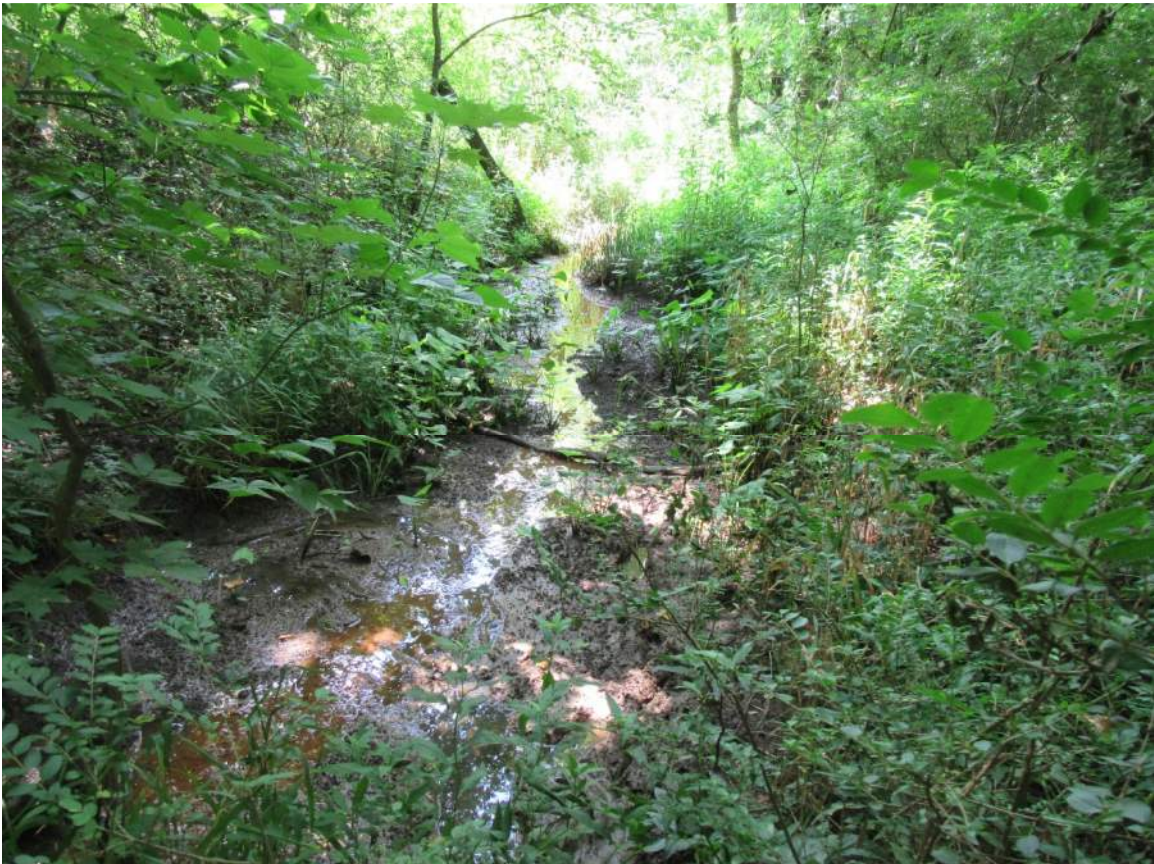
There is significant seepage downstream of the RCP pipe (Photos 14 and 15). The seepage flows downstream and discharges at a drop-off to the Harpeth River. There appeared to be seepage emerging at the base of the drop-off, adjacent to the river.

| ITEM | CONDITION | COMMENTS | MONITOR | INVESTIGATE | REPAIR |
|---|---|---|---|---|---|
| 39 | Foundation Seepage | Seepage downstream of RCP standpipe. | <input type="checkbox"/> | <input checked="" type="checkbox"/> | <input type="checkbox"/> |

**Photo No. 14: Seepage downstream of RCP pipe.**

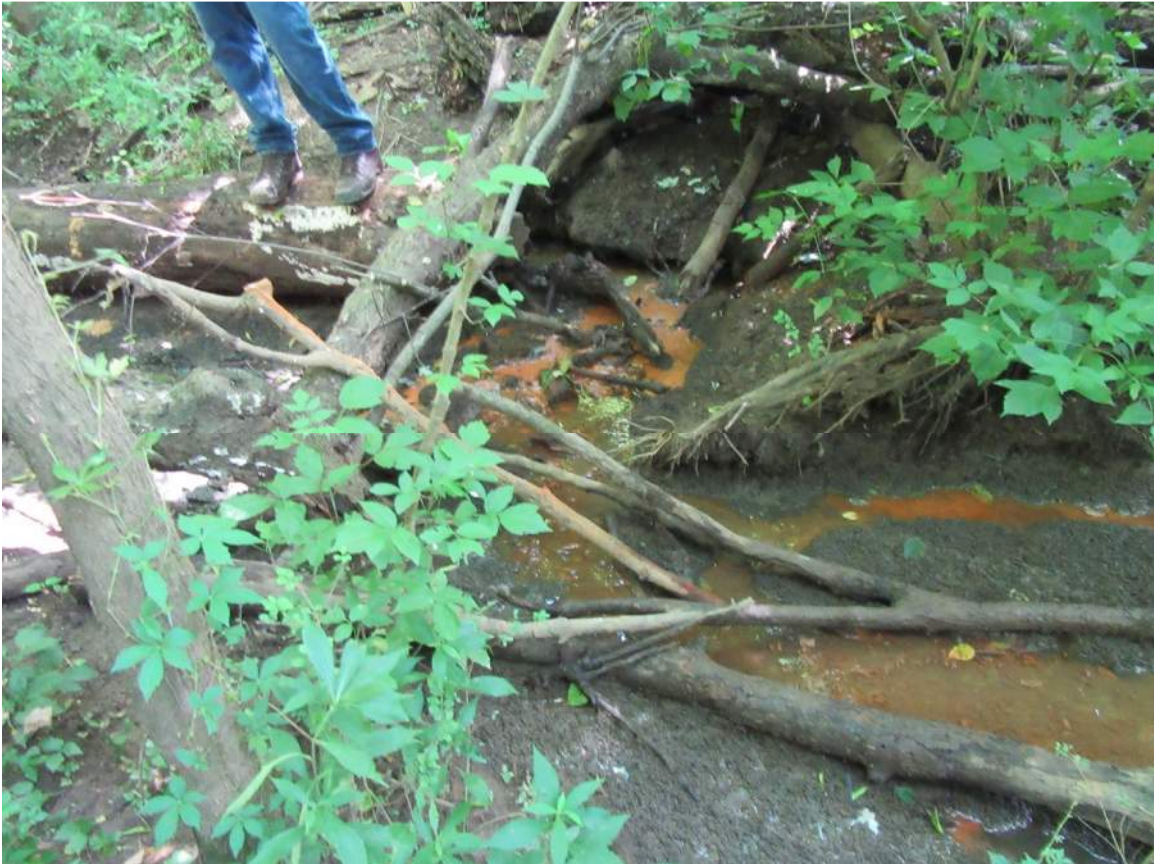
**Photo No. 15: Seepage downstream of RCP pipe.**

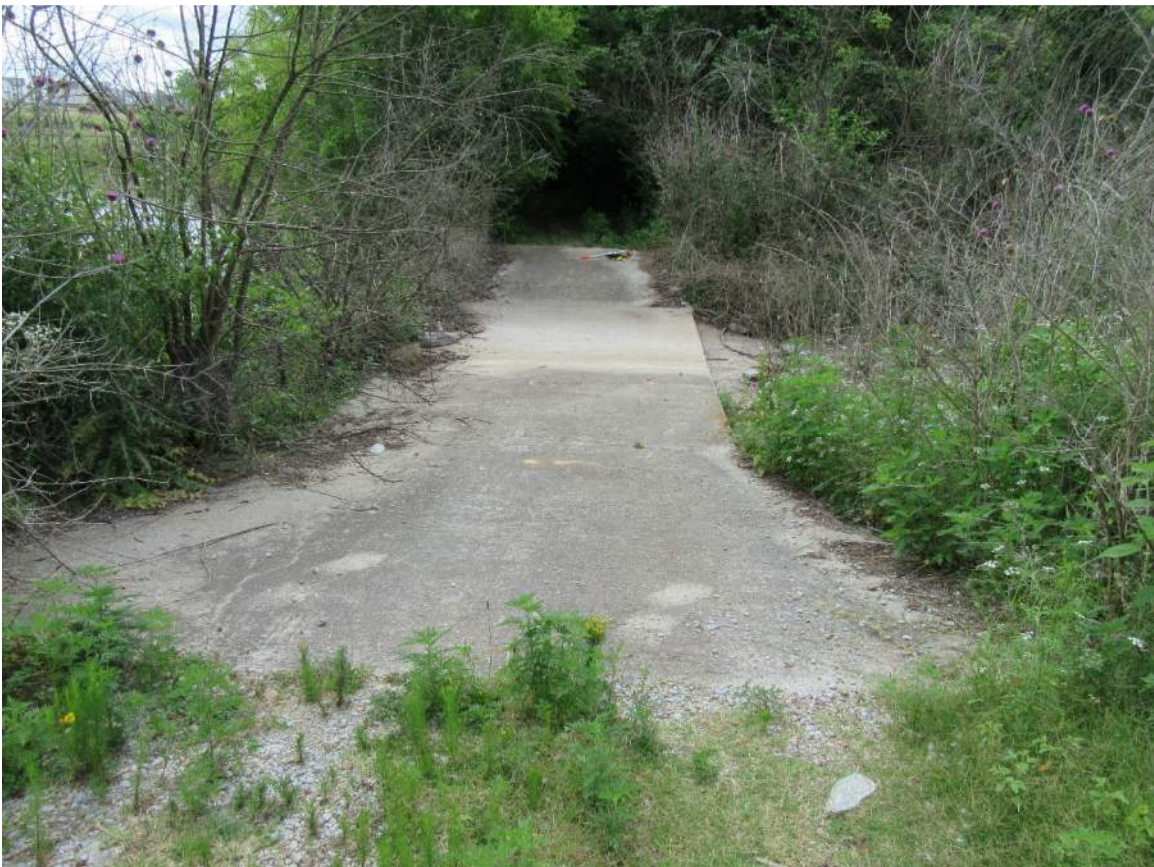
The spillway is located in the right abutment and consists of a trapezoidal concrete weir and discharge channel. The weir is about 46.5 wide with a 25-foot bottom width (Photo16). There is a partially intact fence along the upstream side of the weir that apparently serves as a trash guard (Photo 17). There are small trees and brush in the approach channel upstream of the fence.

**Photo No. 16: Spillway weir viewed from right abutment.**

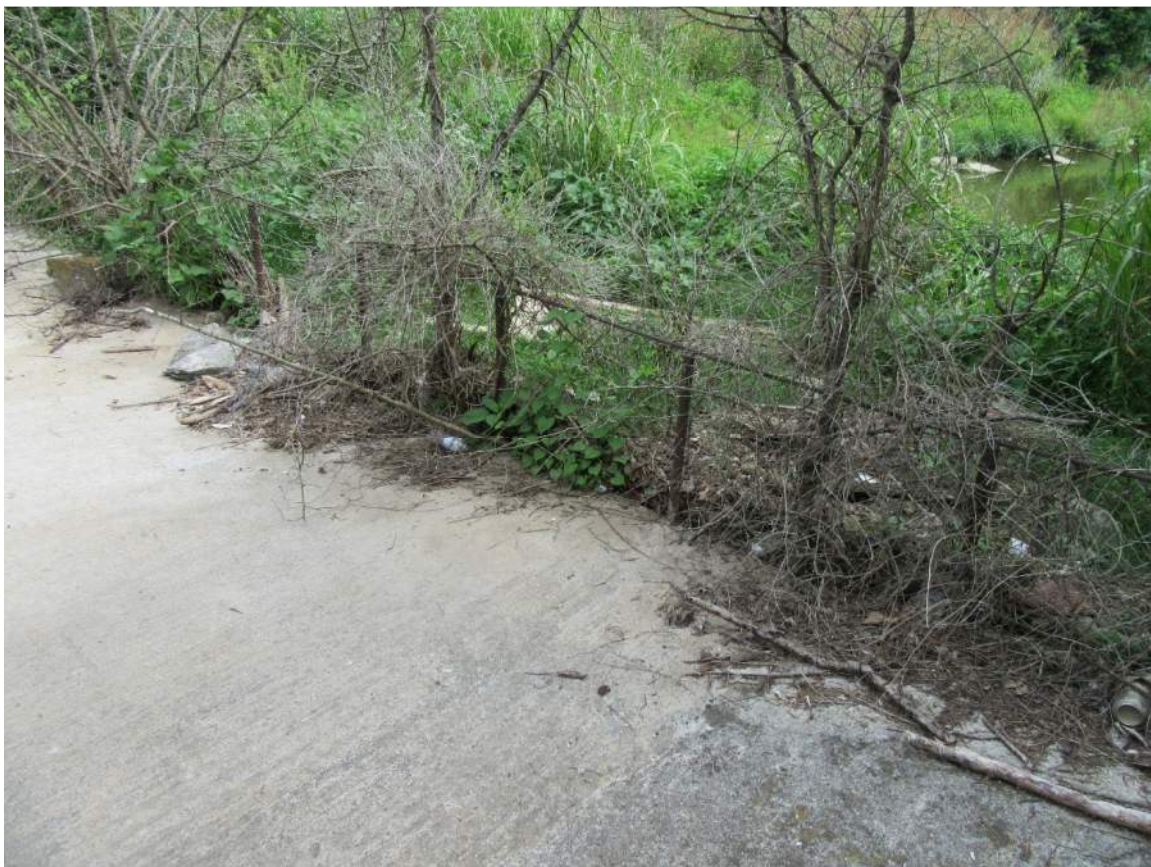
7. There are trees and brush in the approach area to the spillway that will reduce spillway capacity. In addition, the fence along the upstream side of the weir can collect debris and reduce spillway capacity.

**Photo No. 17: Fence (trash guard) on upstream side of spillway weir.**

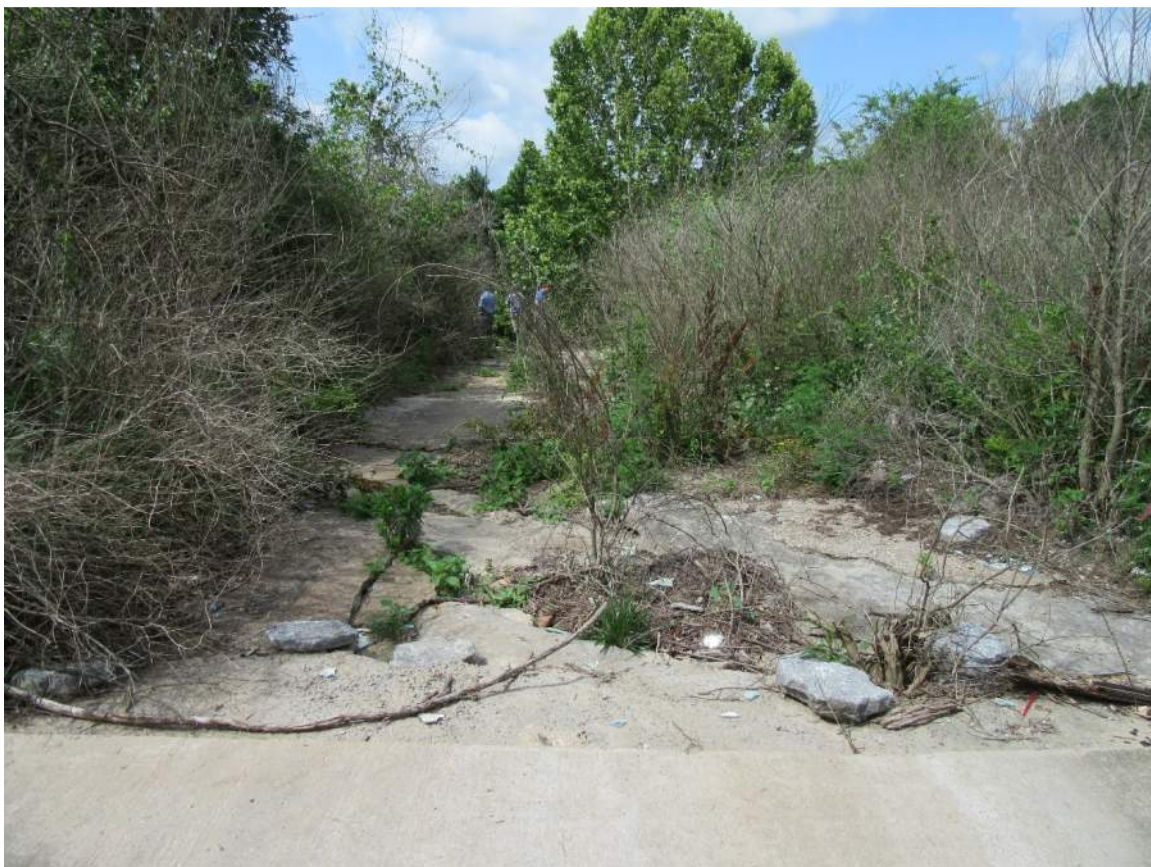
The concrete discharge channel is heavily cracked and has brush growing in the channel bottom and sloped walls (Photos 18 and 19). The channel ends at limestone bedrock (Photo 20) where there is a 15-foot-high drop-off down to the river. Seepage was flowing through the limestone face (Photo 21). In addition, seepage was flowing from the river bank to the left of the limestone face (Photos 22 and 23). Total seepage flow was about 100 to 200 gpm. There was erosion in the seepage area, but the seepage flow appeared to be clear.

8. The concrete in the spillway discharge channel is badly cracked and has brush growing in the bottom and sides of the channel.

| ITEM | CONDITION | COMMENTS | MONITOR | INVESTIGATE | REPAIR |
|---|---|---|---|---|---|
| 57 | Channel Floor | Concrete floor is heavily cracked. | <input type="checkbox"/> | <input checked="" type="checkbox"/> | <input type="checkbox"/> |

**Photo No. 18: Spillway discharge channel viewed looking downstream.**

- c. Repairing or replacing the existing spillway. The spillway modification or replacement would include a drainage system to control seepage.
  - d. Grouting bedrock in the spillway area to reduce seepage.

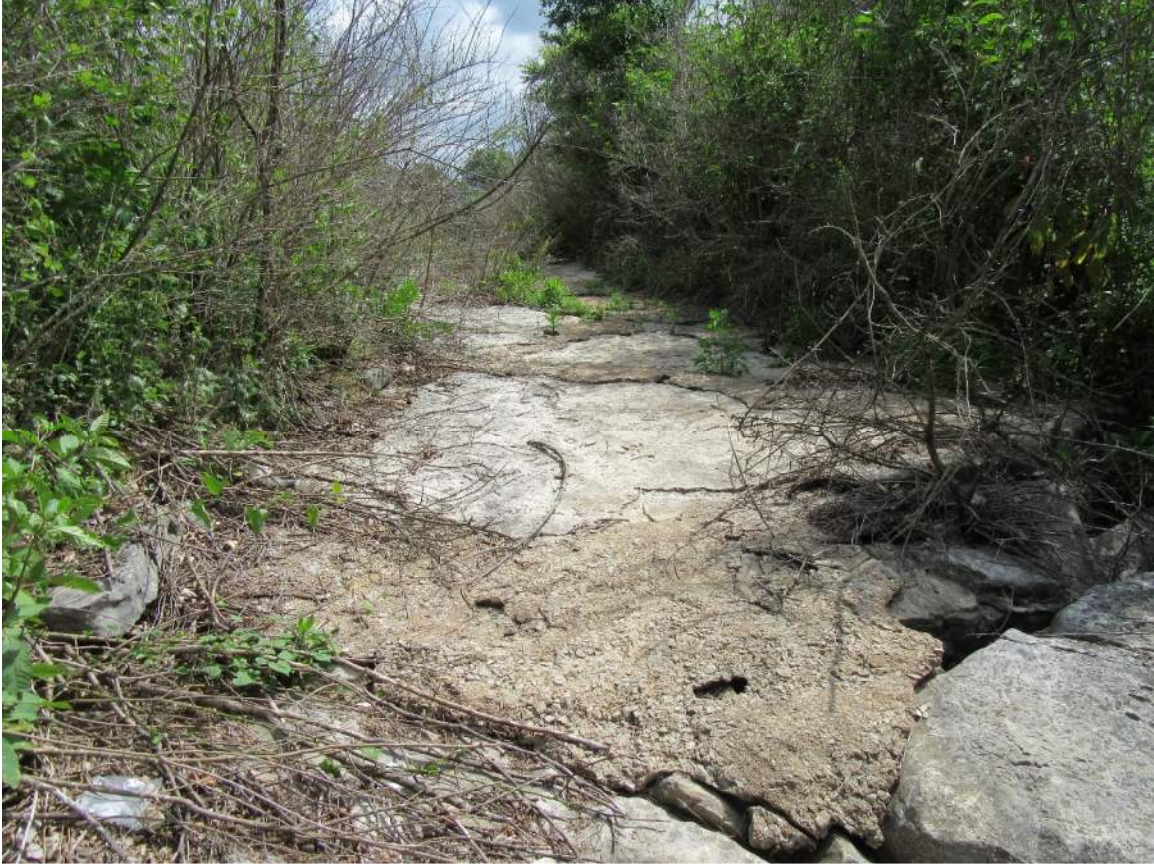
| ITEM | CONDITION | COMMENTS | MONITOR | INVESTIGATE | REPAIR |
|---|---|---|---|---|---|
| 56 | Sidewalls | Sloped concrete side walls are cracked and have brush on them. | <input type="checkbox"/> | <input checked="" type="checkbox"/> | <input type="checkbox"/> |

**Photo No. 19: Spillway discharge channel viewed looking upstream.**

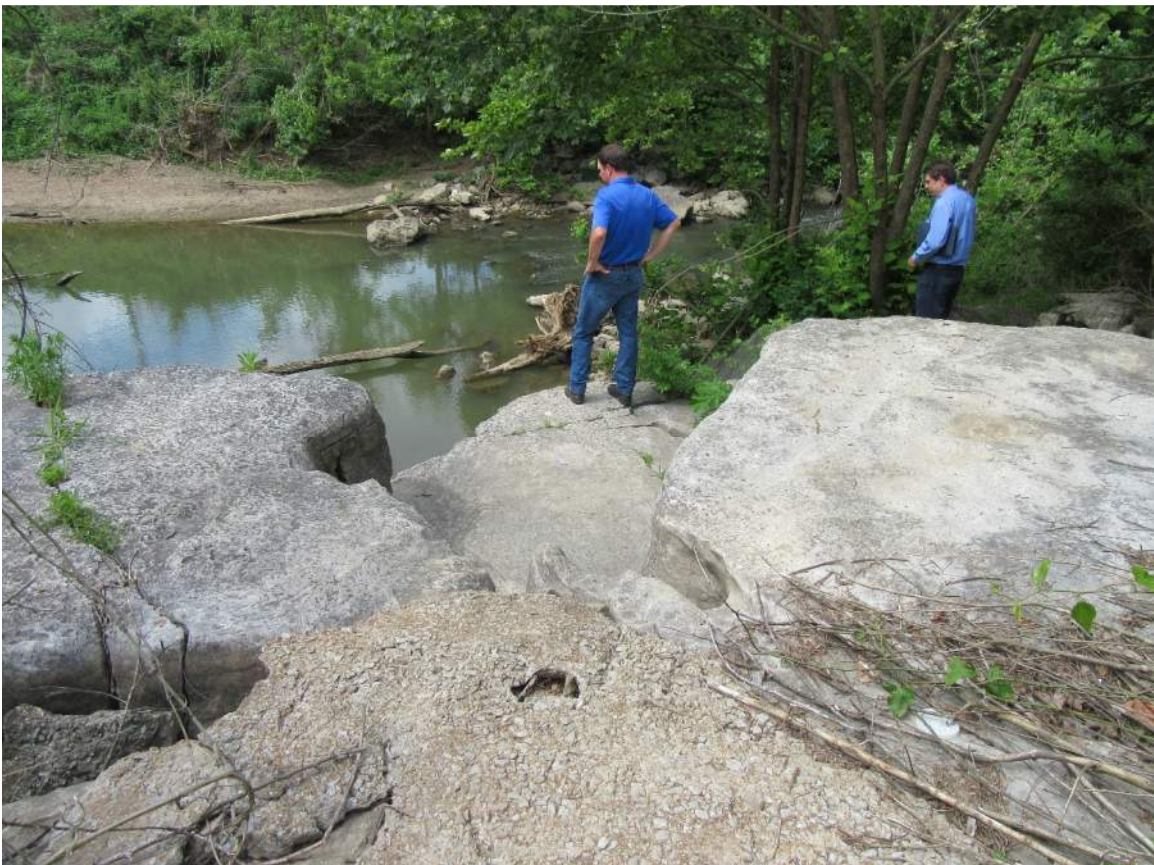
| ITEM | CONDITION | COMMENTS | MONITOR | INVESTIGATE | REPAIR |
|---|---|---|---|---|---|
| <p>Additional Comments (Refer to item number if applicable):</p> <p>60. Trapezoidal weir is 46.5 feet wide with 25-foot bottom width.</p> <p>61. Spillway channel is about 80 feet long. Spillway downstream channel ends at limestone bedrock. There is a 15-foot-high drop-off down to the river. Water was flowing through the limestone face and to the left of it. Portions of the rock have broken off.</p> | | | | | |

**Photo No. 20: Bedrock drop-off at downstream end of spillway discharge channel.**

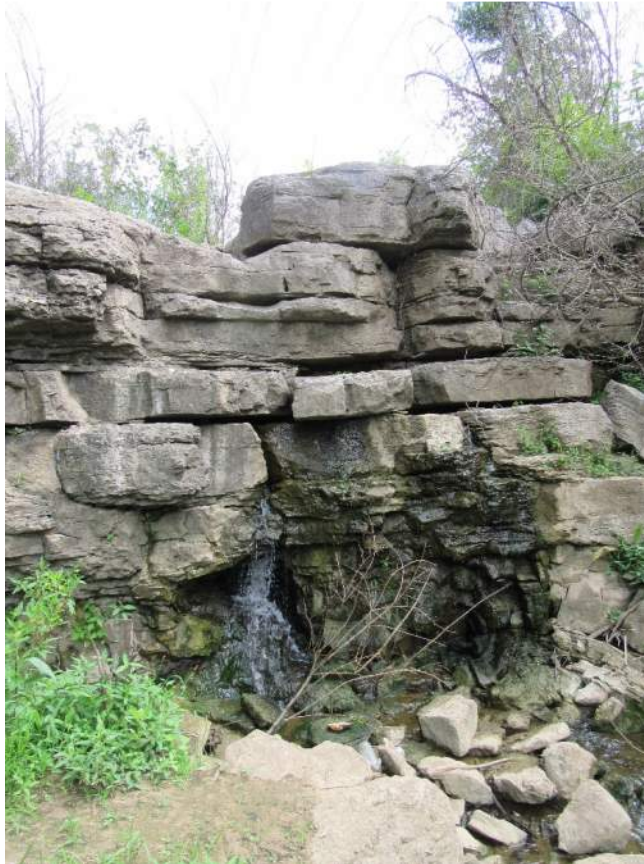
4. No outlet works or low-level outlet for draining the pond were observed.
5. Seepage was observed in the area downstream of the RCP riser pipe.
6. Seepage was observed through and adjacent to the limestone at the end of the spillway discharge channel.

**Photo No. 21: Seepage through bedrock at downstream end of spillway discharge channel.**

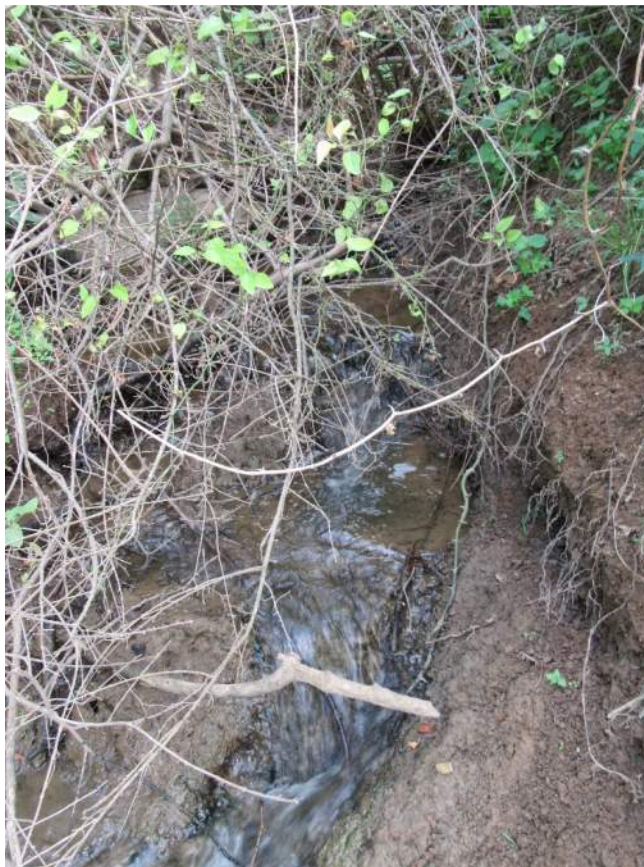
| ITEM | CONDITION | COMMENTS | MONITOR | INVESTIGATE | REPAIR |
|---|---|---|---|---|---|
| 38 | Abutment Leakage | Seepage to left of spillway at Harpeth River. | <input type="checkbox"/> | <input checked="" type="checkbox"/> | <input type="checkbox"/> |

**Photo No. 22: Seepage to left of spillway.**
