## Memorandum

*Subject: Preliminary Assessment of Robinson Lake Dam*  
*Franklin, Tennessee*

CDM Smith was engaged by the City of Franklin to perform a preliminary assessment of Robinson Lake Dam in Franklin, Tennessee. We understand that the City is considering acquiring the property on which the dam and lake are located. The purpose of the assessment is to identify potential dam safety deficiencies and provide recommendations for future actions.

**Robinson Lake Dam Inspection – June 12, 2017**

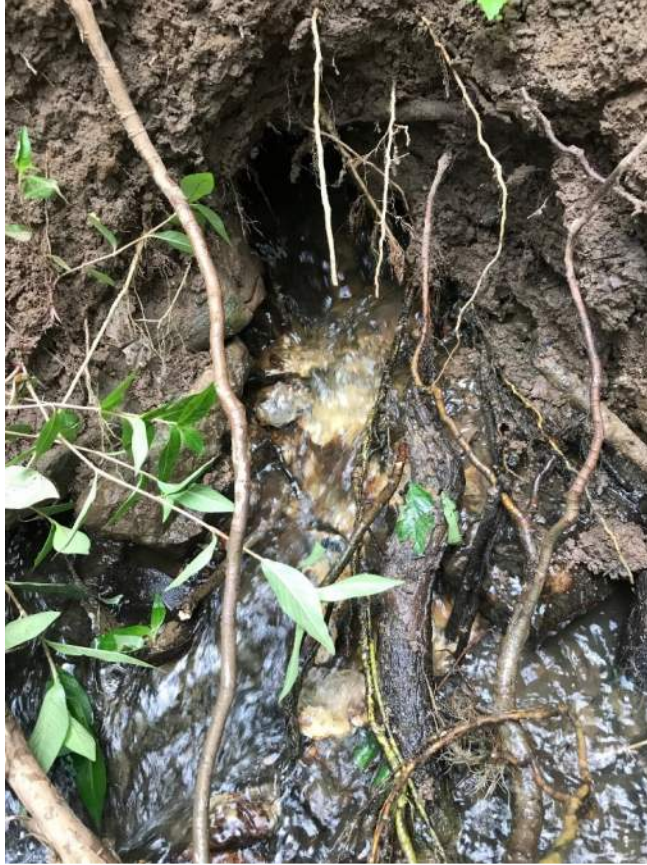
| ITEM | CONDITION | COMMENTS | MONITOR | INVESTIGATE | REPAIR |
|---|---|---|---|---|---|
| 38 | Abutment Leakage | Seepage to left of spillway at Harpeth River. | <input type="checkbox"/> | <input checked="" type="checkbox"/> | <input type="checkbox"/> |

**Photo No. 23: Seepage to left of spillway.**

- c. Repairing or replacing the existing spillway. The spillway modification or replacement would include a drainage system to control seepage.
  - d. Grouting bedrock in the spillway area to reduce seepage.
