ASSESSMENT OF TWO CITY OF FRANKLIN CEMETERIES, FRANKLIN, TENNESSEE

Chicora Research Contribution 559

Michael Trinkley
Debi Hacker

September 2014

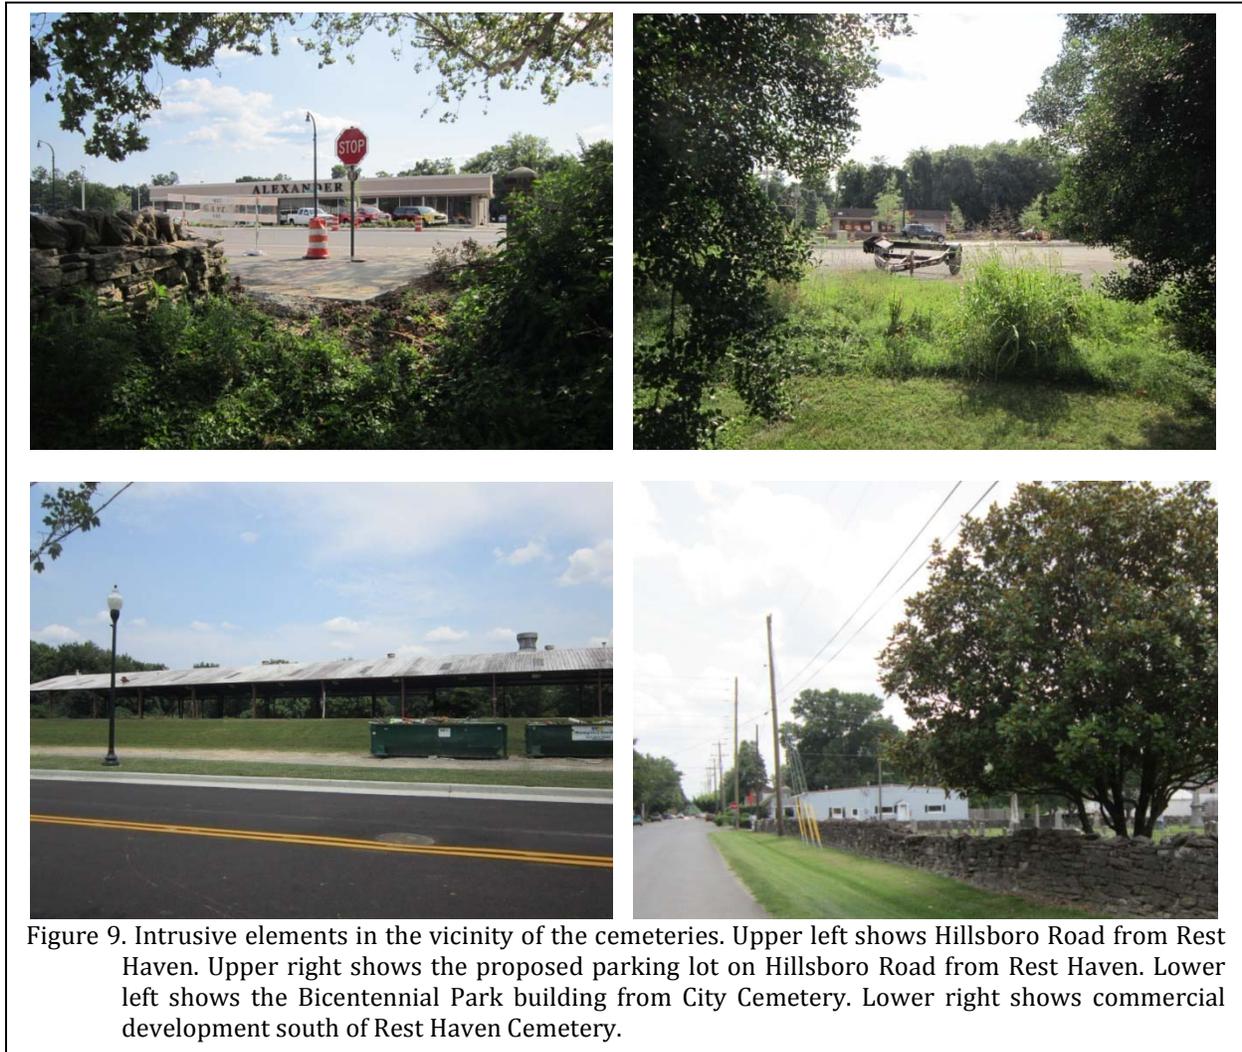
Unfortunately, there is relatively little vegetative screening, especially to the west of Rest Haven, and the 4-lane Hillsboro Road has a significant visual and noise impact on the cemetery. No screening exists to shelter either cemetery from activities to the south, many of which are also intrusive to the National Register properties (Figure 9).

Figure 9. Intrusive elements in the vicinity of the cemeteries. Upper left shows Hillsboro Road from Rest Haven. Upper right shows the proposed parking lot on Hillsboro Road from Rest Haven. Lower left shows the Bicentennial Park building from City Cemetery. Lower right shows commercial development south of Rest Haven Cemetery.

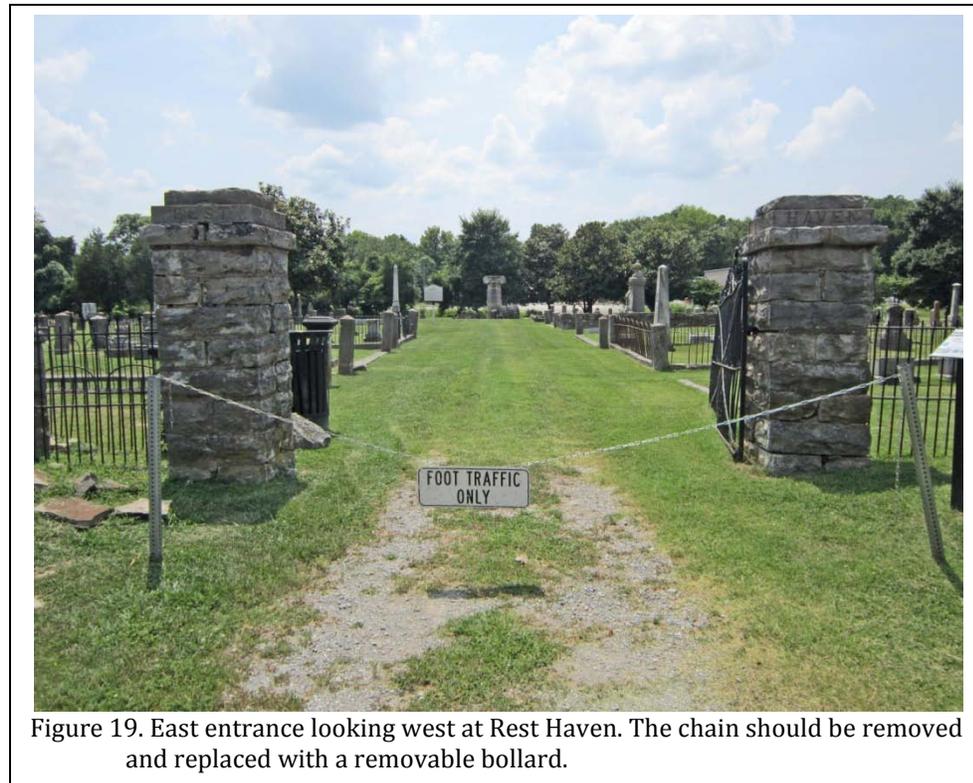
Figure 19. East entrance looking west at Rest Haven. The chain should be removed and replaced with a removable bollard.

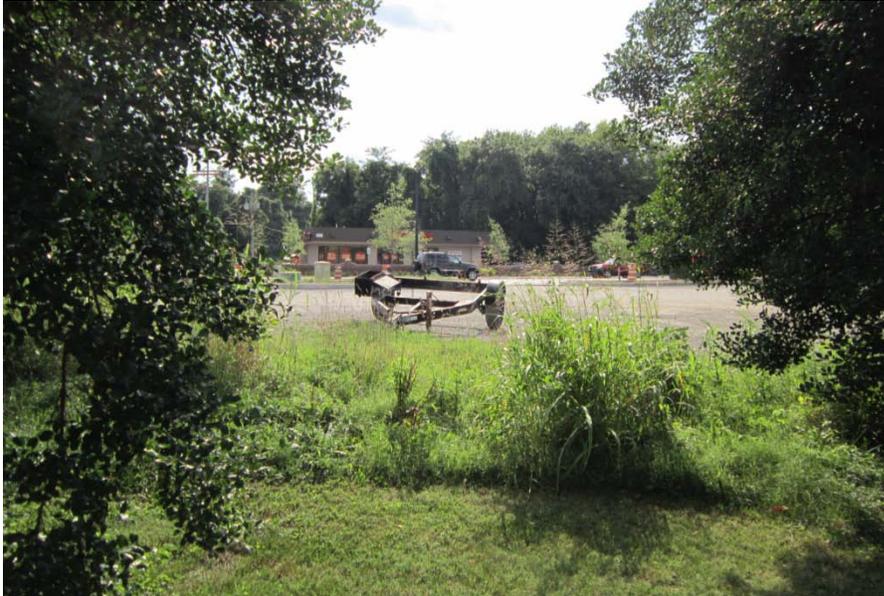
Figure 21. The proposed parking area along Hillsboro Road will require visual screening to prevent intrusion into Rest Haven Cemetery.

absolutely no function since it cannot be extended. This is a poor design feature and we recommend that the sidewalk turn off Hillsboro Road into the cemetery be removed.

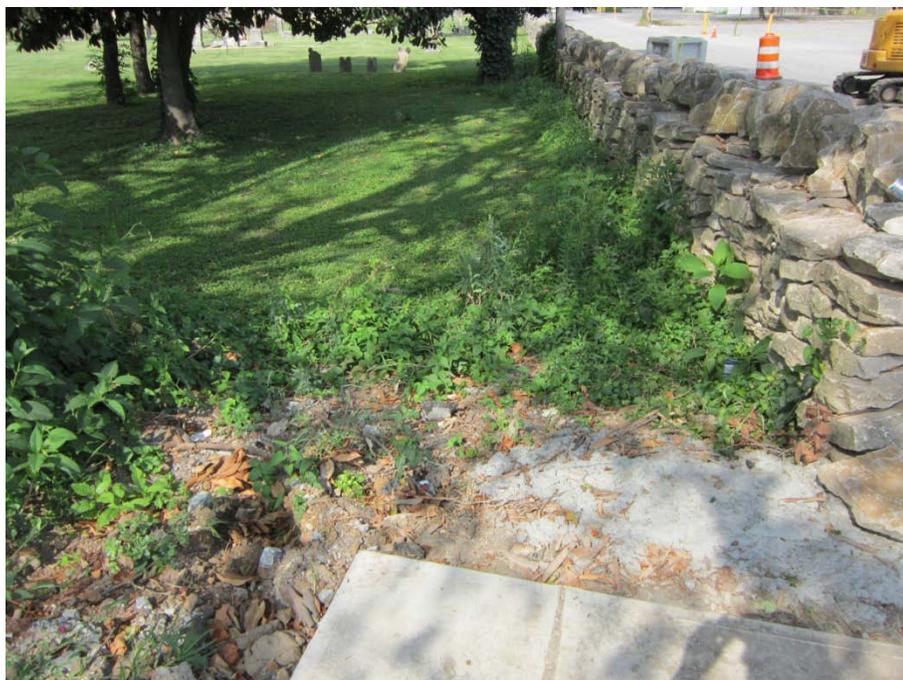
Of greater concern is the construction of the sidewalk on the east side of Hillsboro Road. Where this sidewalk turns the corner at Margin Street, it terminates, dumping users – as well as rain water – directly into Rest Haven Cemetery. This is an exceptionally poor design that will increase maintenance and serve

Figure 22. Newly constructed Hillsboro Road sidewalk terminating in Rest Haven Cemetery.

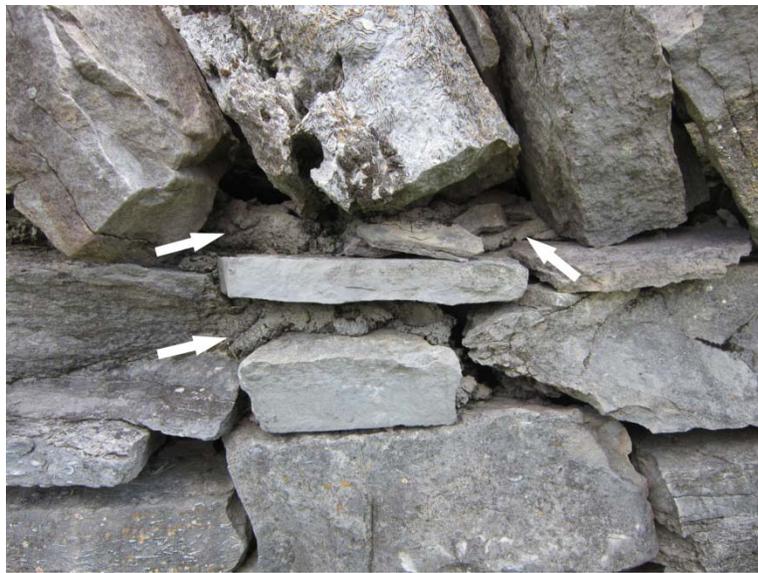
Figure 24. Evidence of hard Portland cement mortar in some areas of the walls.

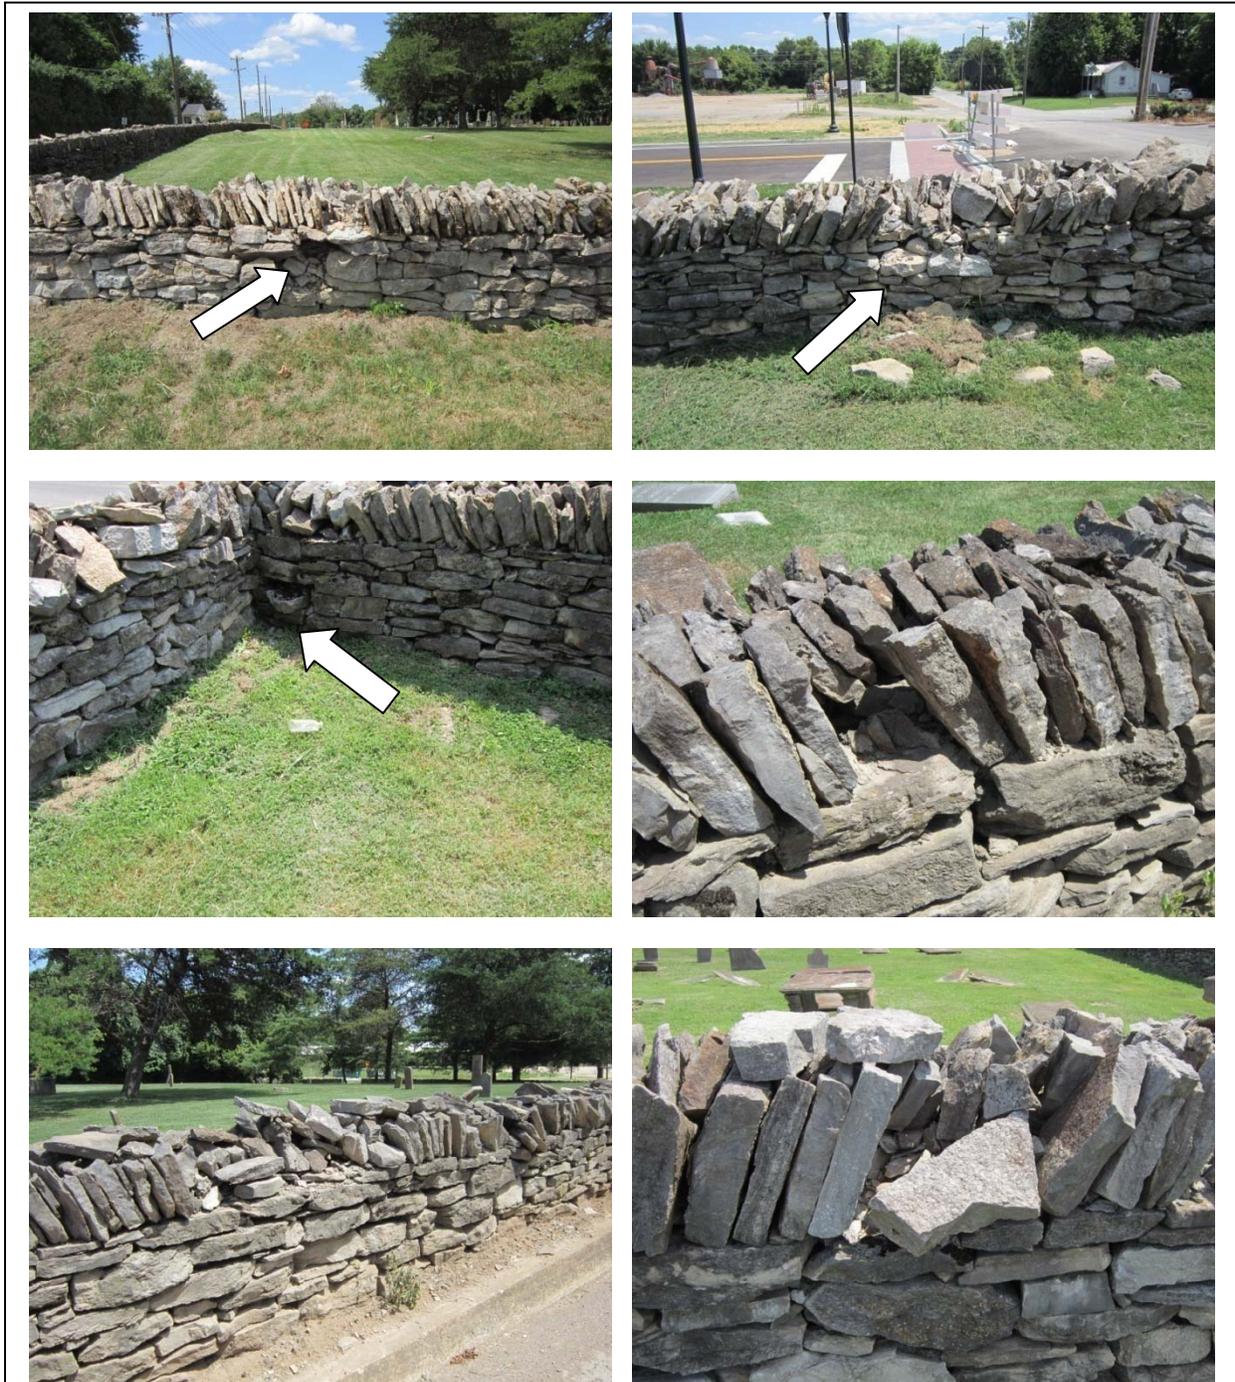
Figure 26. City Cemetery stone wall defects. Upper row shows damage to the eastern wall, exterior (left) and interior (right). Middle left, southeast interior corner showing stone loss. Middle right, south exterior loss of capping stones. Lower left, jumbled and dumped capping stones on the south wall. Lower right, west wall damaged cap.

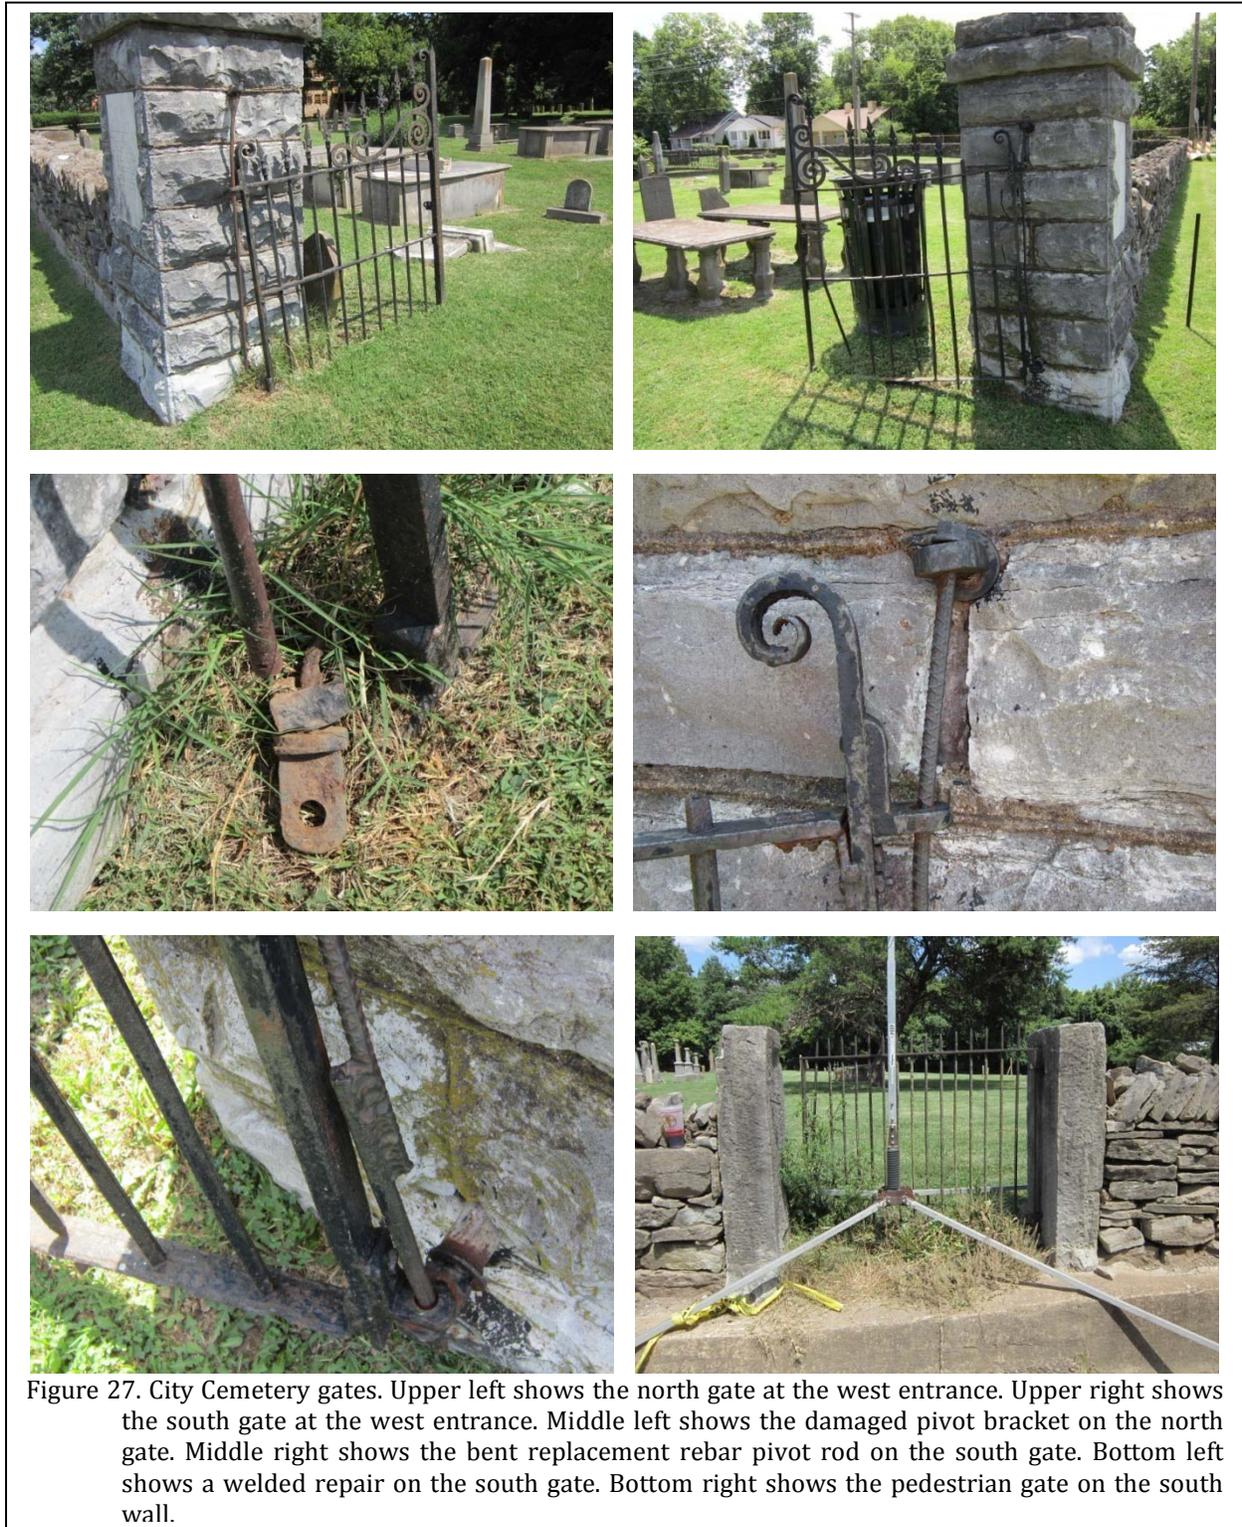
Figure 27. City Cemetery gates. Upper left shows the north gate at the west entrance. Upper right shows the south gate at the west entrance. Middle left shows the damaged pivot bracket on the north gate. Middle right shows the bent replacement rebar pivot rod on the south gate. Bottom left shows a welded repair on the south gate. Bottom right shows the pedestrian gate on the south wall.

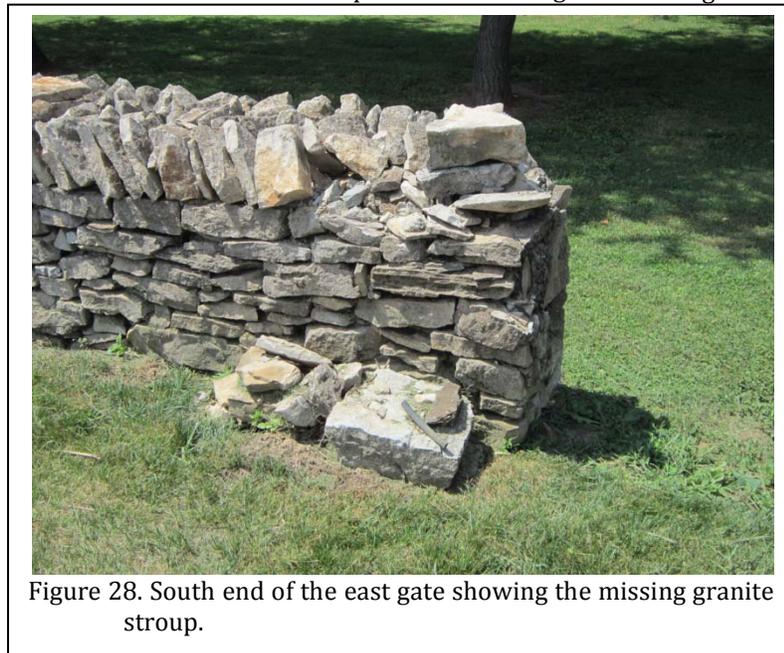
Figure 28. South end of the east gate showing the missing granite stroup.

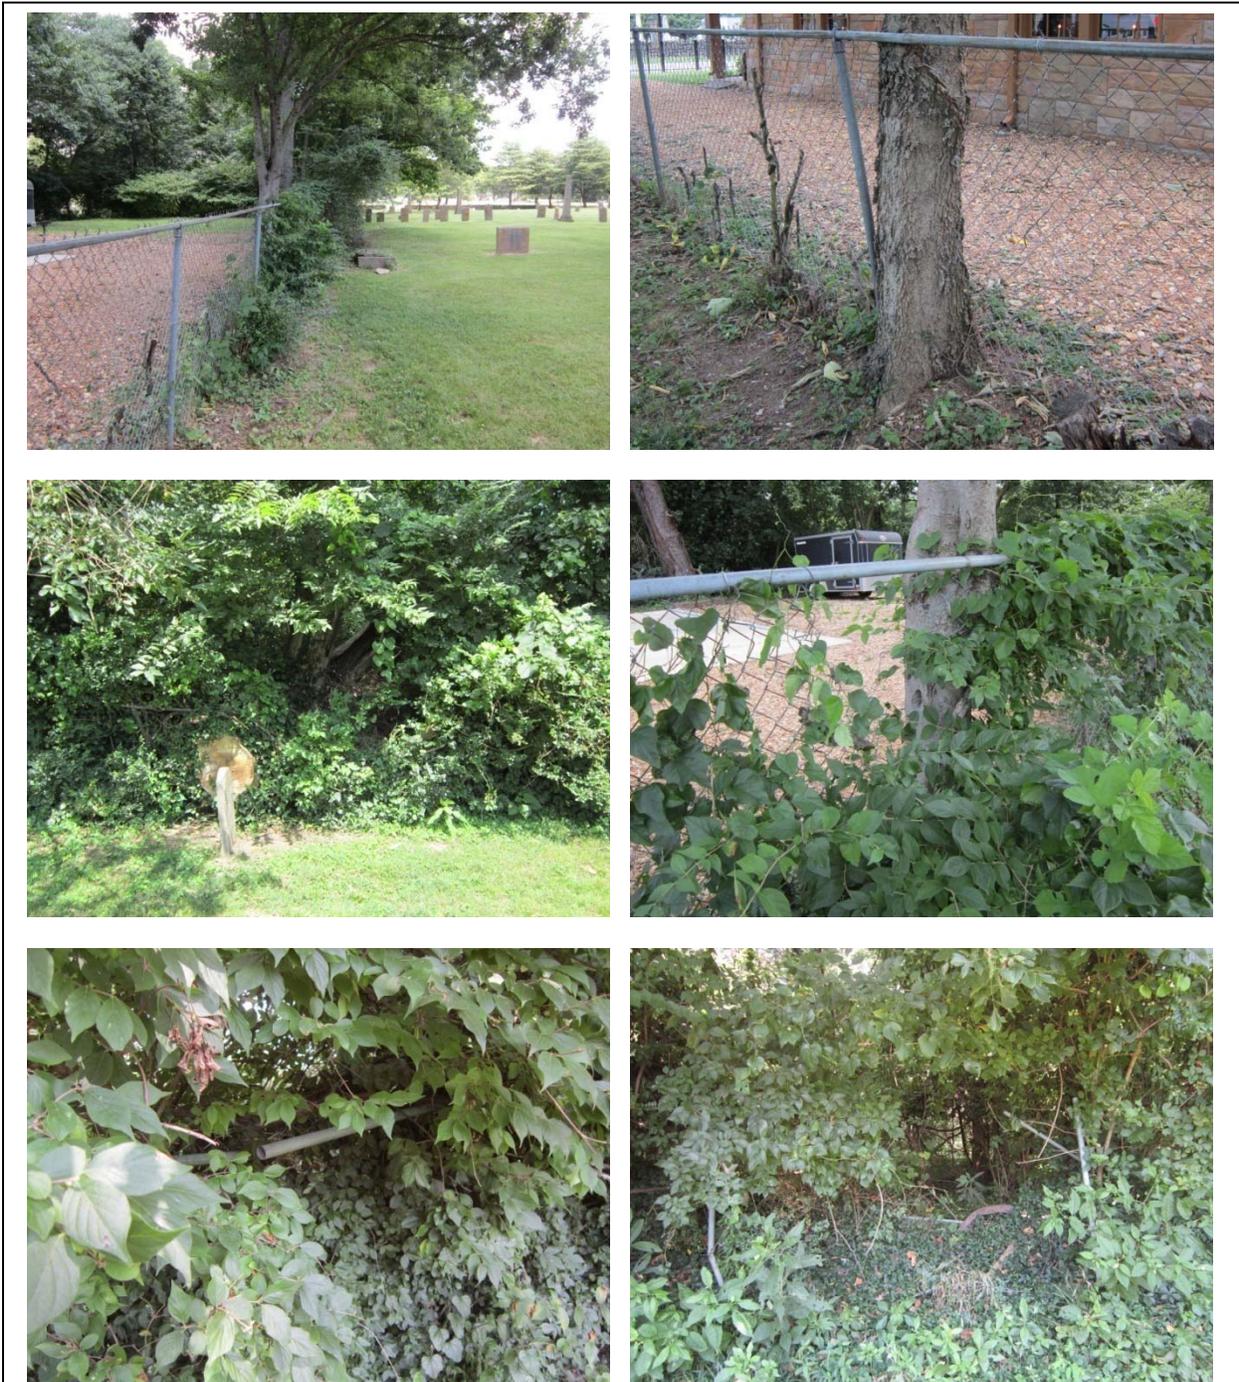
Figure 29. Chain link fence along the north property line. Upper left, vines and other vegetation should be removed from the fence. Limbs from adjoining property should be removed to the property line. Upper right shows a tree grown into the fence. Middle left shows a tree fallen on the fence. Middle right shows a second tree growing into the fence which must also be removed. Lower left shows a damaged and bent top rail. Lower right shows a section of fence that is totally down.

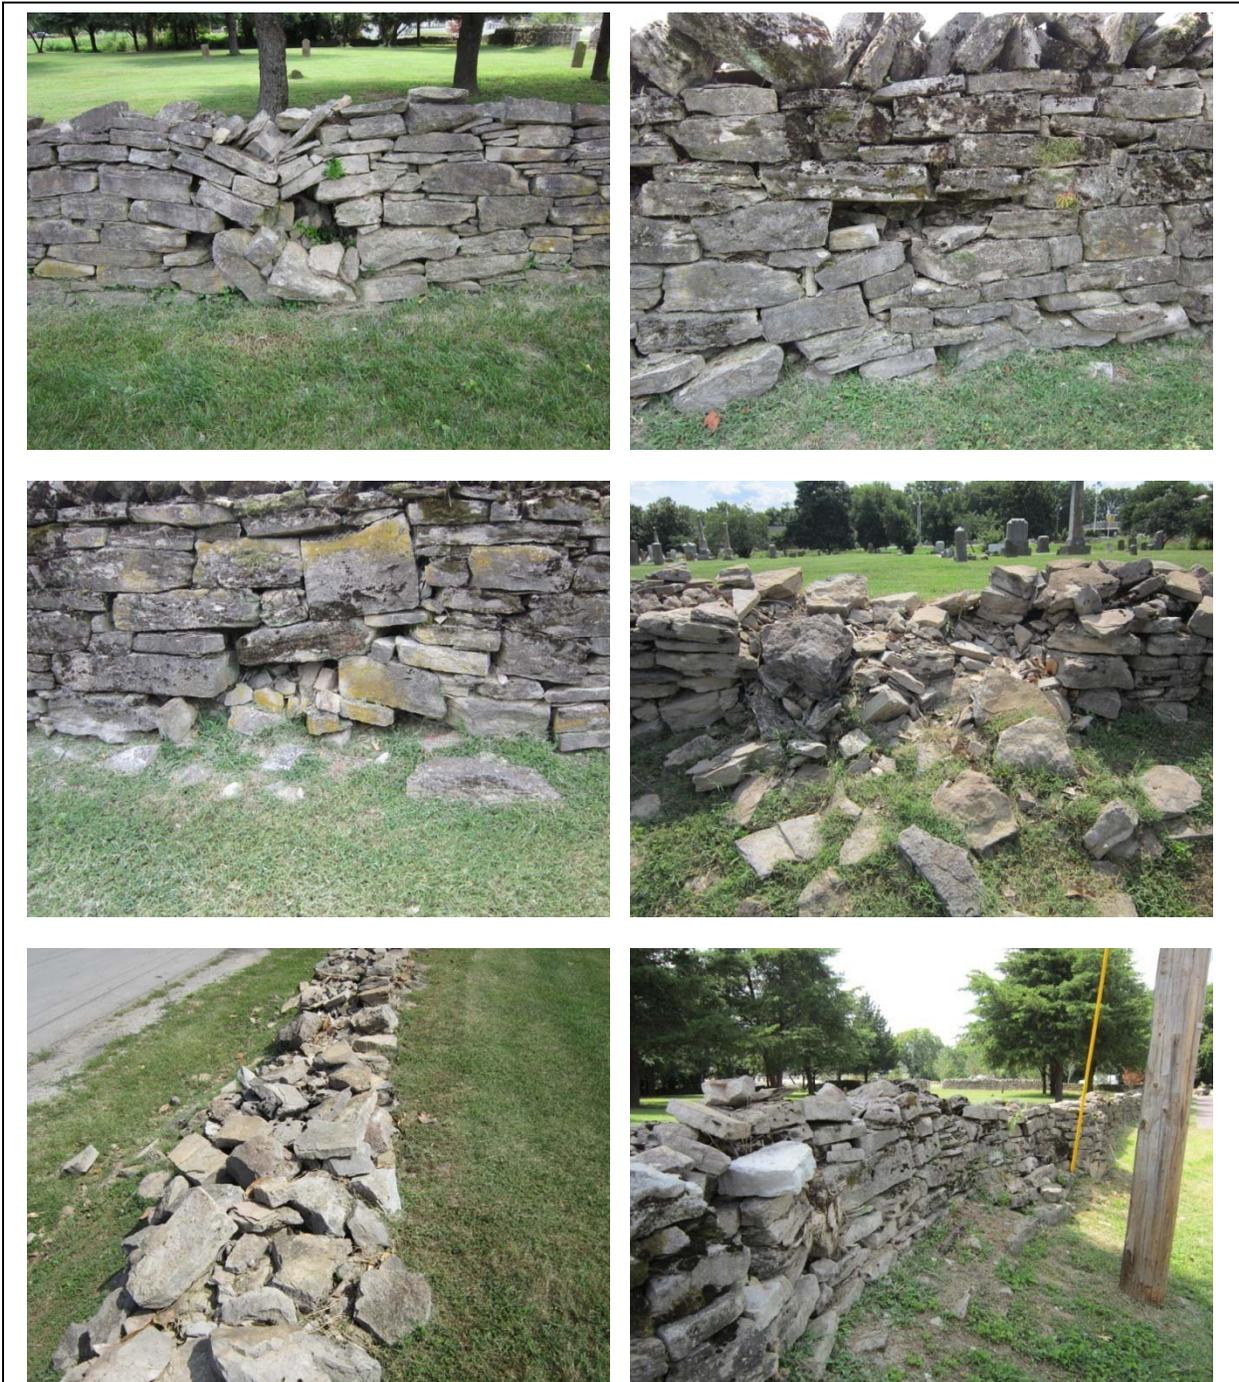
Figure 30. Condition of the stone wall at Rest Haven Cemetery. Upper left shows a slump on the east exterior wall. Upper right shows stone loss and incipient slump on the east wall. Middle left, stone loss with stones partially buried in the soil beyond the wall. Middle right shows more extensive area of wall collapse. Lower left shows total collapse of the wall. Lower right shows bowing of the wall.

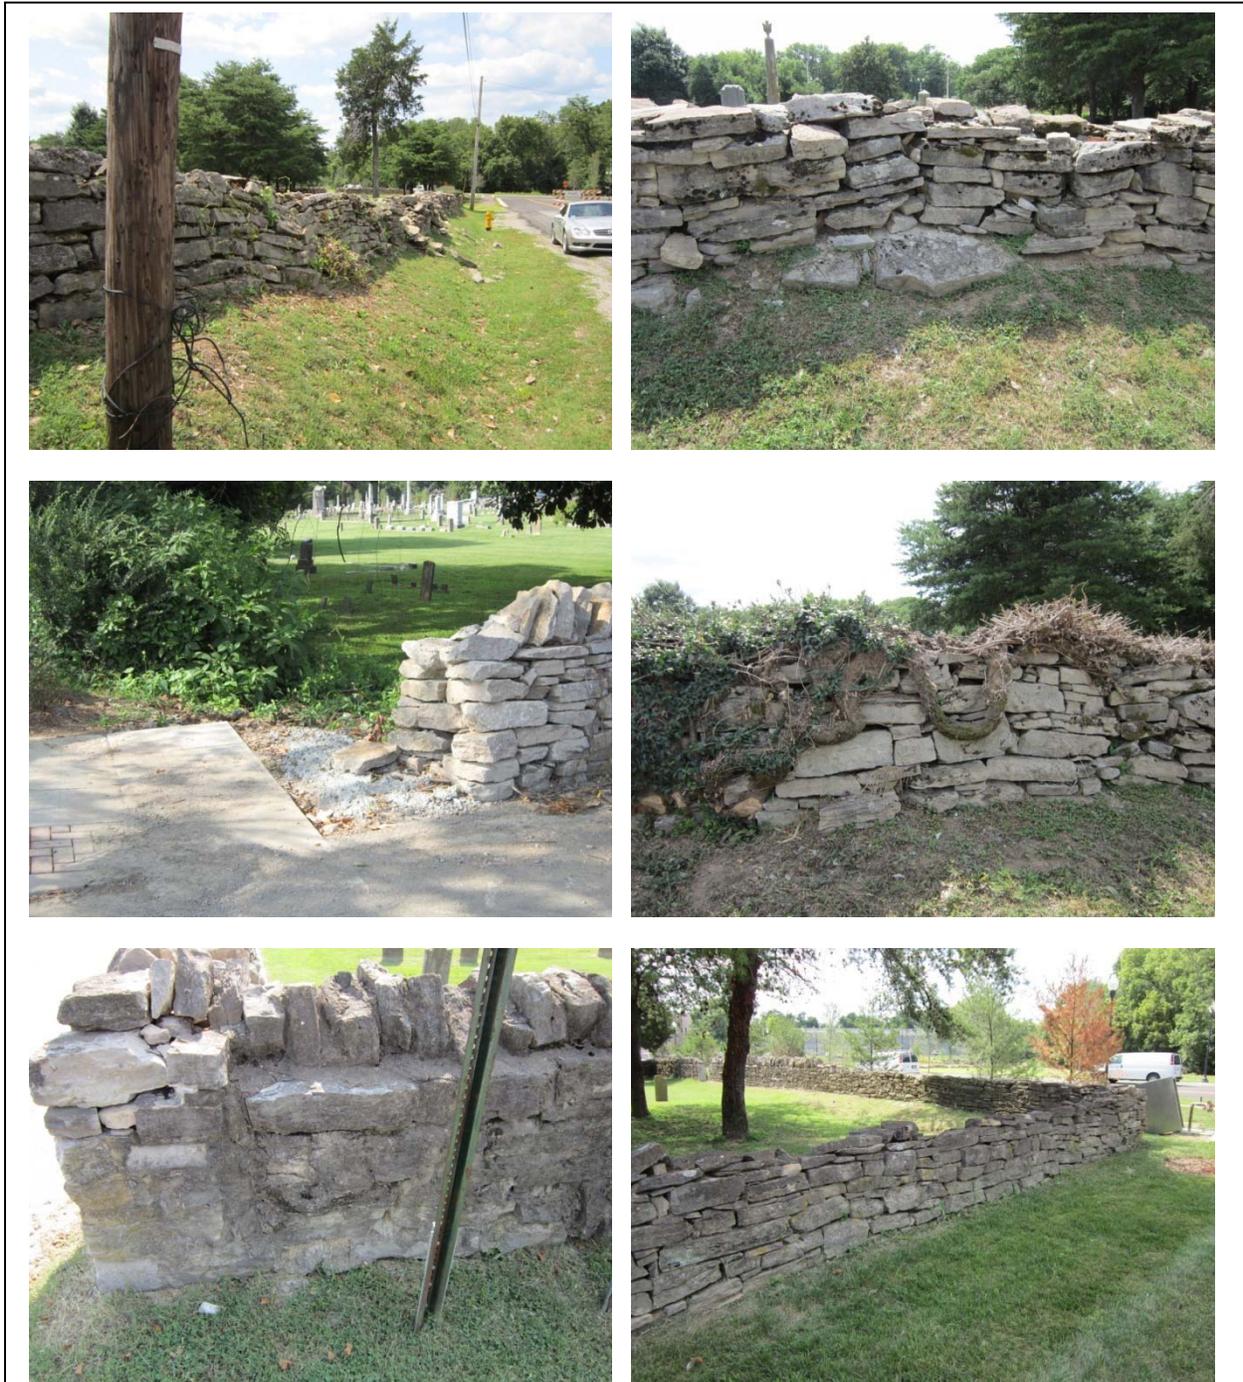
Figure 31. Condition of the stone wall at Rest Haven Cemetery. Upper left shows an overview of damage along the east wall. Upper right shows very poor construction techniques in one area. Middle left shows the terminus of the southern wall without a stroup. Middle right shows vegetation allowed to overtake the wall. Lower left shows the southeast corner with Portland cement repair. Lower right, missing top stones, northeast corner.

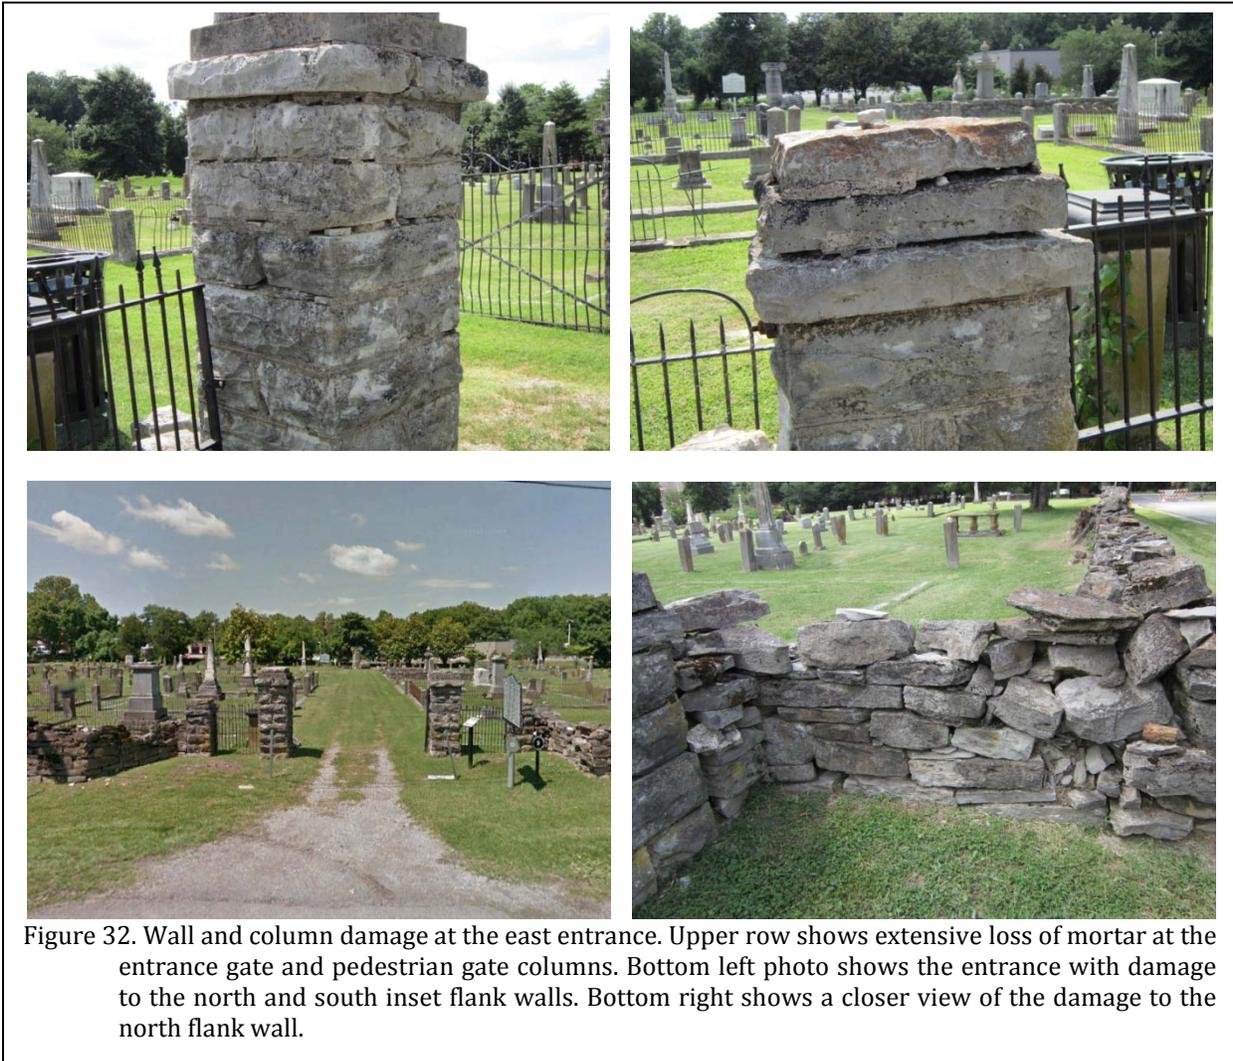
Figure 32. Wall and column damage at the east entrance. Upper row shows extensive loss of mortar at the entrance gate and pedestrian gate columns. Bottom left photo shows the entrance with damage to the north and south inset flank walls. Bottom right shows a closer view of the damage to the north flank wall.

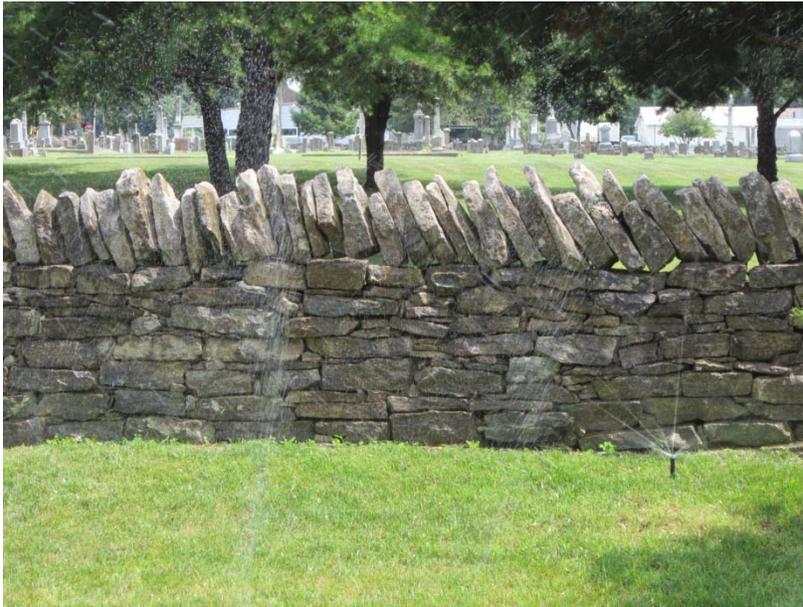
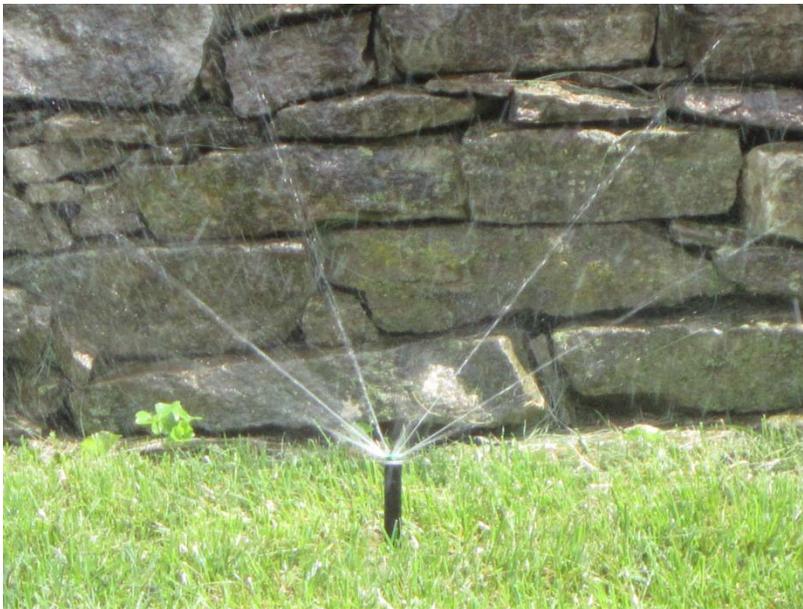
Figure 33. Sprinklers wetting the north cemetery wall should be removed or adjusted to ensure the wall remains dry.

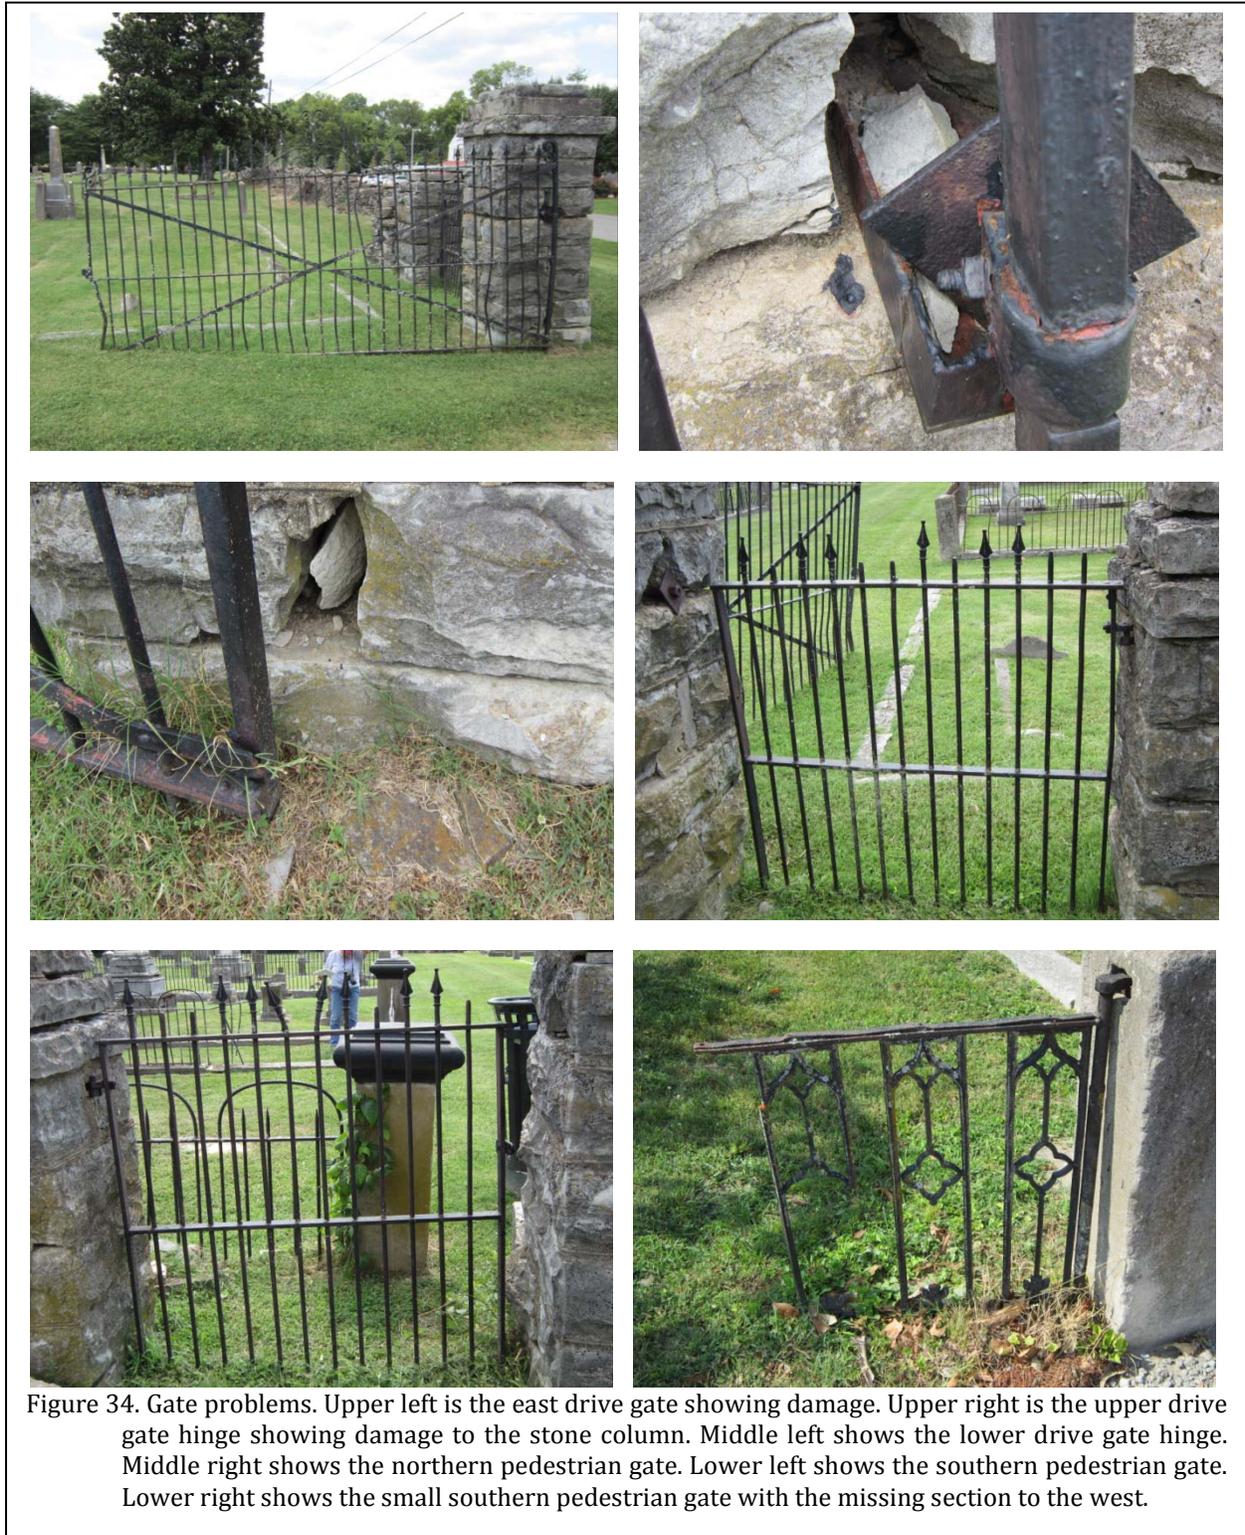
Figure 34. Gate problems. Upper left is the east drive gate showing damage. Upper right is the upper drive gate hinge showing damage to the stone column. Middle left shows the lower drive gate hinge. Middle right shows the northern pedestrian gate. Lower left shows the southern pedestrian gate. Lower right shows the small southern pedestrian gate with the missing section to the west.

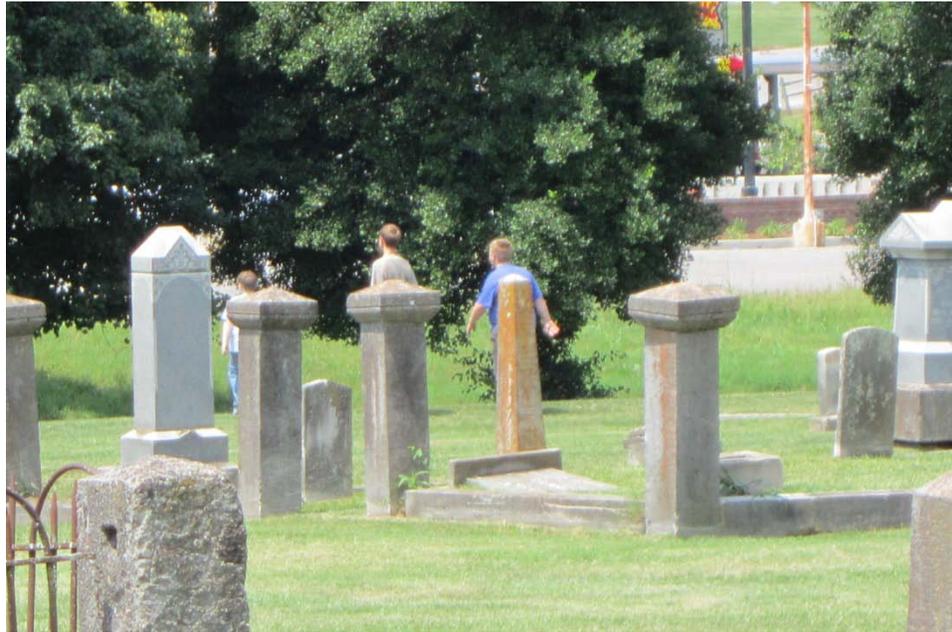
During our assessment we observed pre-adolescents cutting through Rest Haven Cemetery from Fourth Avenue North to Hillsboro Street (Figure 38). This is made easy and convenient by the collapsed stone wall and the absence of any barrier along Hillsboro. It also demonstrates the need for the stone wall to receive a high priority for repair and for a security fence to be constructed along Hillsboro. Unaddressed this behavior will create social pathways or trails and will also promote vandalism.

Figure 38. Pre-adolescents cutting through Rest Haven Cemetery.

and the absence of a boundary fence along Hillsboro Road be addressed.

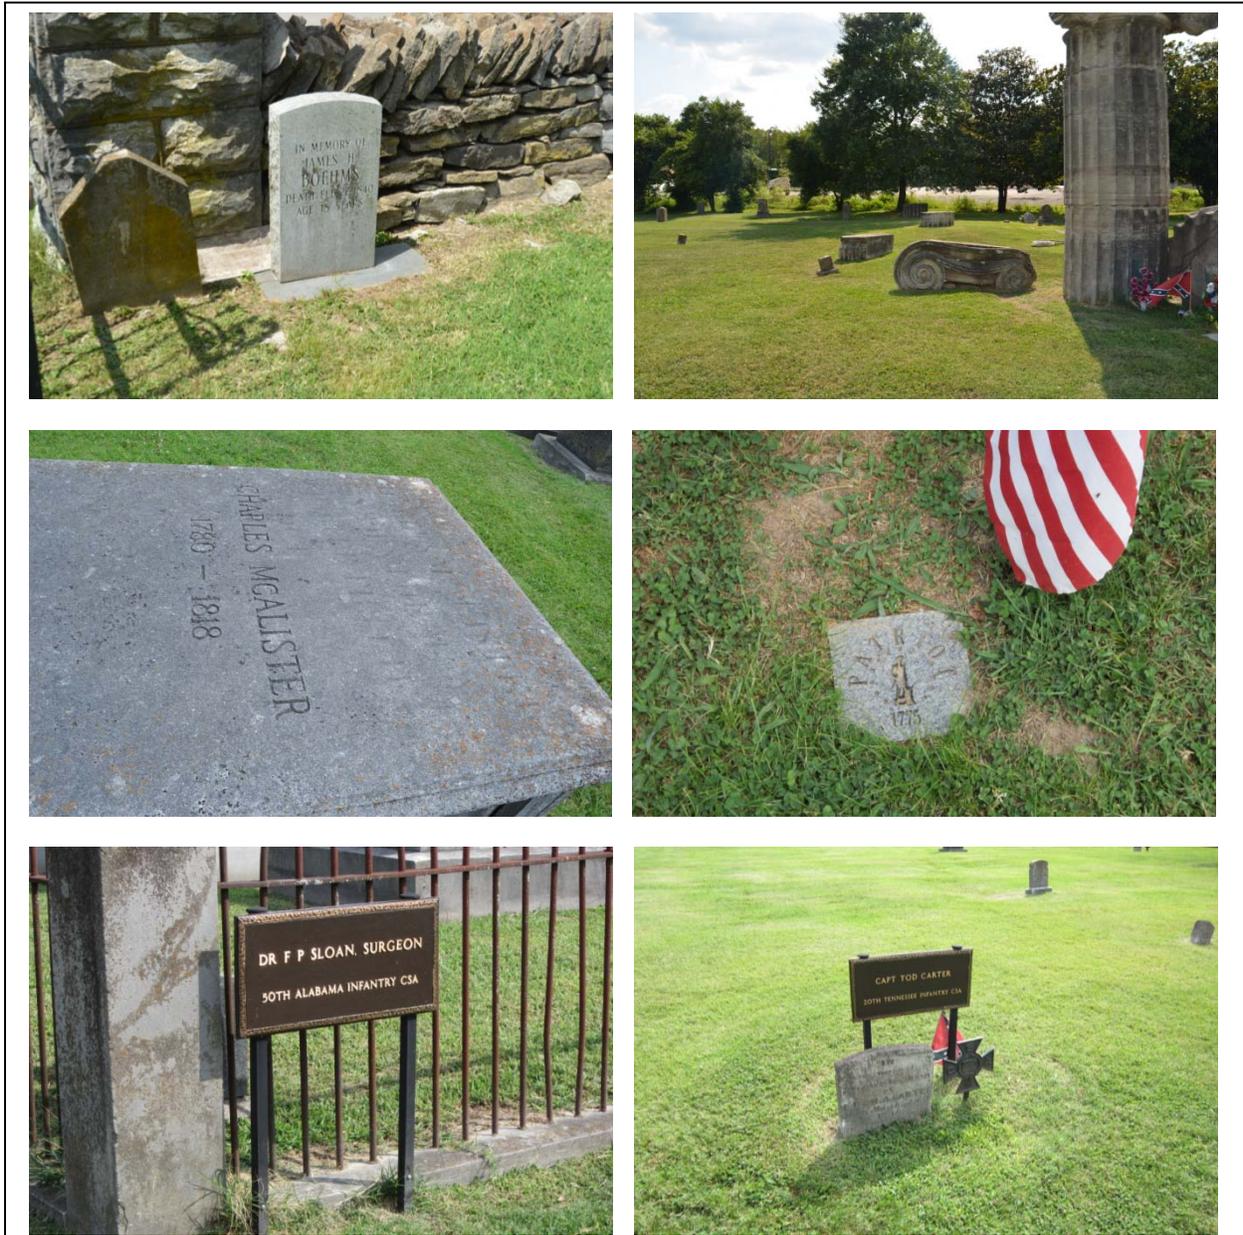
Figure 39. Introduction of new elements. Upper left shows an inappropriate style monument introduced into City Cemetery. Upper right shows the monument to the unknown soldier that is out of scale with the cemetery and all other monuments. Middle left shows recarving of a monument which damages the original historic fabric and should never be allowed. Middle right shows an acceptable flush mounted emblem that doesn't detract from the cemetery landscape. The lower two photographs show examples of inappropriate markers that should be removed since the graves are already well marked or minimally should be laid as flush lawn markers.

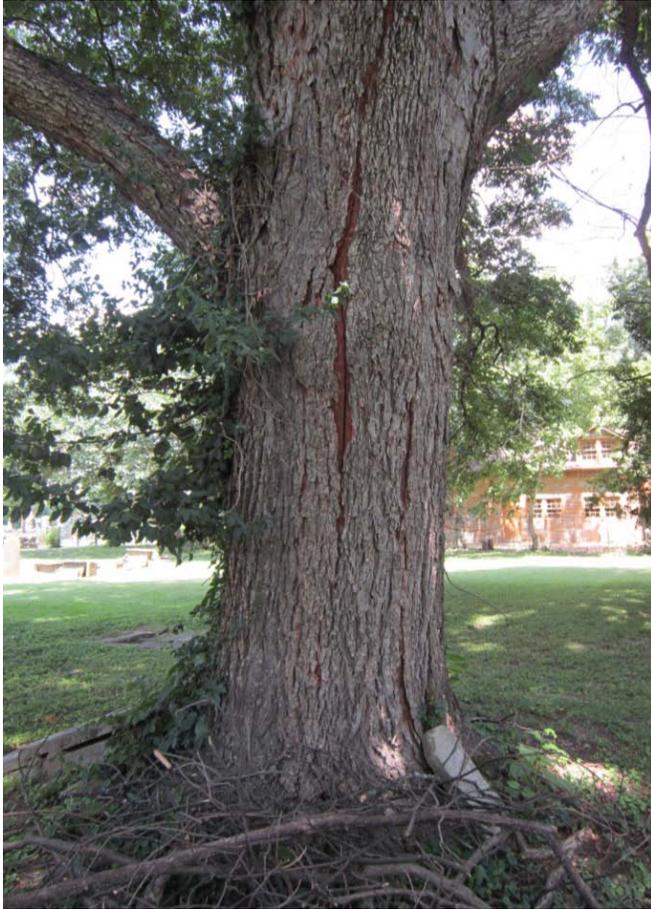
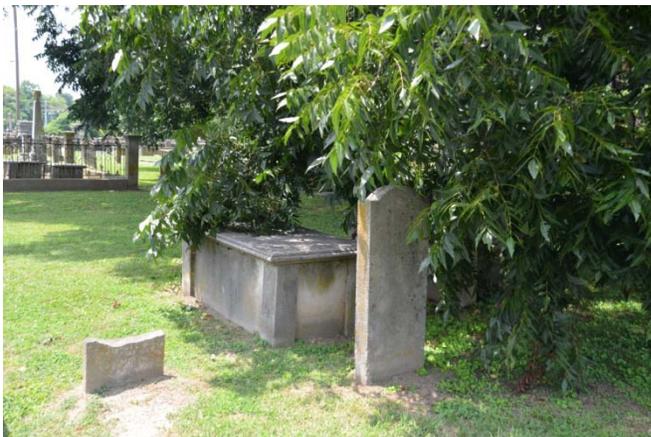
Figure 42. Pecan tree at City Cemetery. Upper photo shows splits in the bark and piles of branches at the base. Lower photo shows drooping branches on monuments.
