ASSESSMENT OF TWO CITY OF FRANKLIN CEMETERIES, FRANKLIN, TENNESSEE

Chicora Research Contribution 559

Michael Trinkley
Debi Hacker

September 2014

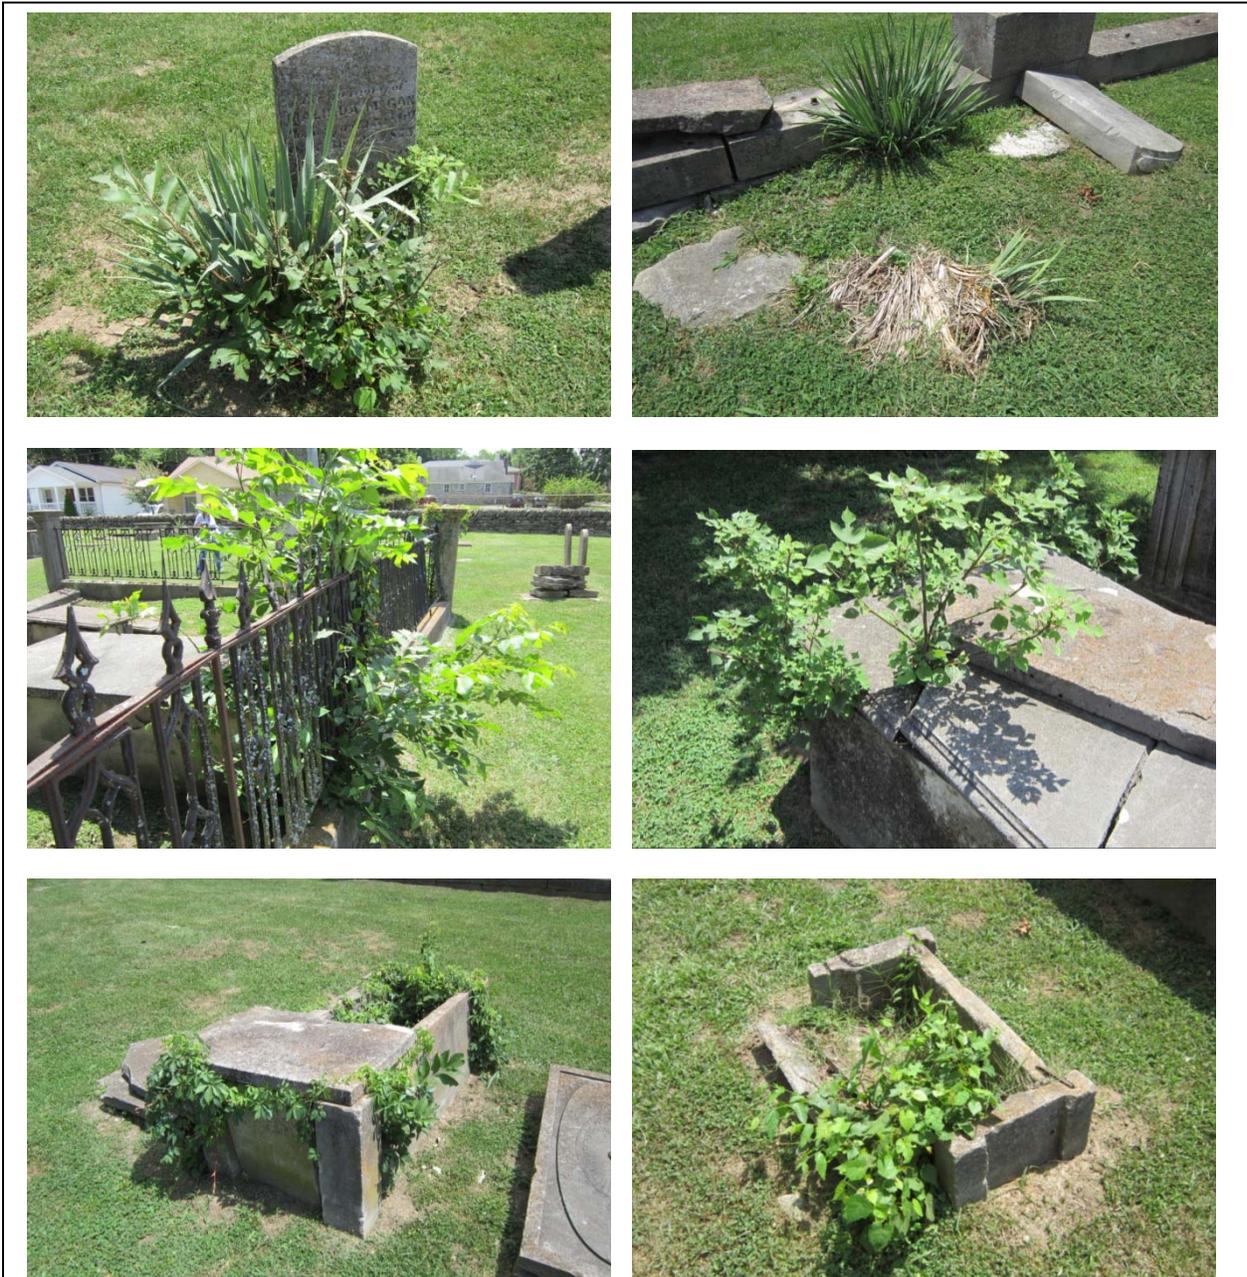
Figure 44. Shrubs and undesirable vegetation. The upper left photo shows a yucca taken over by undesirable vegetation. The upper right shows yuccas, one of which has been mowed. The middle left photo shows vegetation growing up in an iron fence. Without removal, it will destroy the fence. Middle right photo shows trees growing out of a broken box tomb. The two lower photos show vines and other undesirable vegetation taking over the interiors of box tombs. All of this invasive vegetation must be removed.

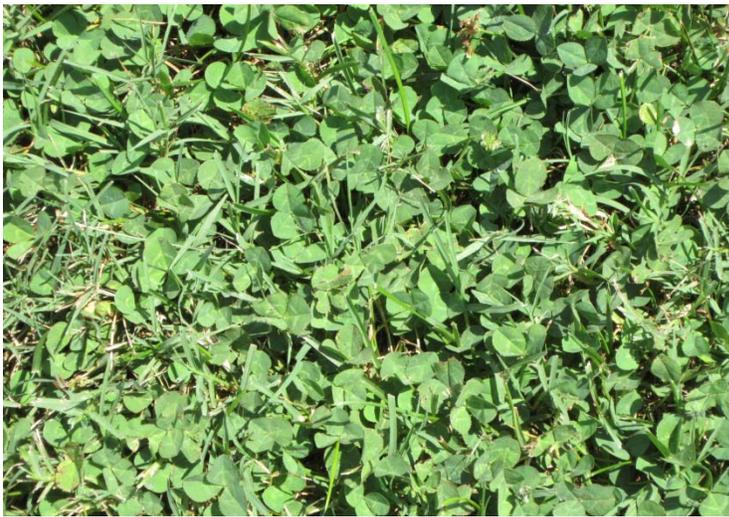
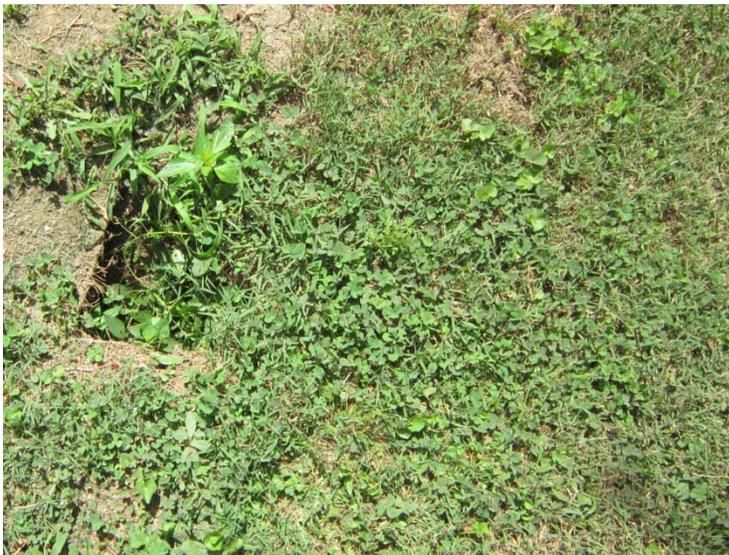
Figure 45. Weedy turf at City Cemetery.

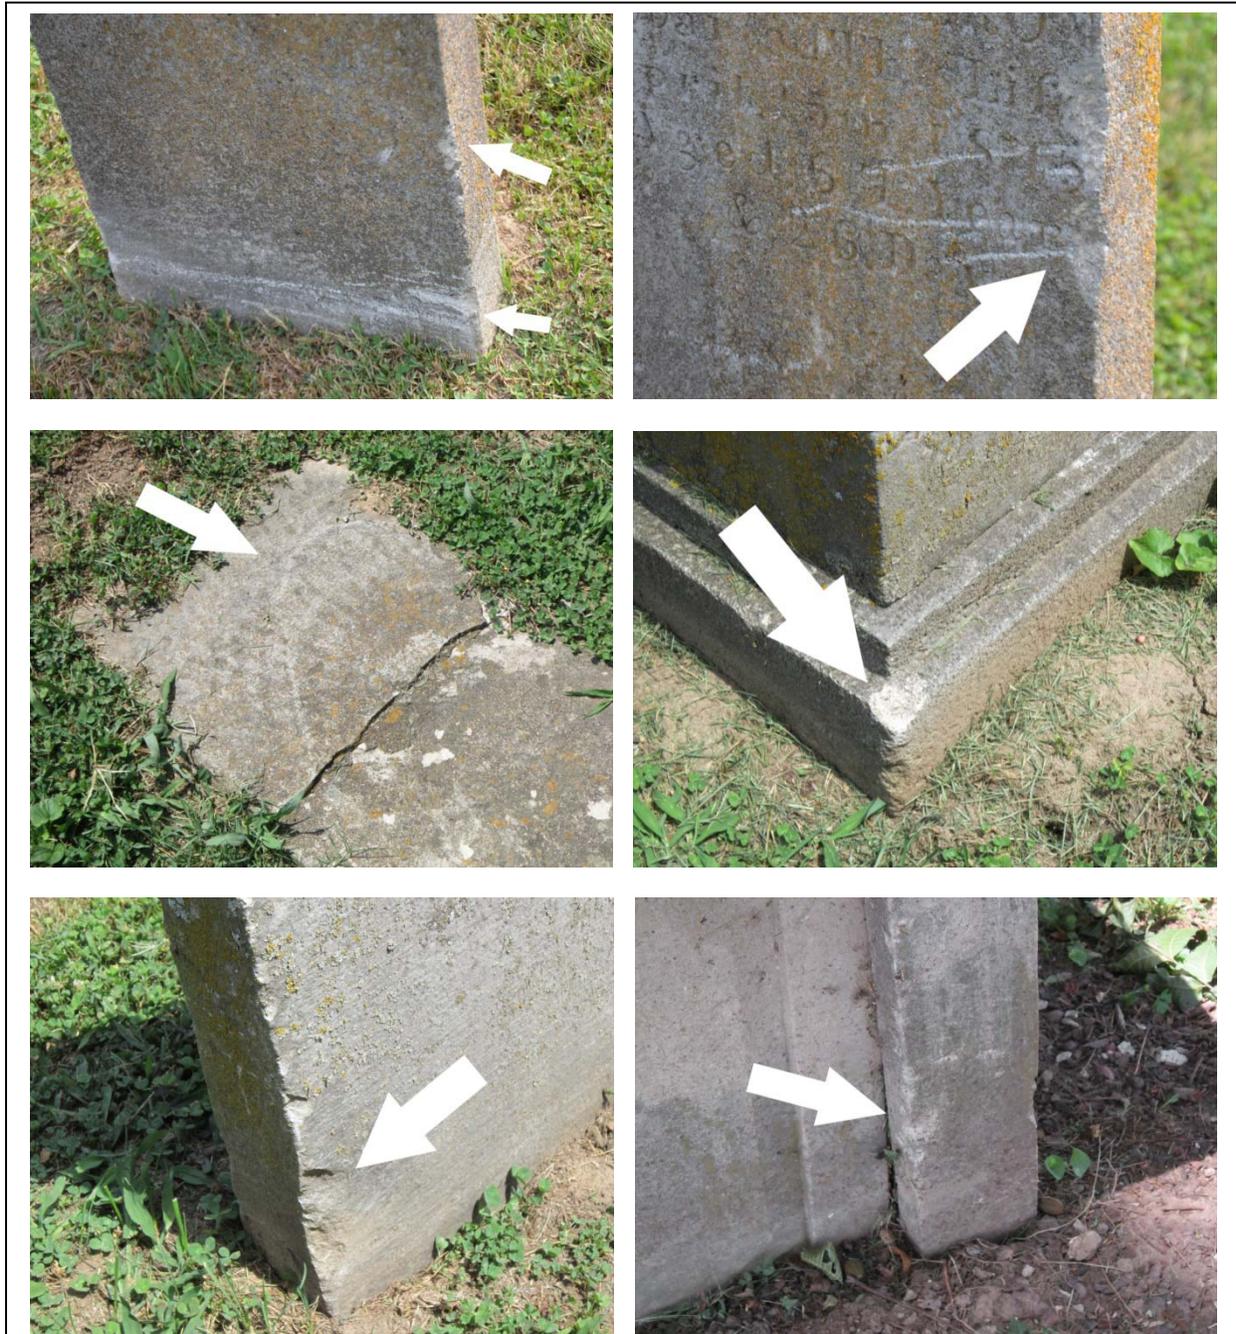
Figure 46. Mowing issues at City Cemetery. Upper left shows scrapes at ground level from mower guards. Upper right shows scrapes from riding mowers. Middle left shows tire tracks across a broken stone. Middle right shows edge damage to a base. Lower left shows edge damage to a headstone. Lower right shows edge damage to a box tomb from mower impacts.

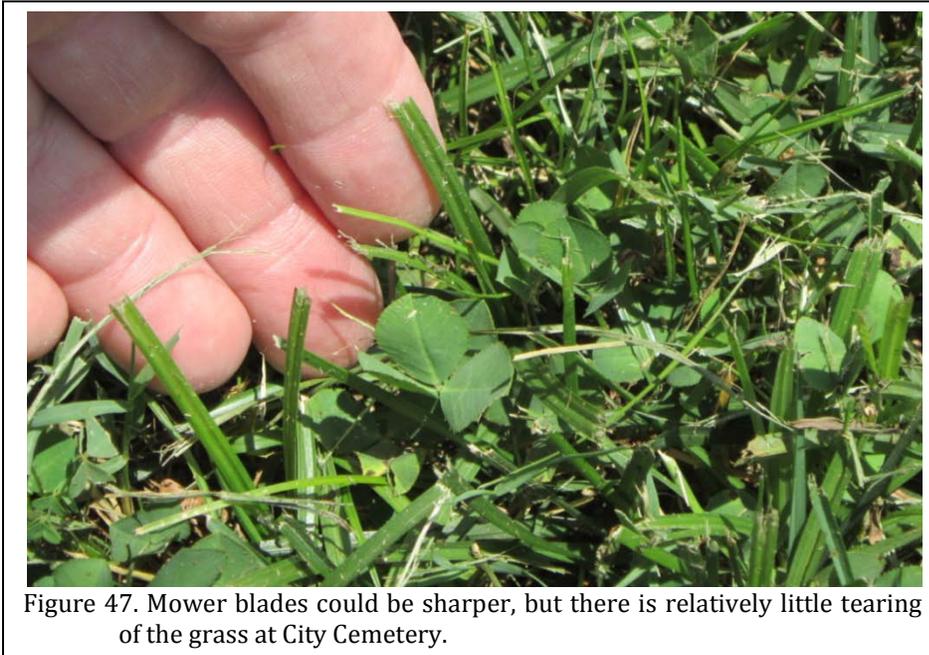
Figure 47. Mower blades could be sharper, but there is relatively little tearing of the grass at City Cemetery.

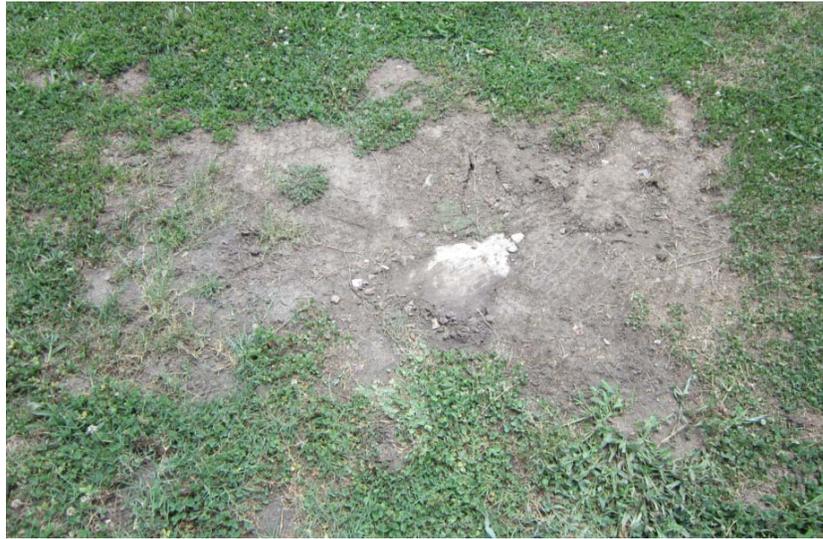
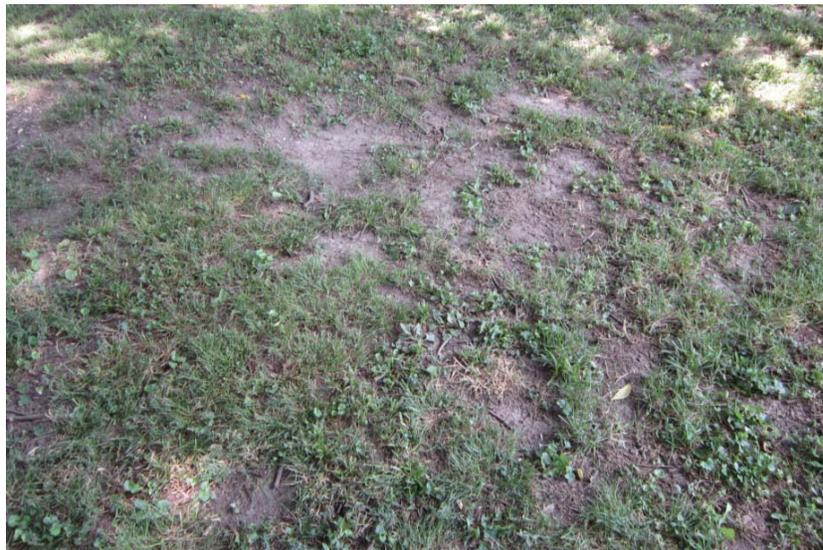
Figure 48. Examples of a bare spots in the cemetery. In the upper photo there is a fallen monument almost totally covered by soil.

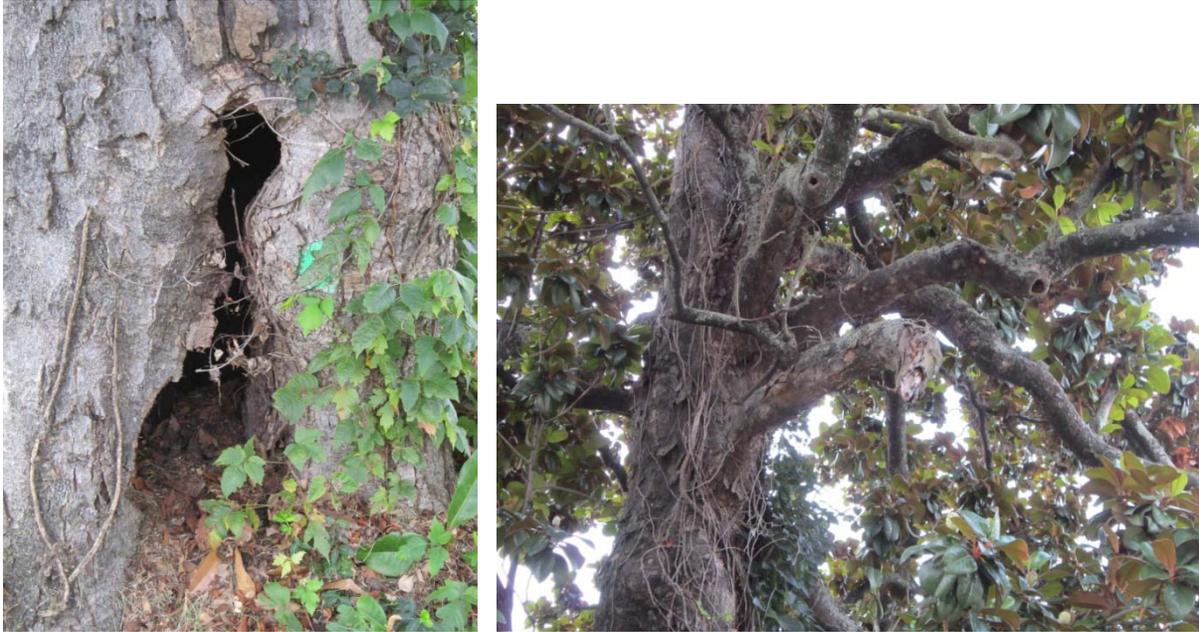
Figure 49. Magnolia at the east side of the cemetery. The photo on the left shows the hollow trunk. The right photo shows the abundant dead wood in the canopy that requires removal if the tree is not being removed.

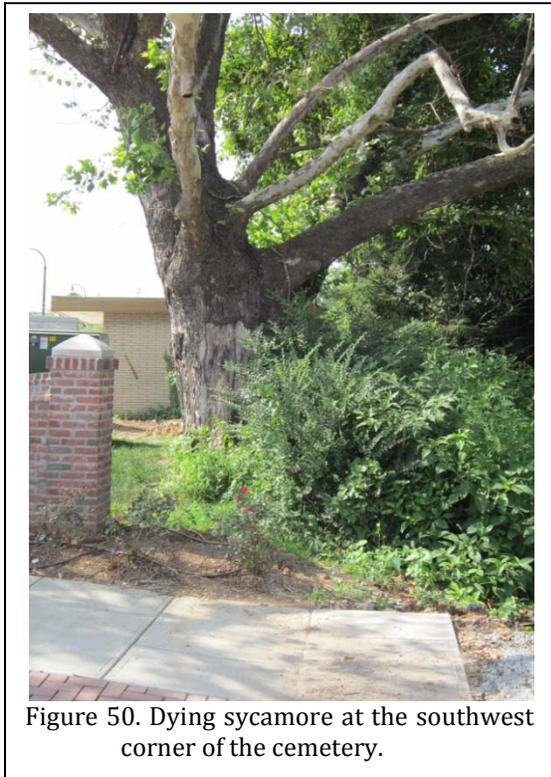
Figure 50. Dying sycamore at the southwest corner of the cemetery.

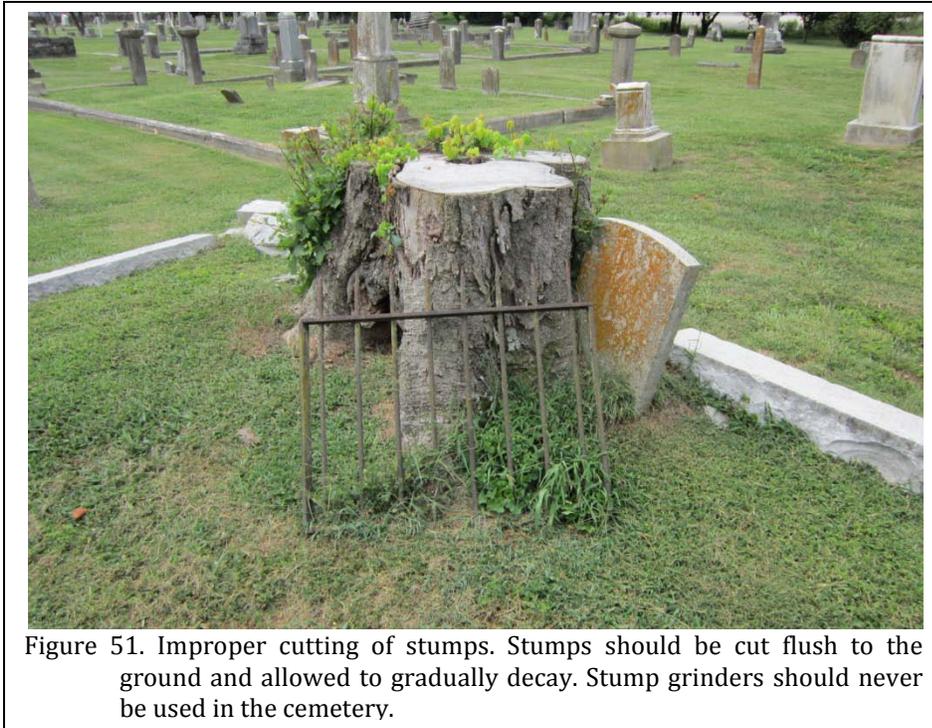
Figure 51. Improper cutting of stumps. Stumps should be cut flush to the ground and allowed to gradually decay. Stump grinders should never be used in the cemetery.

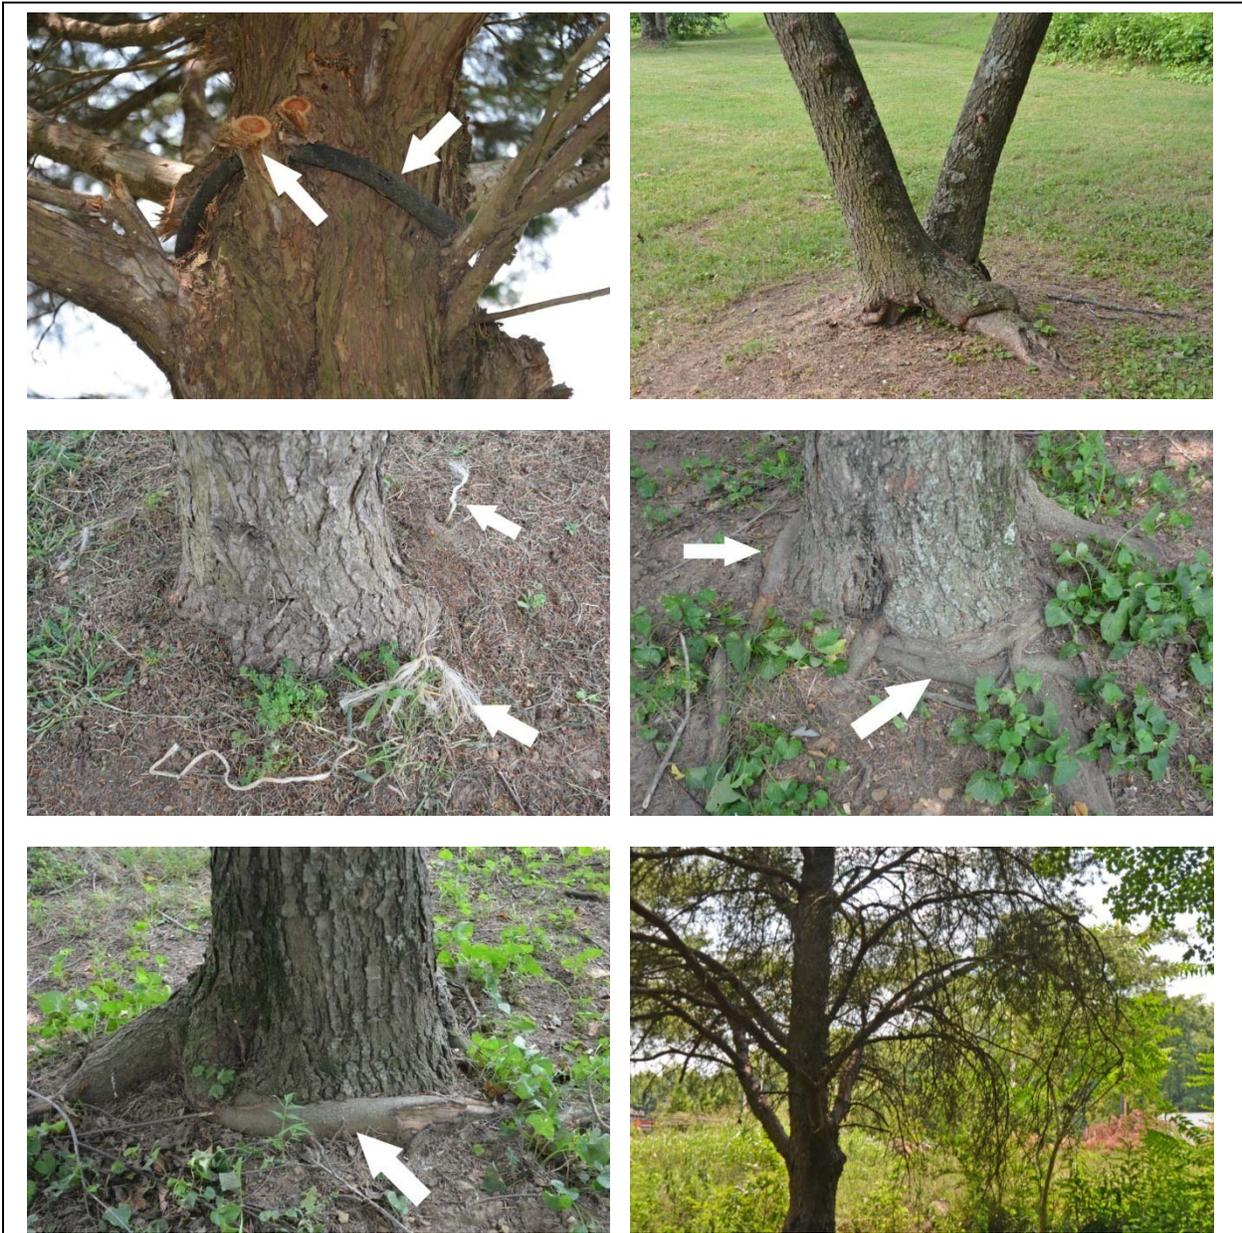
Figure 52. Additional tree issues at Rest Haven Cemetery. Upper left shows a cedar with an abandoned strap left in place. Note also improper pruning that left a stub. Even during pruning no effort was made to remove the choking strap. Upper right shows a tree with a weak crotch and girdling roots. Middle left shows nylon strings from balled roots left in place. Middle right shows multiple girdling roots. Lower left shows girdled roots. Lower right shows dead and dying branches on a tree requiring pruning.

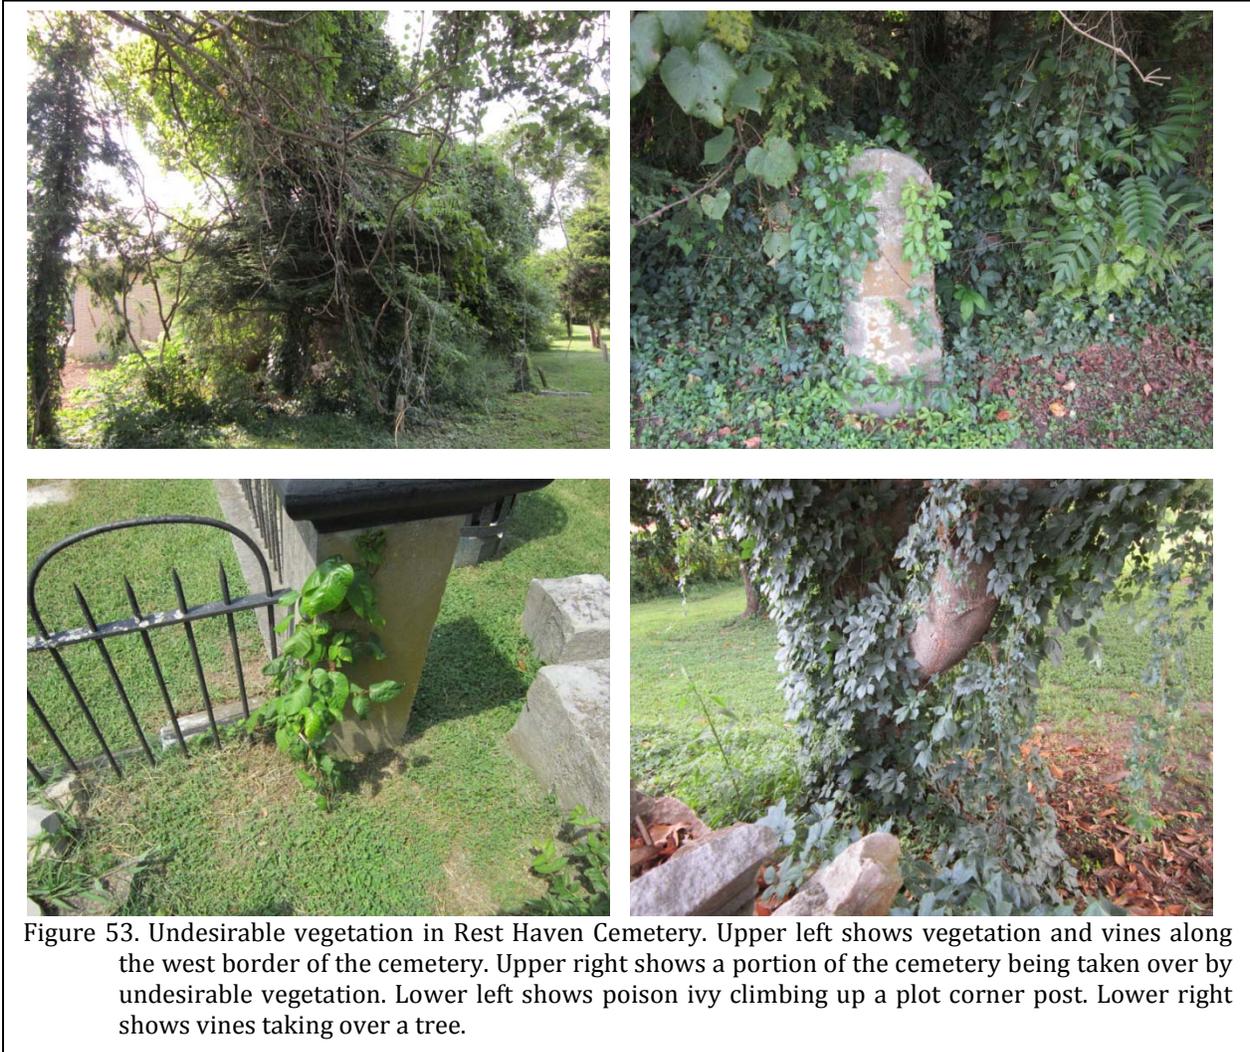
Figure 53. Undesirable vegetation in Rest Haven Cemetery. Upper left shows vegetation and vines along the west border of the cemetery. Upper right shows a portion of the cemetery being taken over by undesirable vegetation. Lower left shows poison ivy climbing up a plot corner post. Lower right shows vines taking over a tree.

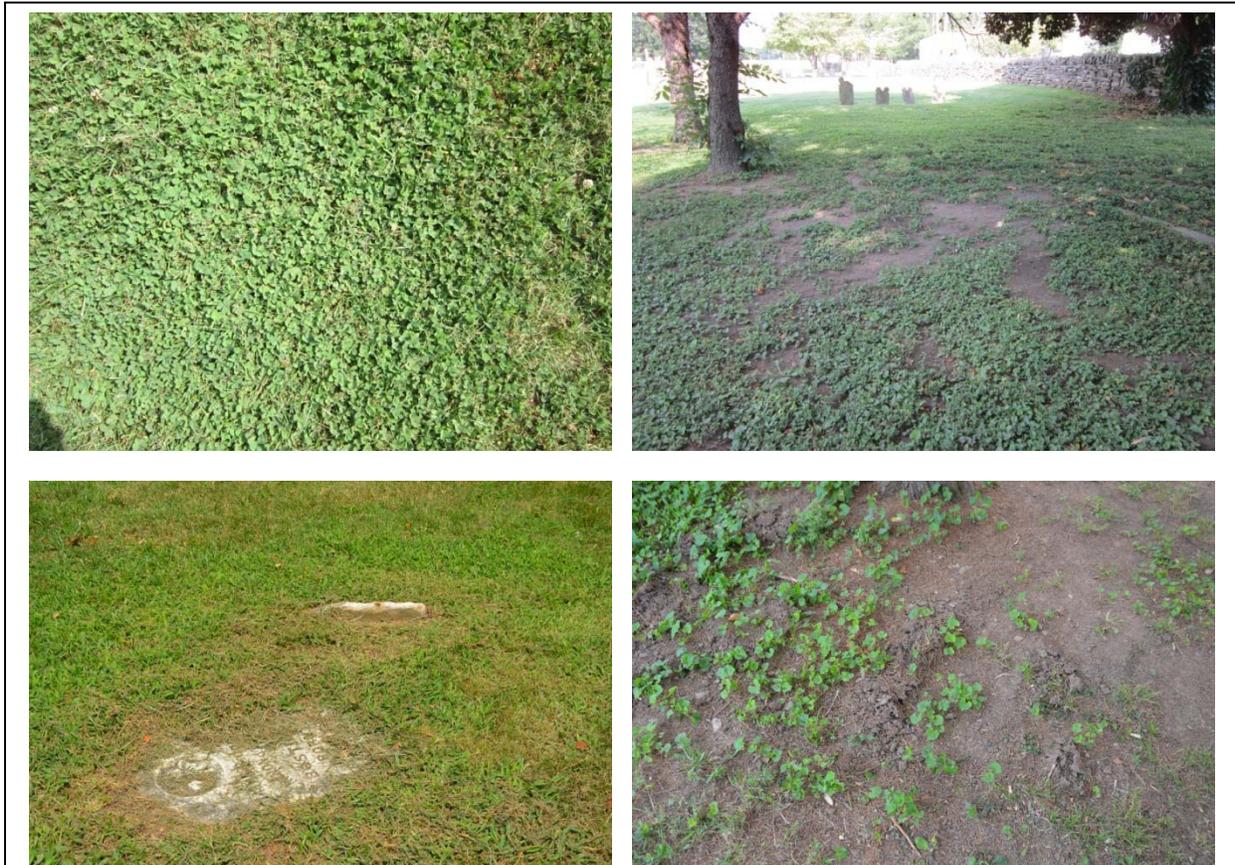
Figure 54. Turf problems at Rest Haven Cemetery. Upper left shows primarily broadleaf weeds. Upper right shows much bare ground in a shady area that would be suitable for mulch. Bottom left shows a displaced monument being covered by soil and grass. Bottom right shows extensive mole damage which seems worse at Rest Haven than City Cemetery.

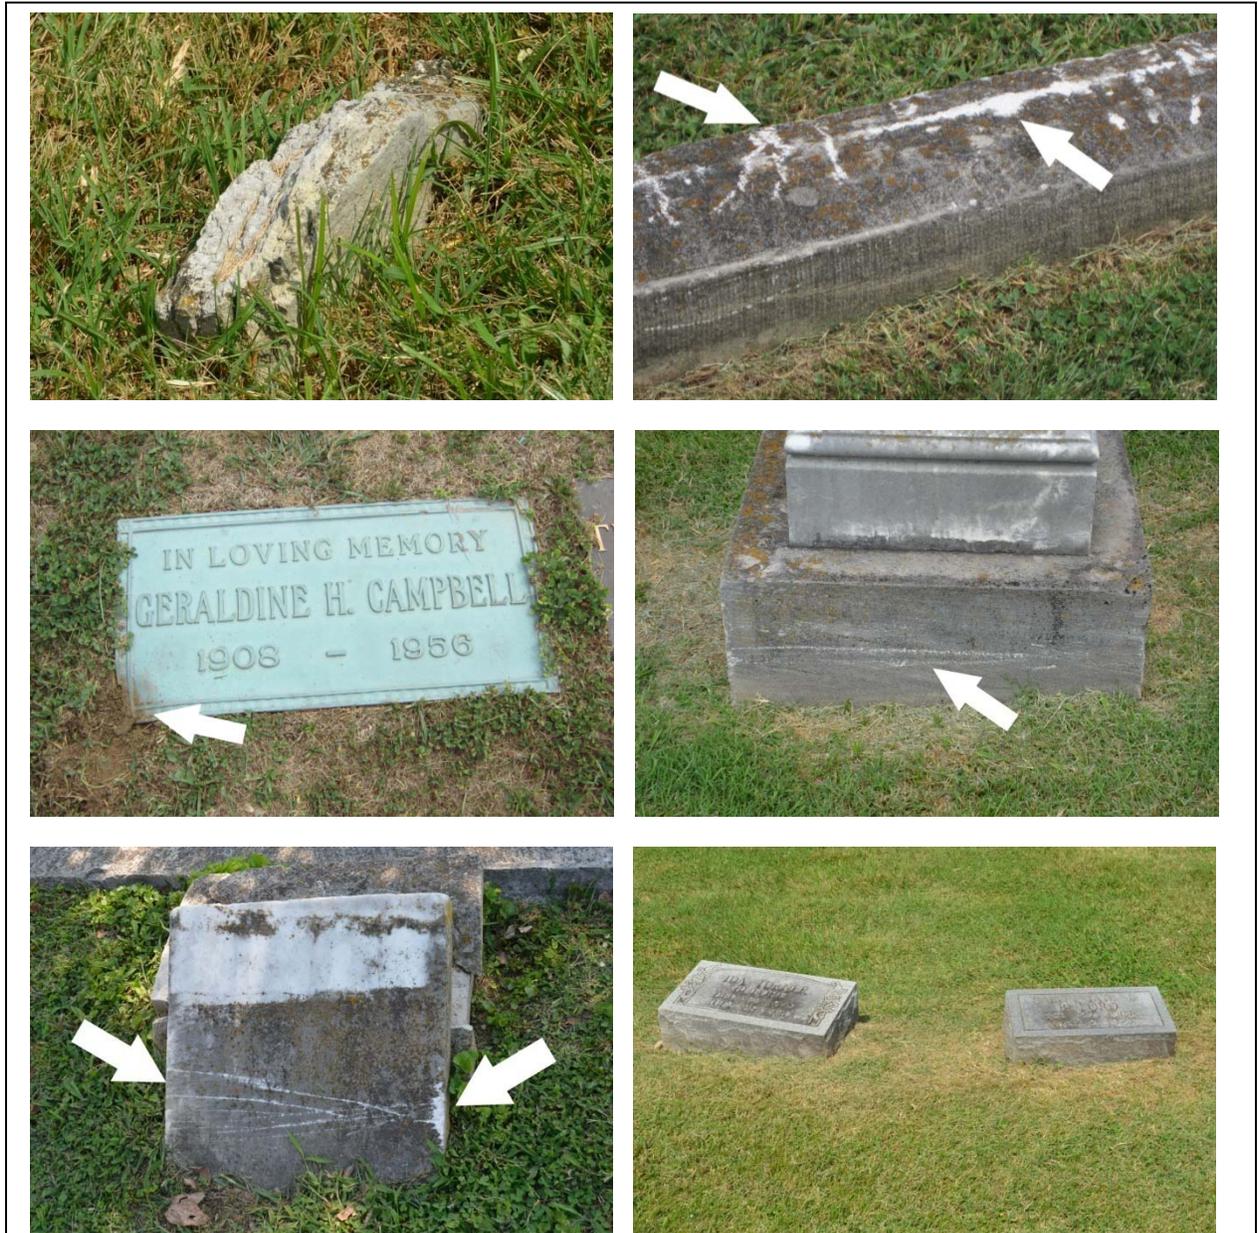
Figure 55. Mowing damage in Rest Haven Cemetery. Upper left shows a footstone repeatedly run over by mowers fragmenting and destroying the top. Upper right shows coping repeatedly impacted by mowers running over it. Middle left shows a bronze lawn marker damaged by a mower. Middle right shows a monument scraped by a mower. Bottom left shows both mower impacts and mower scrapes on a toppled monument. Bottom right shows a lawn marker displaced by mower impacts.

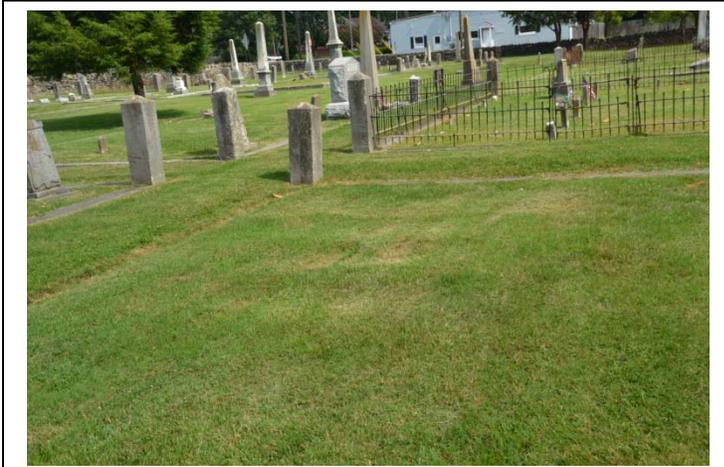
Figure 56. Grave depressions in a lot.

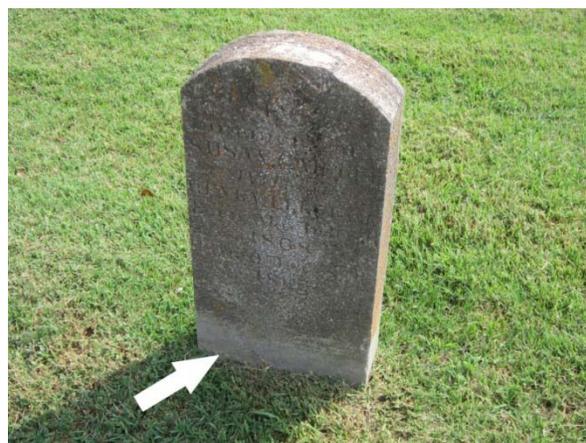
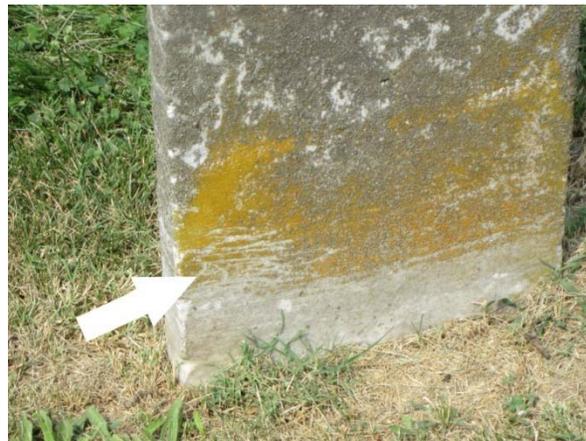
Figure 57. Examples of nylon string trimmer damage at Rest Haven Cemetery.

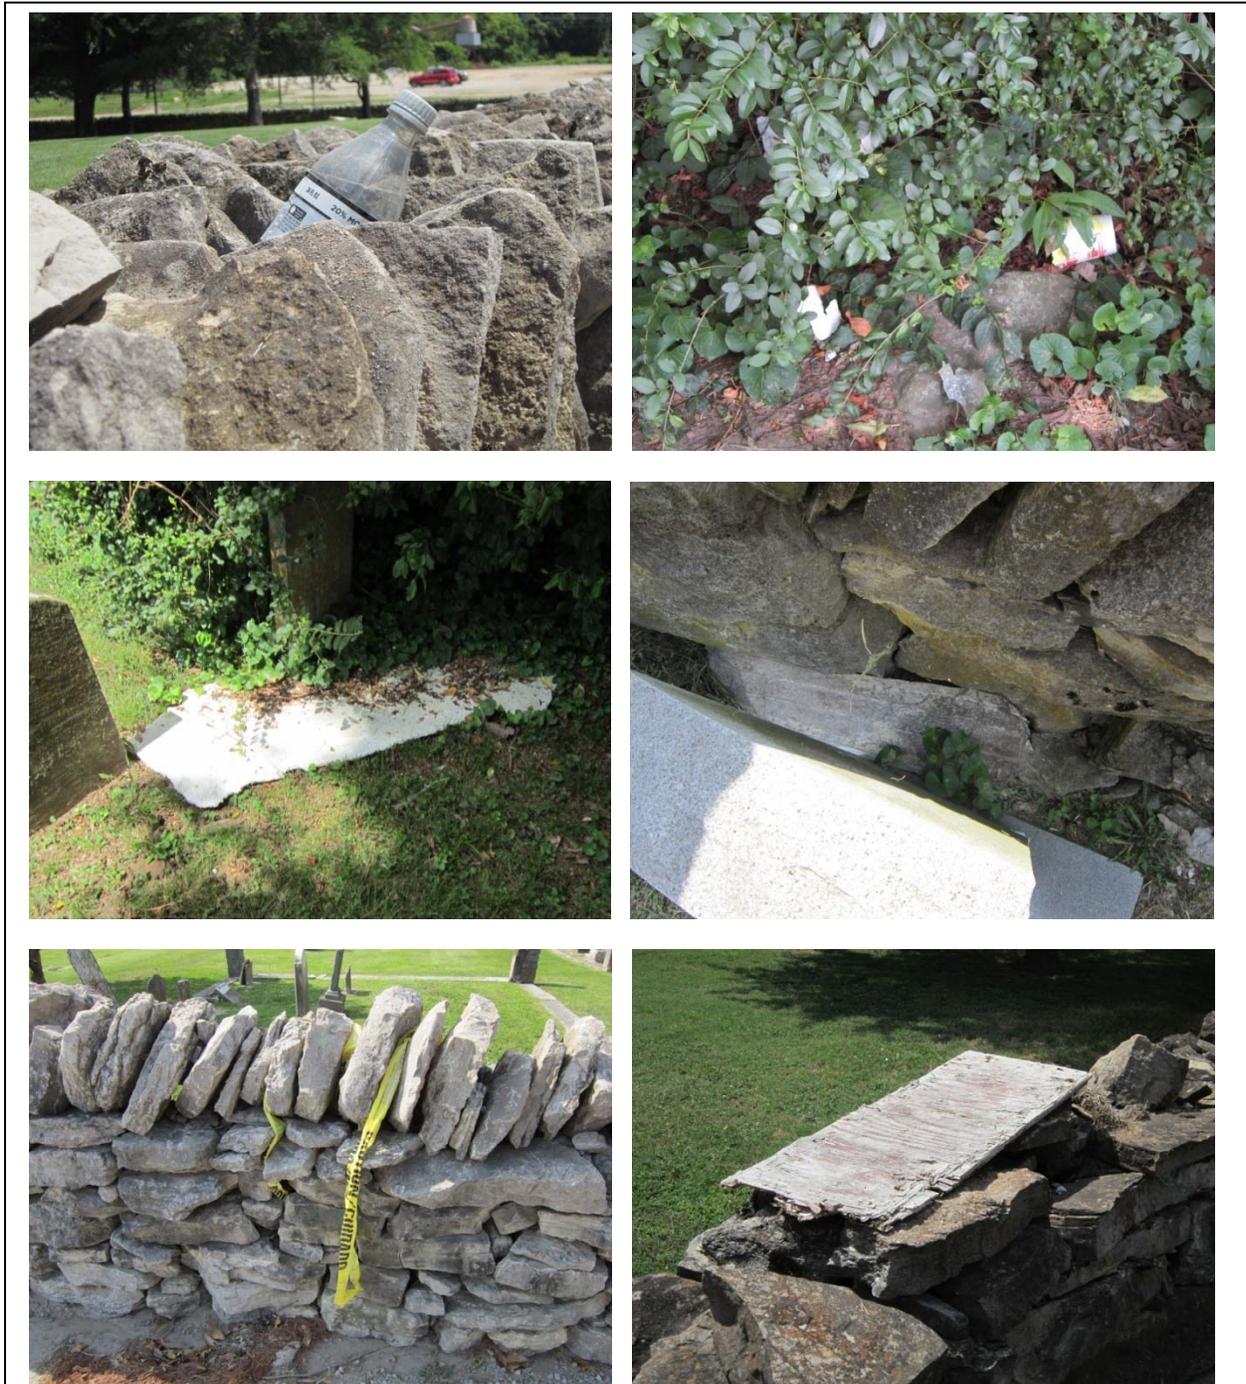
Figure 60. Trash in City and Rest Haven cemeteries. Upper left shows trash on the stone walls, present in both cemeteries. Upper right shows trash along northern boundary of City Cemetery. Middle left shows a sheet of Styrofoam insulation board that has been mowed over in City Cemetery. Middle right shows a piece of roofing metal at the front gate of City Cemetery. Lower left, construction trash on the Rest Haven wall. Lower right, trash on the Rest Haven wall.

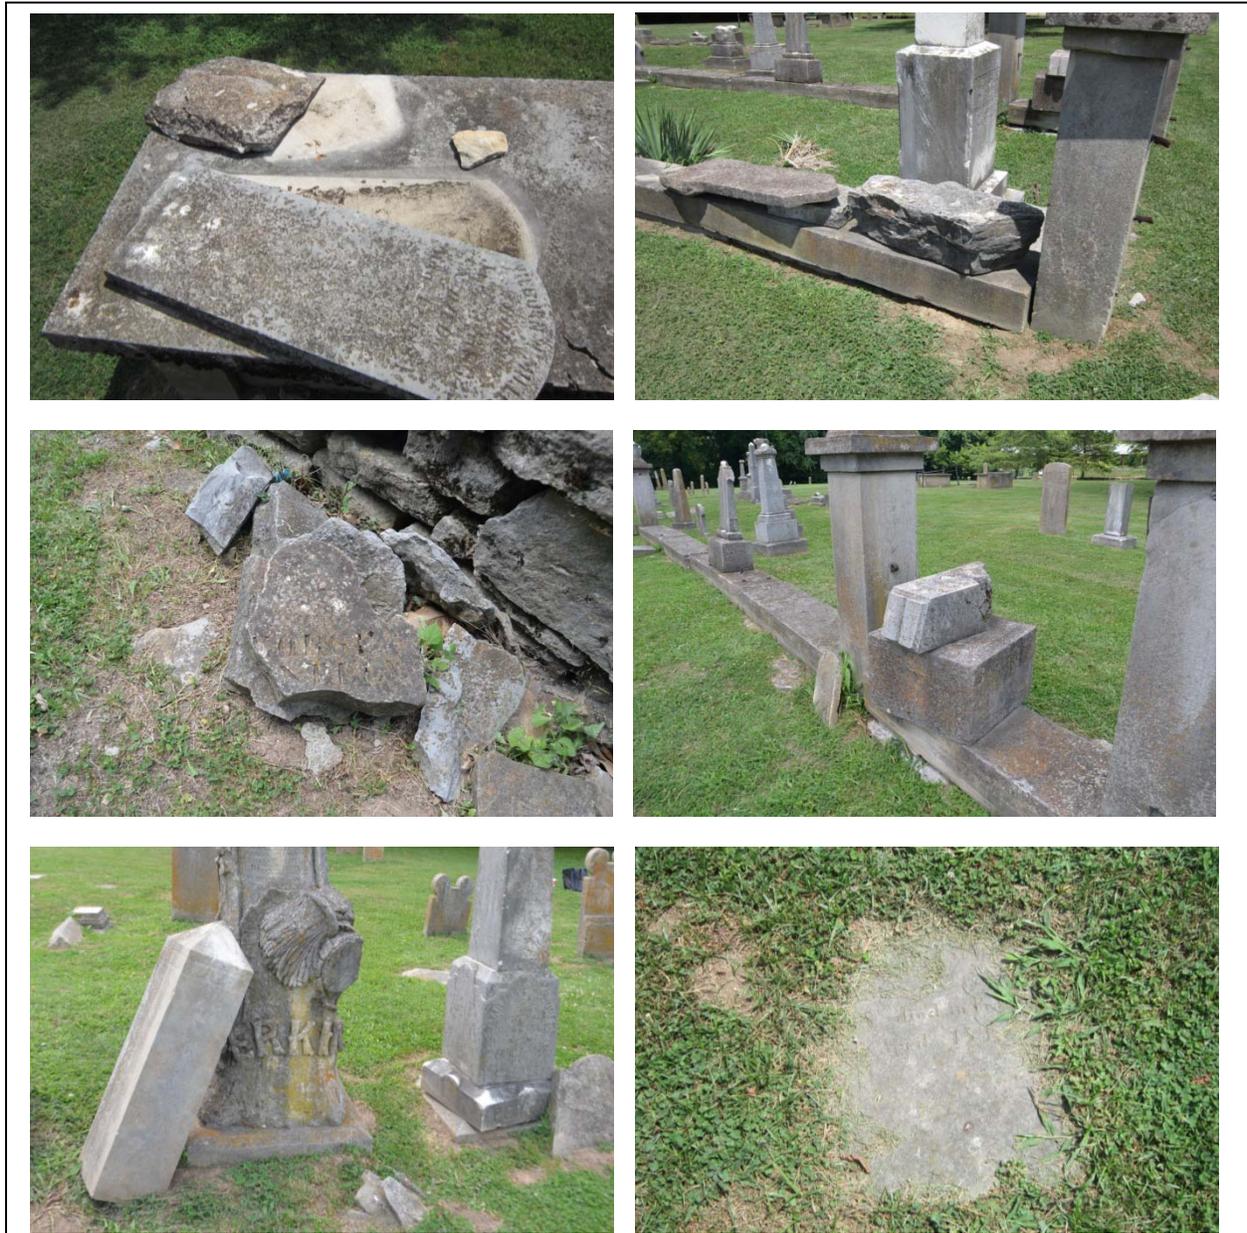
Figure 61. Orphan stones in City Cemetery. Upper left shows stones set on a box tomb for so long that stains have been created. Upper right shows stones stacked on plot coping. Middle left shows stone fragments dumped against the boundary wall. Middle right, stones set on plot coping. Lower left, obelisk fragment leaning against another monument. Lower right, stone fragment almost buried in the soil with no obvious grave association.

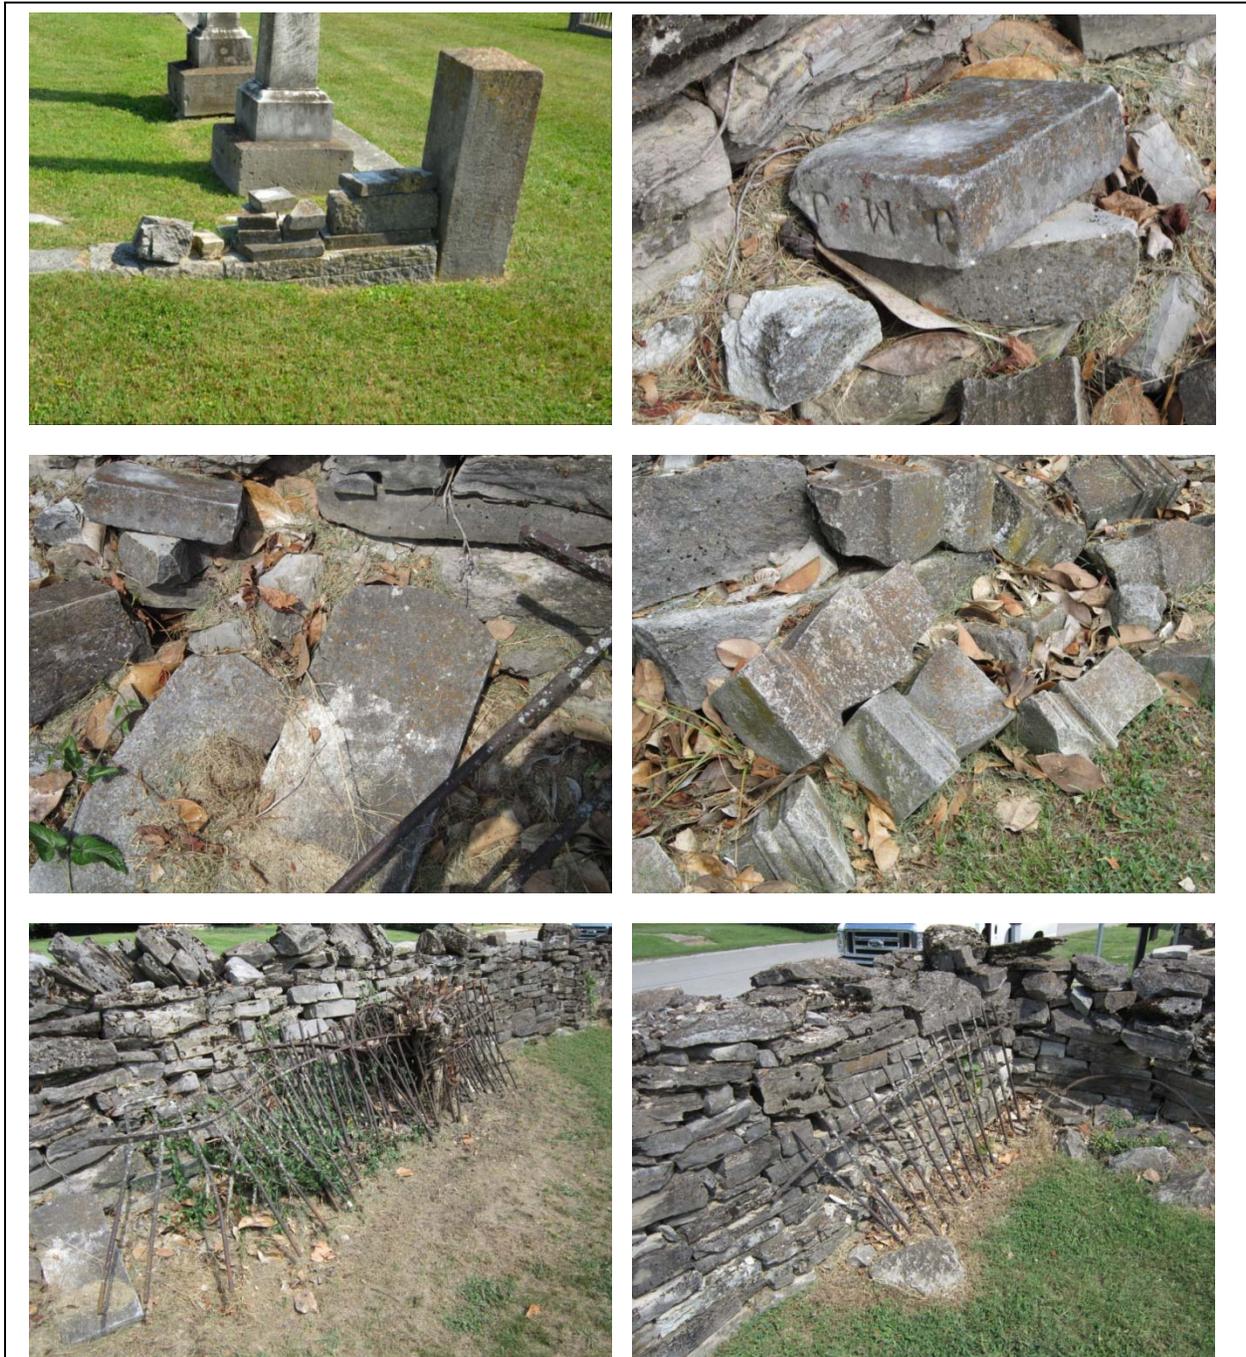
Figure 62. Orphan stones and fence parts in Rest Haven Cemetery. Upper left, a pile of foot stones stacked on plot coping. Upper right, foot stones tossed on the east stone boundary wall. Middle left, headstones dumped along the boundary wall. Middle right, table tomb legs and other fragments dumped along the boundary wall. Lower left, fence sections dumped against the boundary wall. Lower right, a second pile of fence parts.

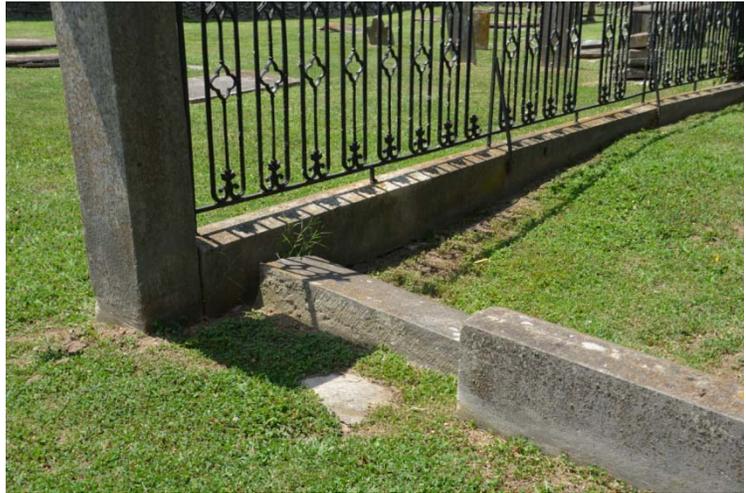
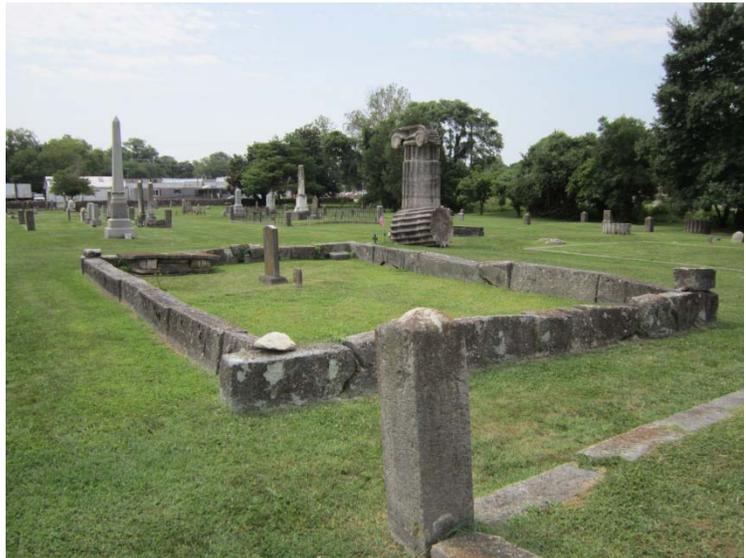
Figure 64. Displaced or damaged curbs and copings. Upper photo shows displaced coping in City Cemetery. Lower photo shows broken and badly displaced wall coping at Rest Haven Cemetery.

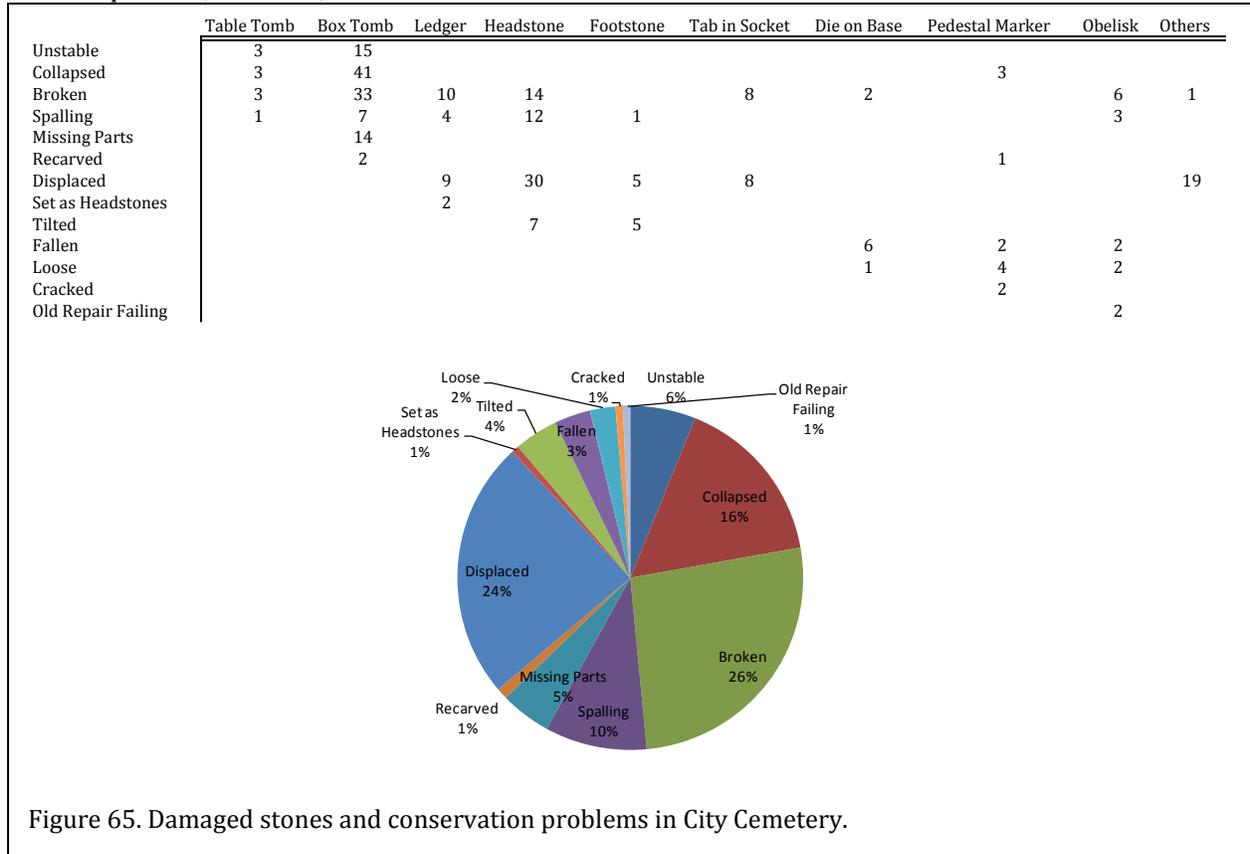
Figure 65. Damaged stones and conservation problems in City Cemetery.
