ASSESSMENT OF TWO CITY OF FRANKLIN CEMETERIES, FRANKLIN, TENNESSEE

Chicora Research Contribution 559

Michael Trinkley
Debi Hacker

September 2014

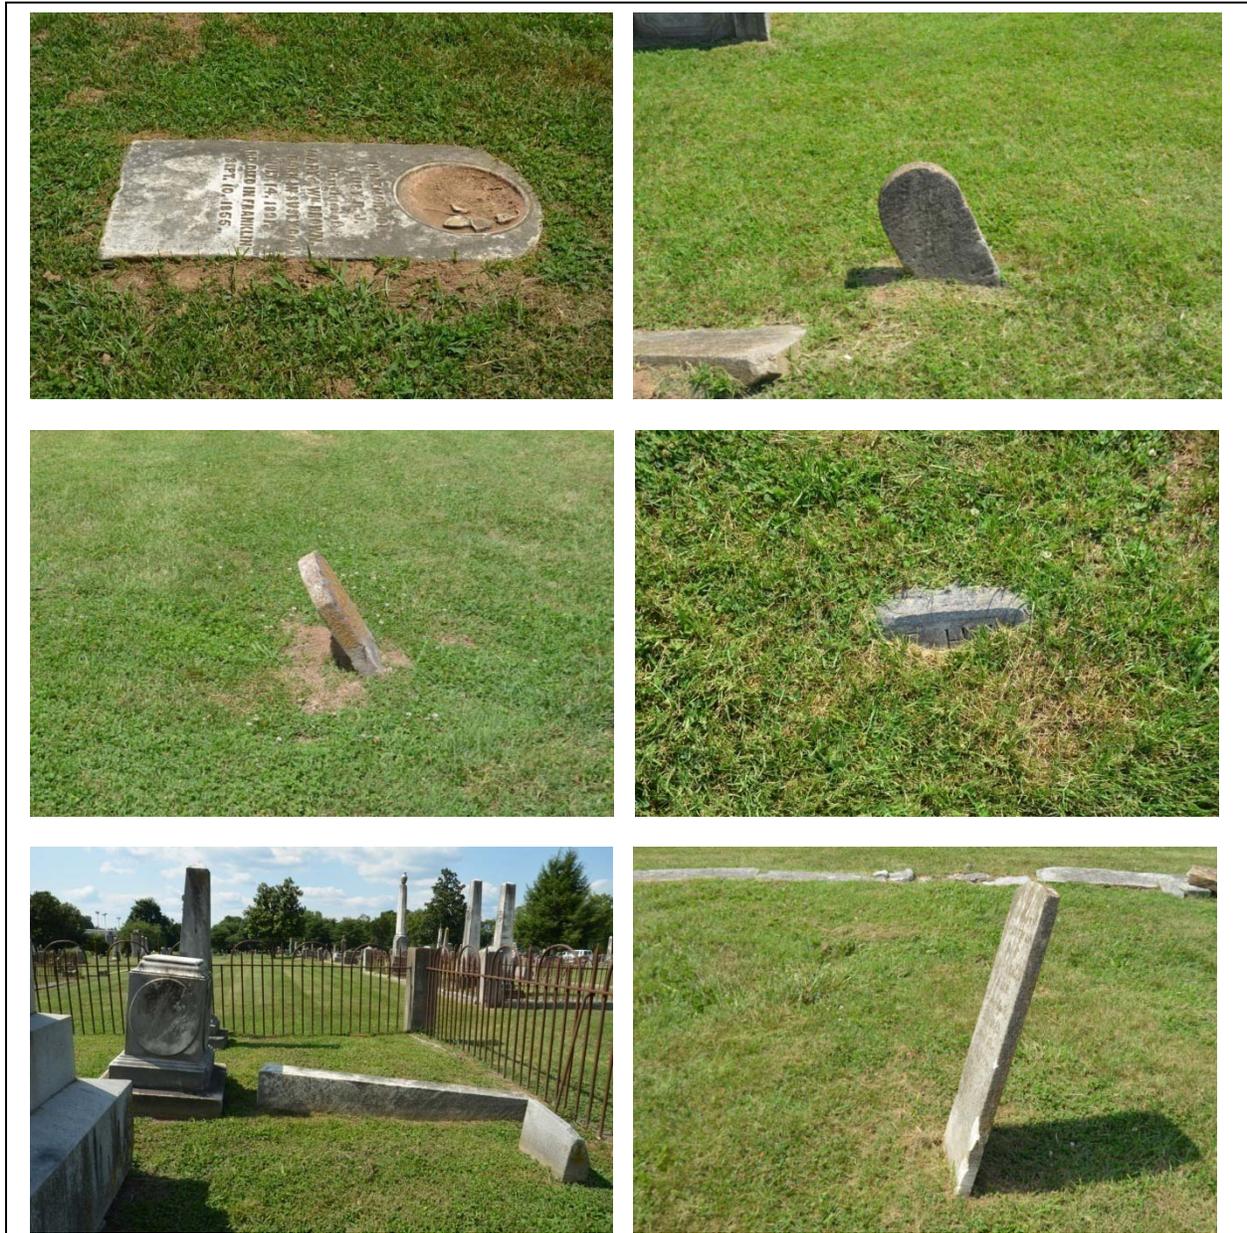
Figure 67. Examples of stones requiring resetting. Upper left, die on base that has collapsed. Upper right, tilted footstone. Middle left, tilted footstone. Middle right, sunken granite footstone being damaged by mowing. Lower left, toppled obelisk that requires resetting. This monument will require lifting equipment and rigging. The bases must first be leveled, and the bases and obelisk shaft drilled for the installation of a stainless steel pin. Bottom right, tilted headstone that requires resetting.

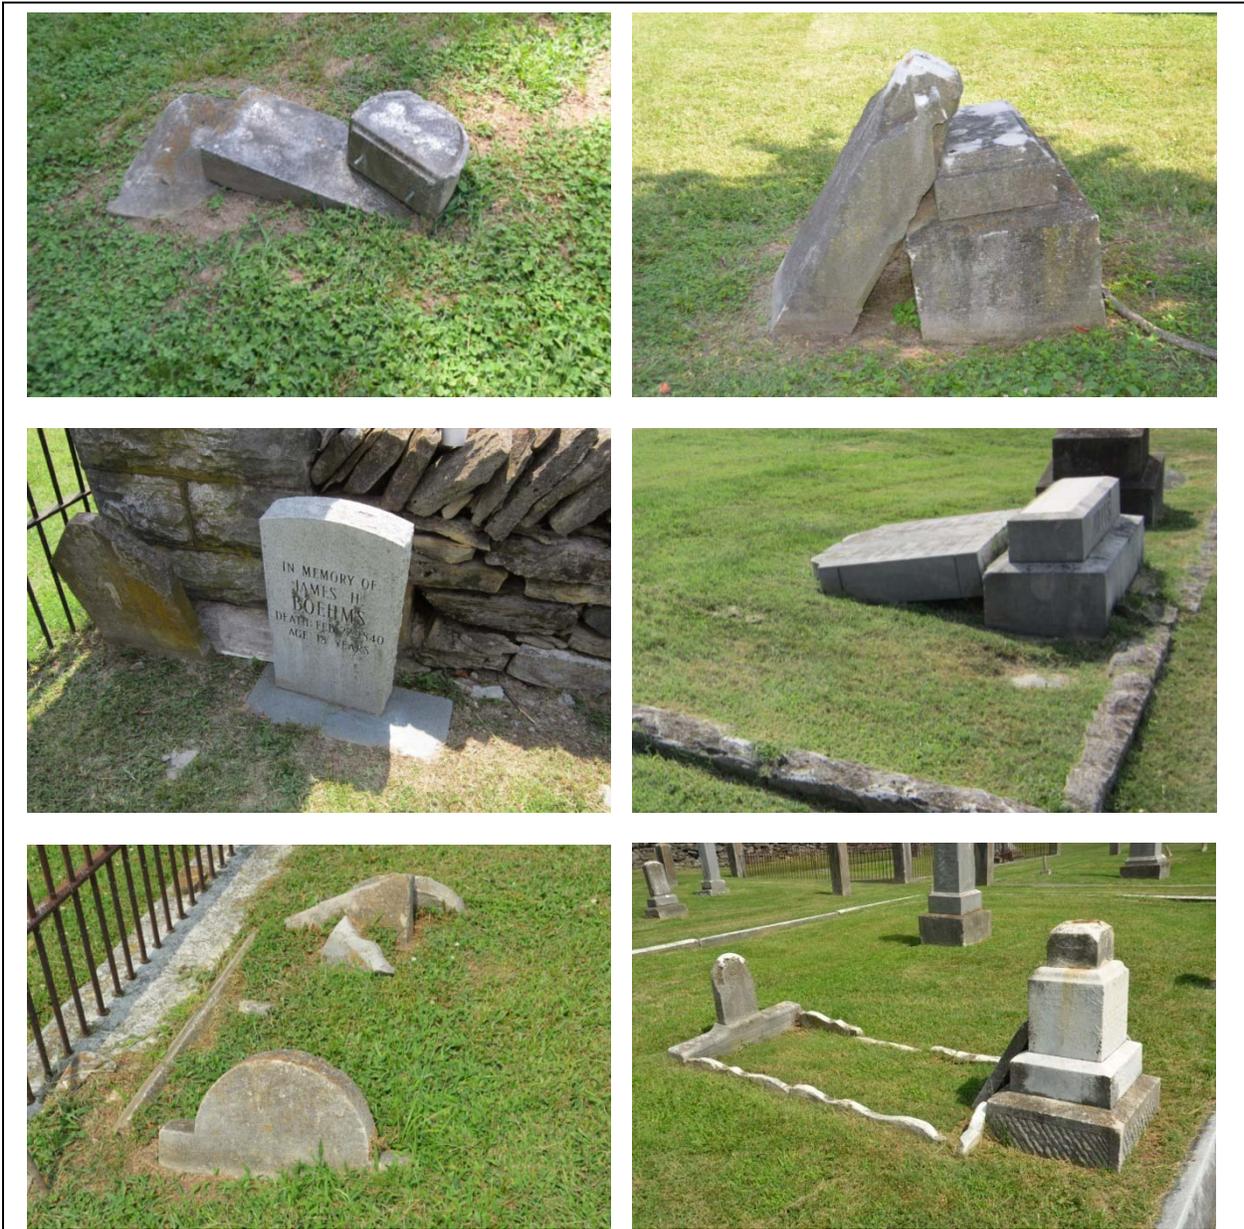
Figure 68. Examples of die on base and cradle grave damage. Upper left shows a die on base. Still present are two ferrous pins in the die which must be replaced with fiberglass or stainless steel pins prior to resetting. Upper right is a die on base that because of its height will require pinning. Middle left shows a modern granite die on base that has shifted significantly and requires resetting. Middle right shows a toppled die on base that requires leveling and pinning as part of resetting. Lower photos show cradle graves that require resetting and repair.

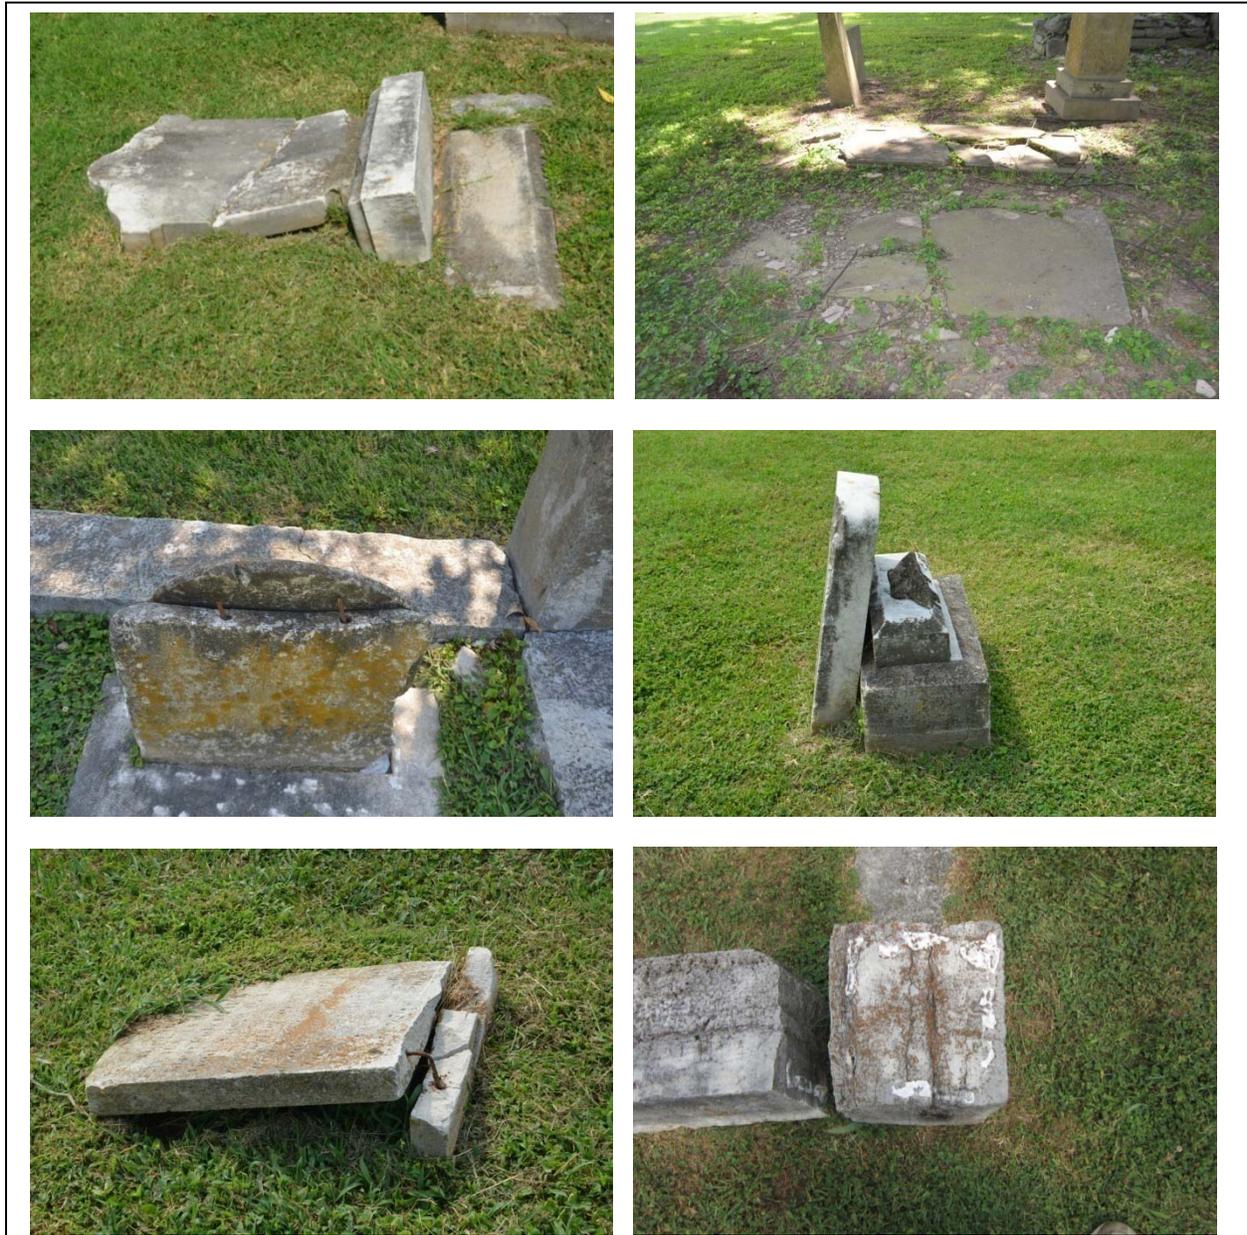
Figure 70. Examples of broken stones. Upper left shows a die on two bases. When the stone fell or was pushed over, the impact of hitting the ground caused the die to break. Upper right shows a badly broken marble ledger. Middle left shows a tab in socket with the die broken and use of ferrous pins in a failed repair. Middle right shows a broken tab in socket. Lower left shows a headstone and use of ferrous pins in a failed repair. Lower right shows a failed simple epoxy repair.

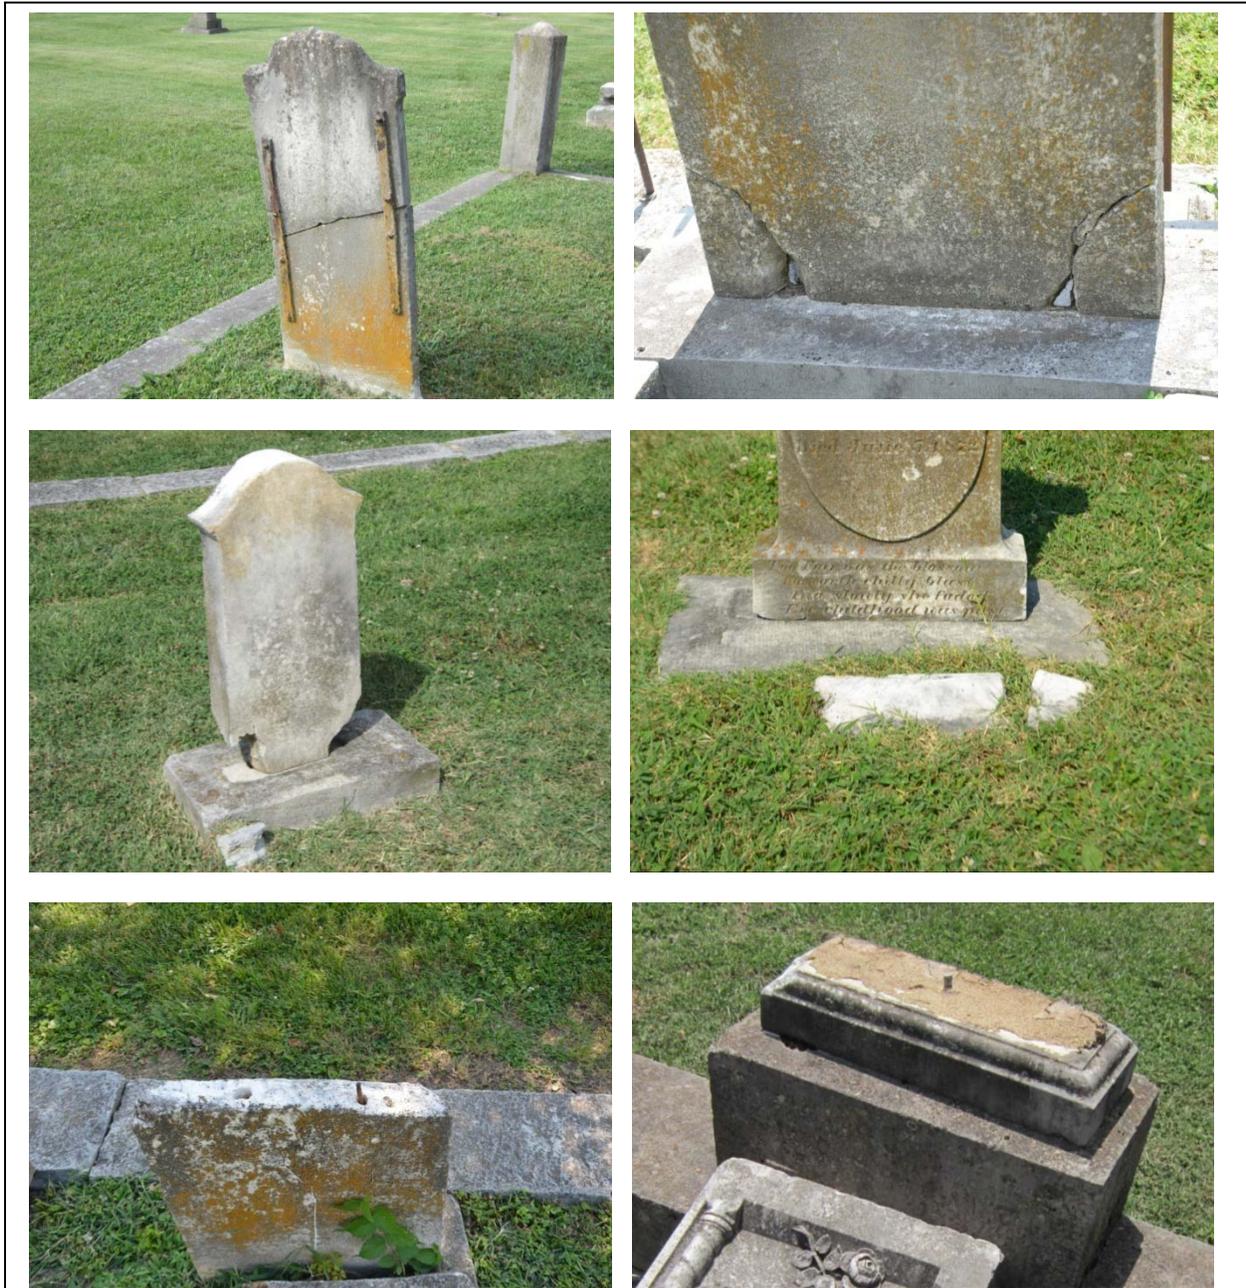
Figure 71. Examples of ferrous pins and iron jacking. Upper left shows a headstone reinforced with iron bars and bolts, all of which are corroding. Upper right shows the die cracking as a result of iron jacking resulting from two ferrous pins. Middle left shows the next phase in the process, with the corners of the die completely shattered by iron jacking. Middle right shows the loss of the middle base (in the grass, foreground) as a result of iron jacking. Lower left shows inappropriate repair using ferrous pins. Lower right shows die on base setting using a ferrous pin.

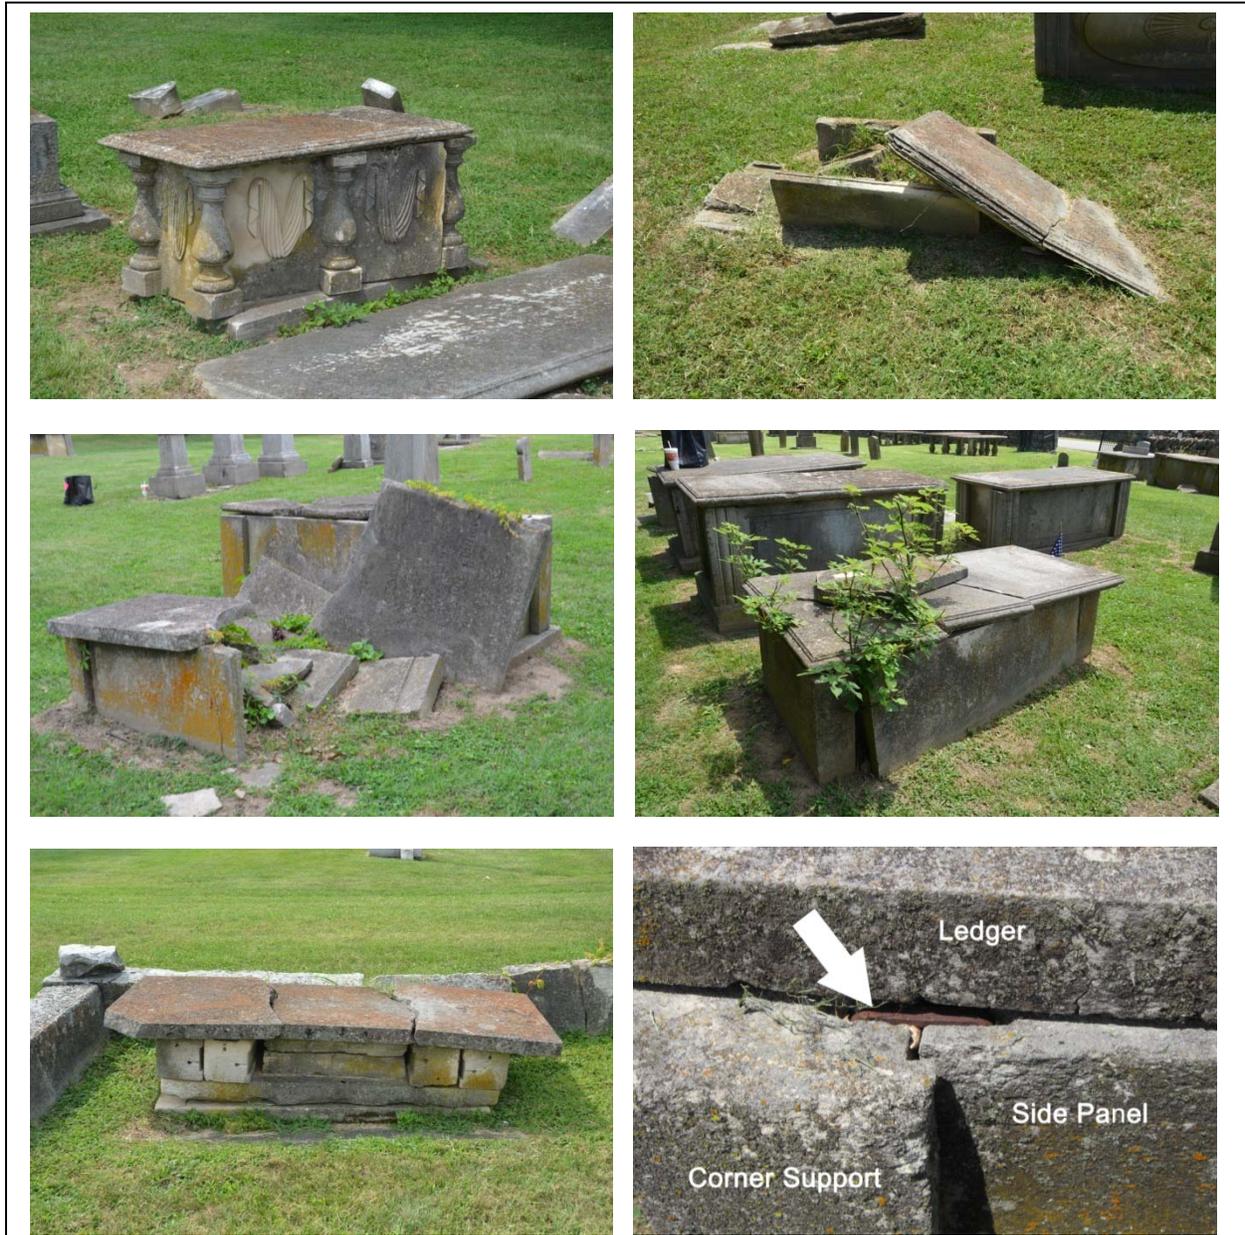
Figure 72. Box tombs. Upper left shows an ornate example that, while intact, has badly shifted on its base. Without resetting it will collapse and suffer damage. Upper right shows a box tomb that has collapsed, resulting in the breakage of the ledger – dramatically increasing repair costs. Middle left shows a partially collapsed box tomb with both the side walls and ledger broken. This box tomb does not have corner posts. Middle right, a box tomb that is badly damaged, but still standing. It also reveals much vegetation growing out of the box, which will eventually cause even more damage. Lower left shows a collapsed box tomb with its parts neatly stacked. Lower right shows a ferrous dog in a still standing box tomb.

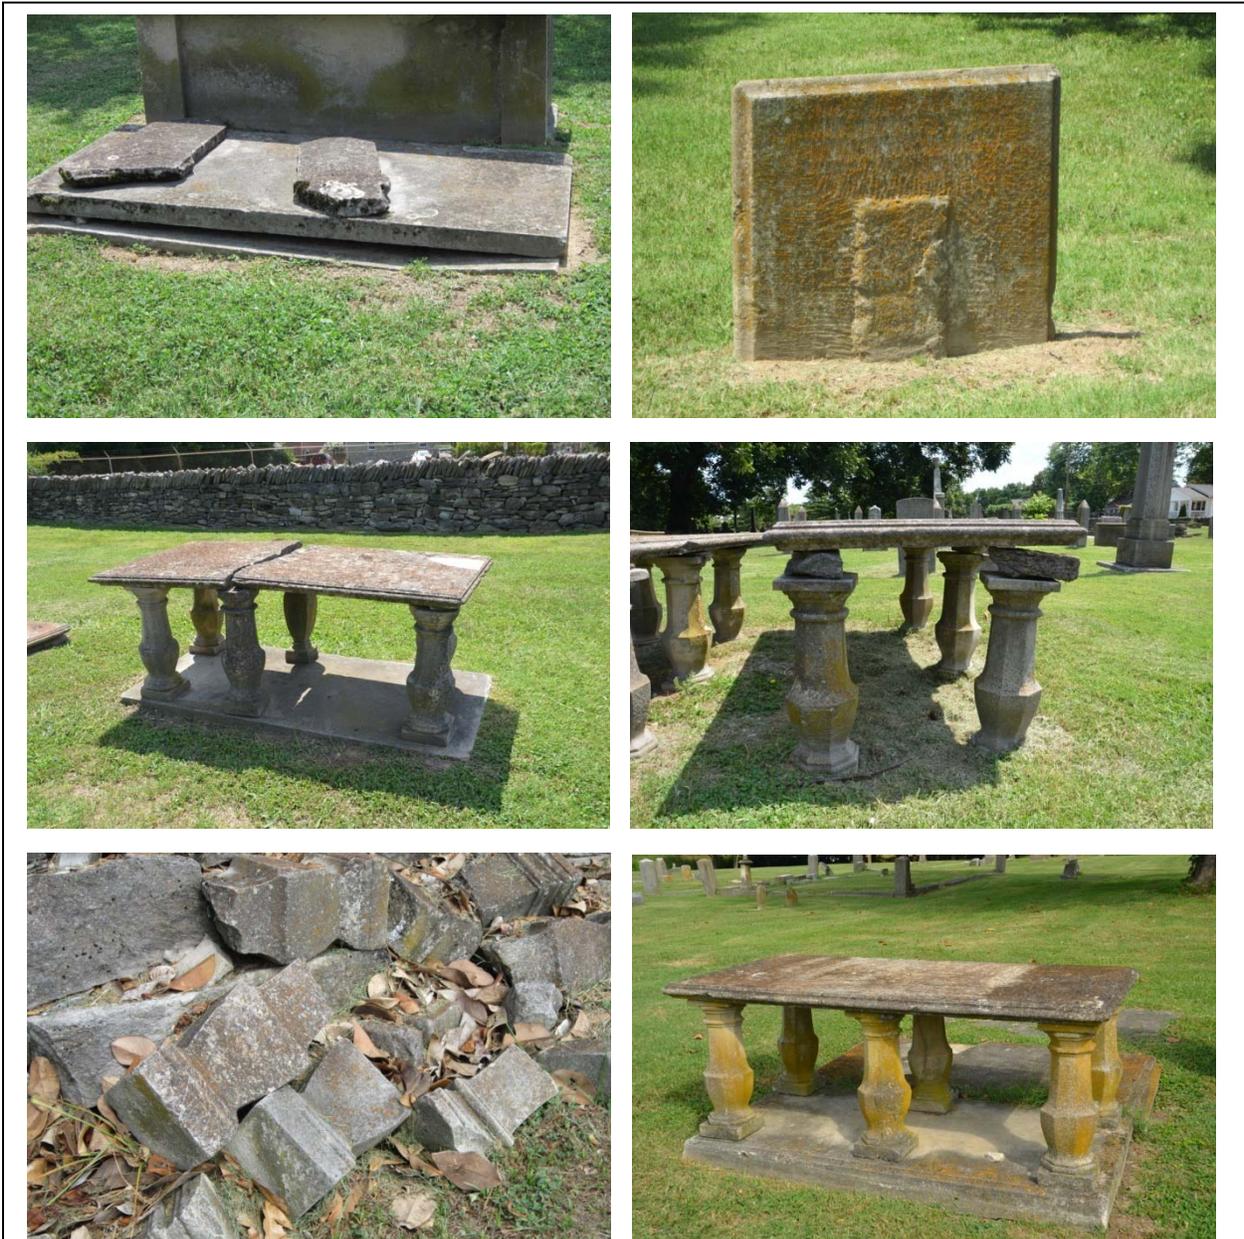
Figure 73. Examples of box and table tombs. Upper left shows a collapsed box tomb. The bottom slab is broken and anyone walking on the supported ledger will cause it to break. Upper right shows a ledger from a box tomb reset as a headstone. Middle left shows a table tomb that, while still standing, is unstable. If it collapses it will likely further break the ledger and possibly one of more of the legs. Middle right shows another unstable table tomb where parts of other monuments have been used in an effort to level the ledger. Lower left shows broken legs from Rest Haven Cemetery dumped along the wall. At that cemetery many of the ledgers were probably originally box or table tombs. Lower right shows one of the few still standing table tombs in Rest Haven Cemetery. In the background are two ledgers that were probably originally table tombs.

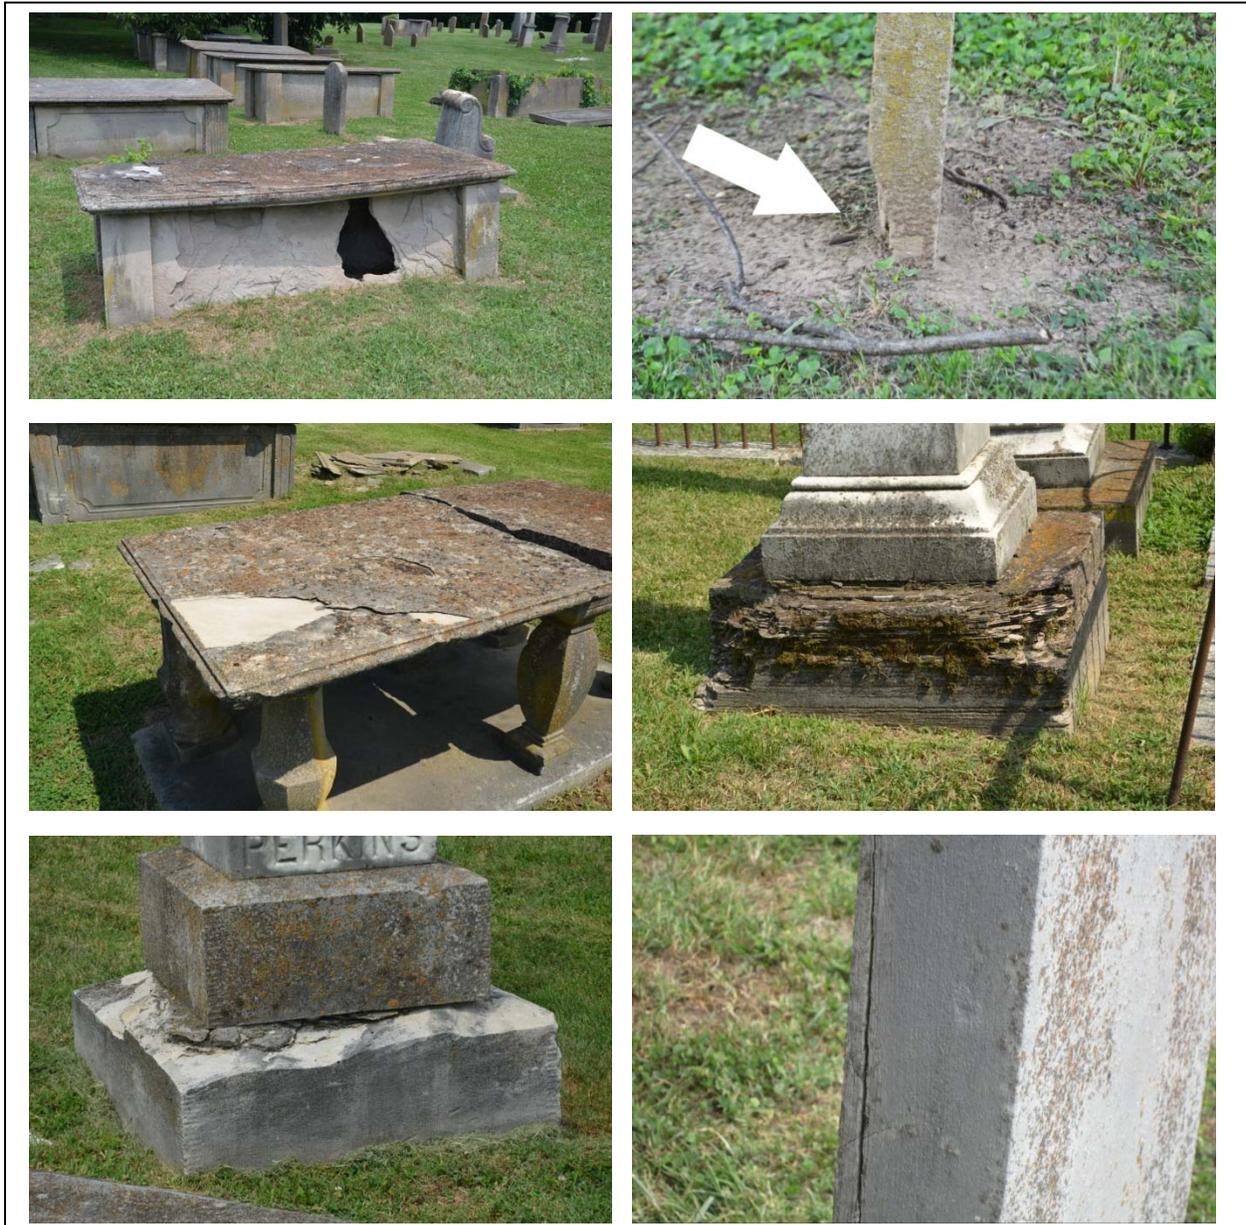
Figure 74. Spalling. Upper left shows a sandstone side panel of a box tomb with heavy spalling or exfoliation to the point that a large segment has been lost. Upper right shows spalling at the base of a headstone resulting from salts. Left unchecked, the headstone will eventually collapse. Middle left shows a spalling (and broken) ledger. Eventually all of the inscription will be lost. Middle right shows a badly deteriorated base where the bedding planes are clearly visible. Bottom left shows another spalling base that is causing instability in the overhead obelisk. Lower right photo shows a crack developing in a headstone. Left untreated this will cause the carved face to spall off the monument.

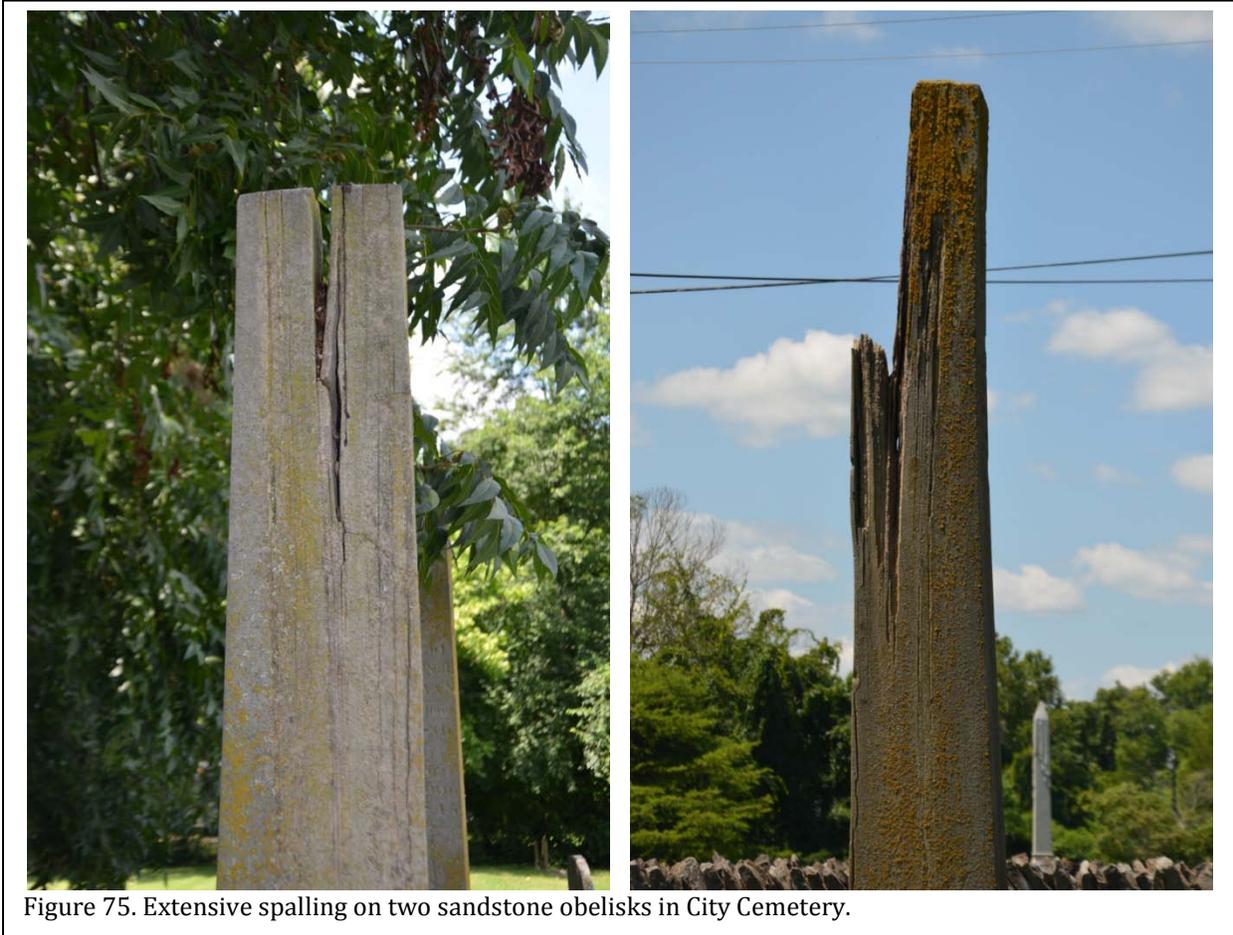
Figure 75. Extensive spalling on two sandstone obelisks in City Cemetery.

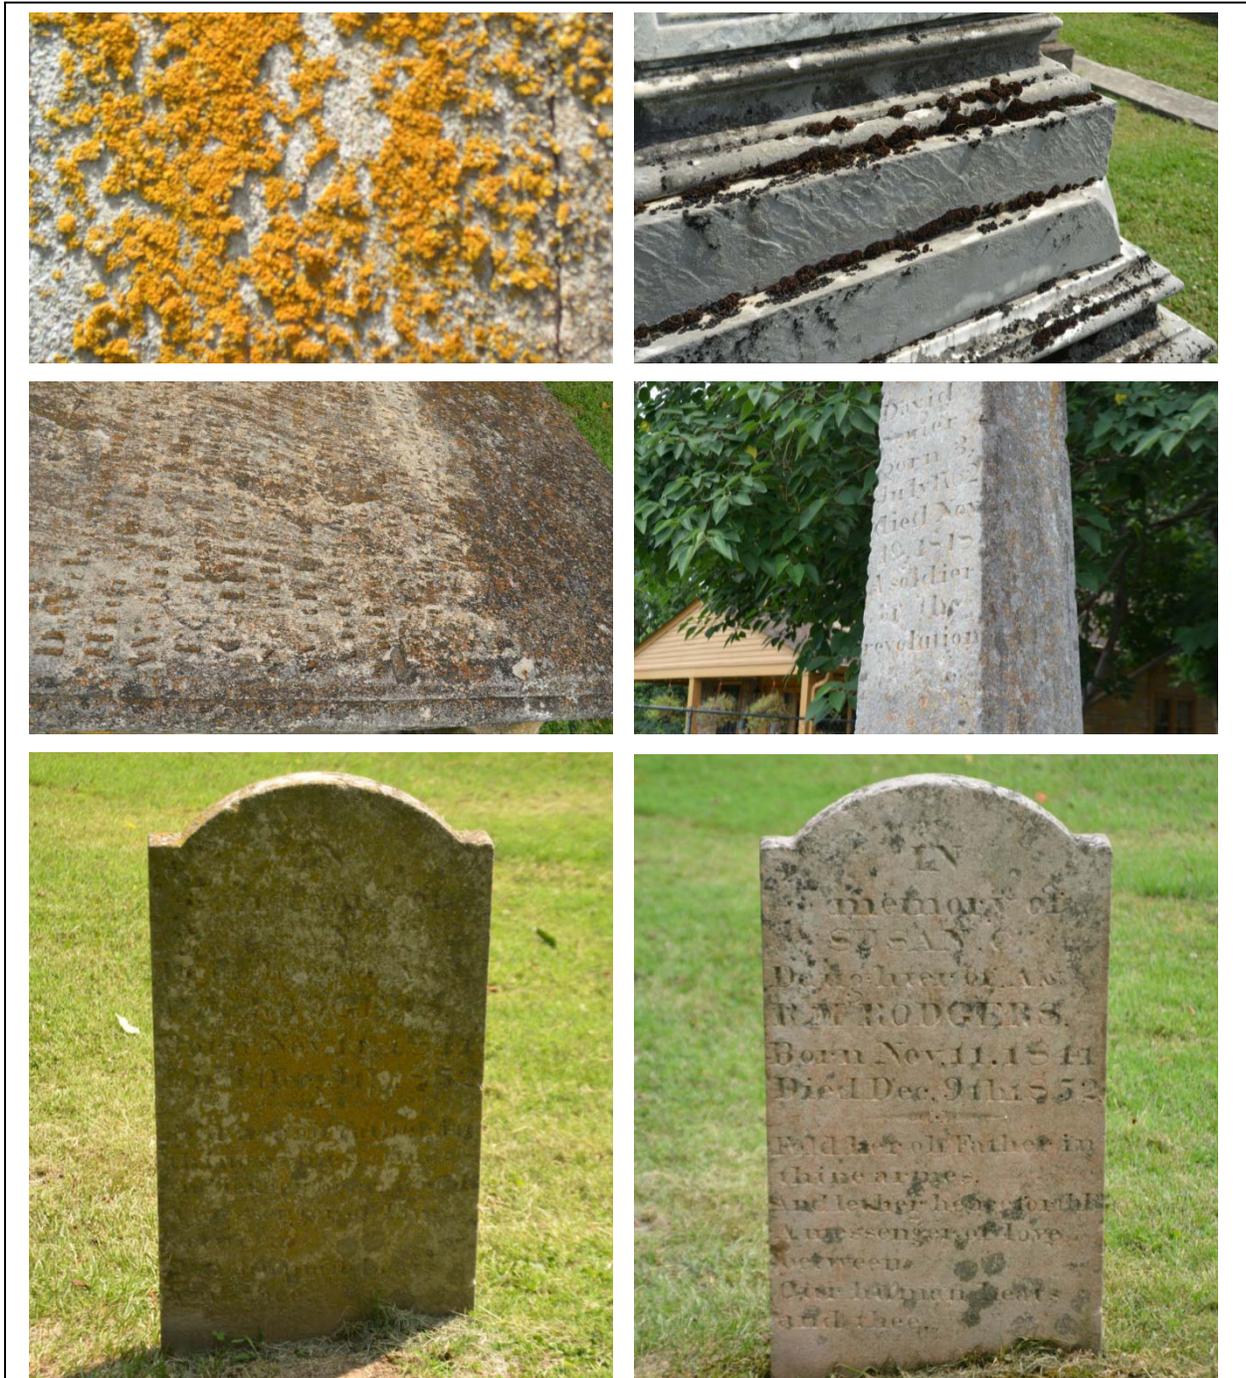
Figure 76. Cleaning issues in the cemeteries. Upper left shows a close-up of lichen on a stone at City Cemetery. Upper right shows a different lichen form at Rest Haven Cemetery. Middle left shows a table tomb harshly cleaned in an effort to read the inscription. Middle right shows an improperly cleaned inscription on an obelisk; the remainder of the monument was left soiled. Bottom shows a stone before and 10 minutes after cleaning with D/2 Biological Solution.

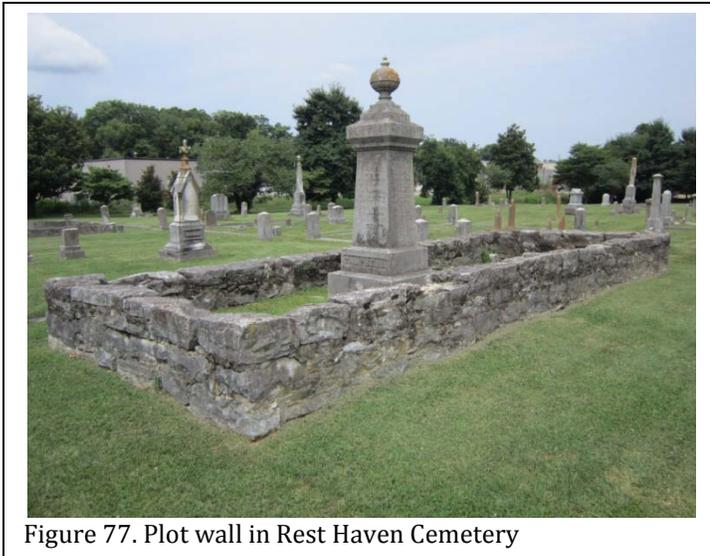
Figure 77. Plot wall in Rest Haven Cemetery

being in good condition. While these findings are very troubling, they are sadly consistent with our discovery of the great many monuments that are damaged. Unfortunately, the fences in these two cemeteries were did not receive preventative maintenance. As a result, almost immediate intervention is critical.

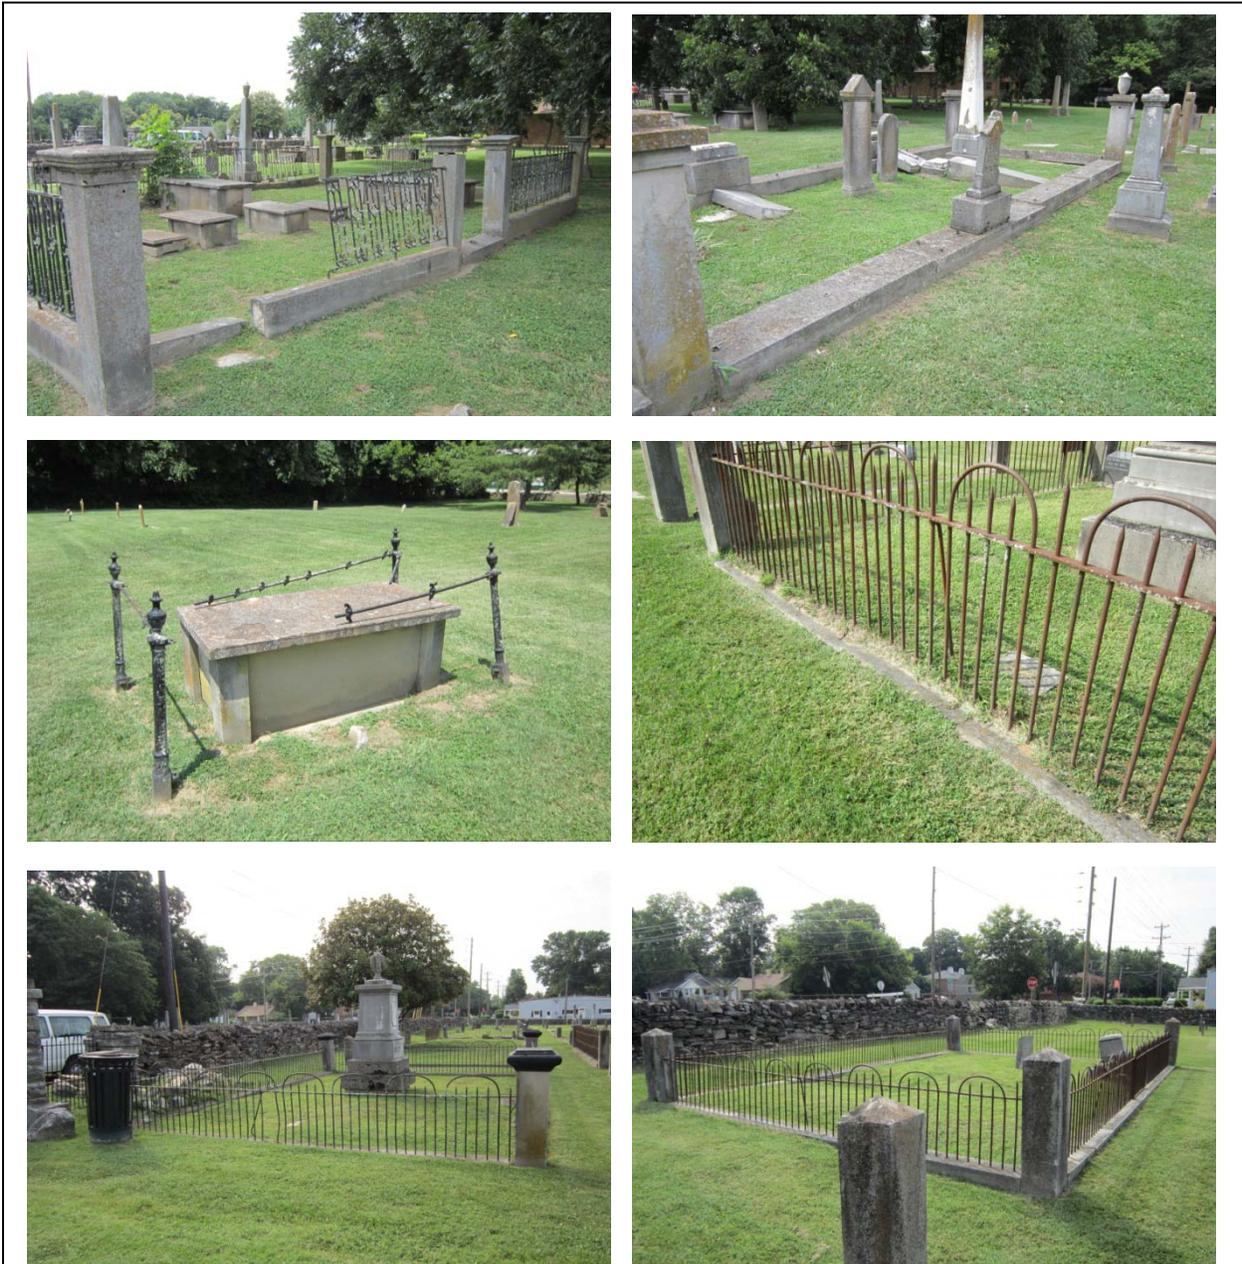
Figure 78. Fence Problems. Upper left shows a fence rated in poor condition. The gate, several sections, and individual pickets are missing; coping is displaced; and the fence requires painting. Upper right shows a fence that has been completely lost, being cut off its stone coping using a cutting torch. Middle left photo shows a fence that is almost entirely missing. Middle right shows grass growing over the coping and bottom of the ironwork. Lower left shows a fence classified in fair condition, requiring some structural support and painting. Lower right shows a fence considered to be in good condition that requires only painting.
