CONCEPTUAL ENGINEERING REPORT

**Robinson Lake Dam
Franklin, Tennessee**

City of Franklin

December 8, 2017

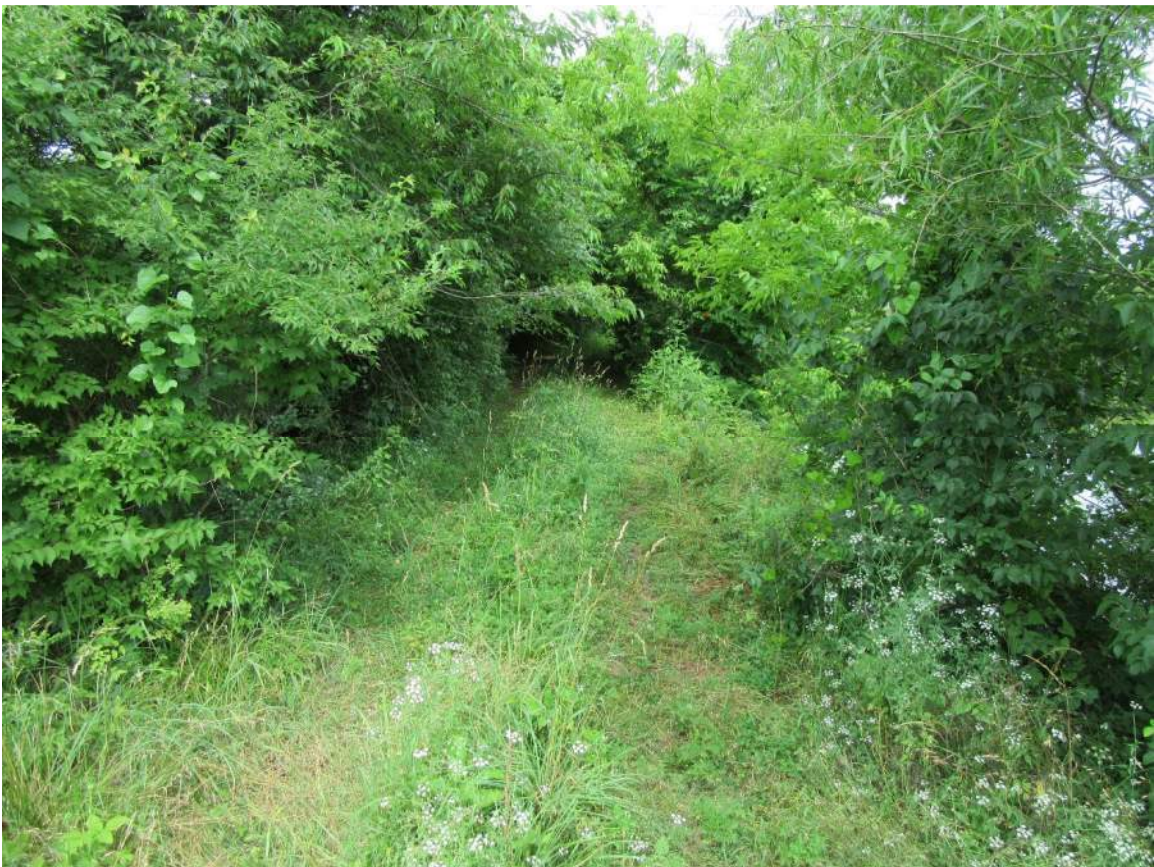
The crest is approximately 12 feet wide. The left portion is covered with tall grass and weeds, and the right portion is mostly bare with tall grass and weeds along both sides of the crest (Photos 2 and 3). There is a bare, slightly eroded area on the may be due to a previous overtopping event (Photo 4).

Photo No. 2: Crest viewed from left abutment.

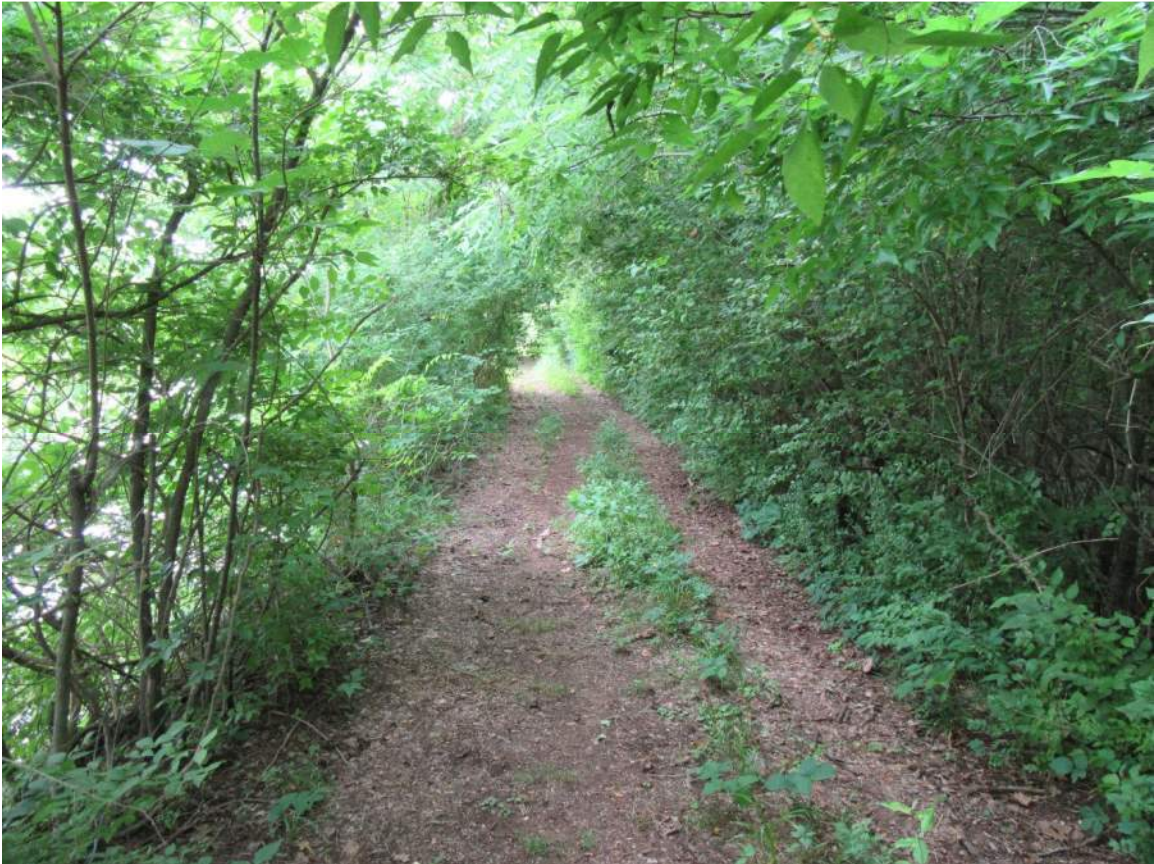
Photo No. 3: Crest viewed from right abutment.

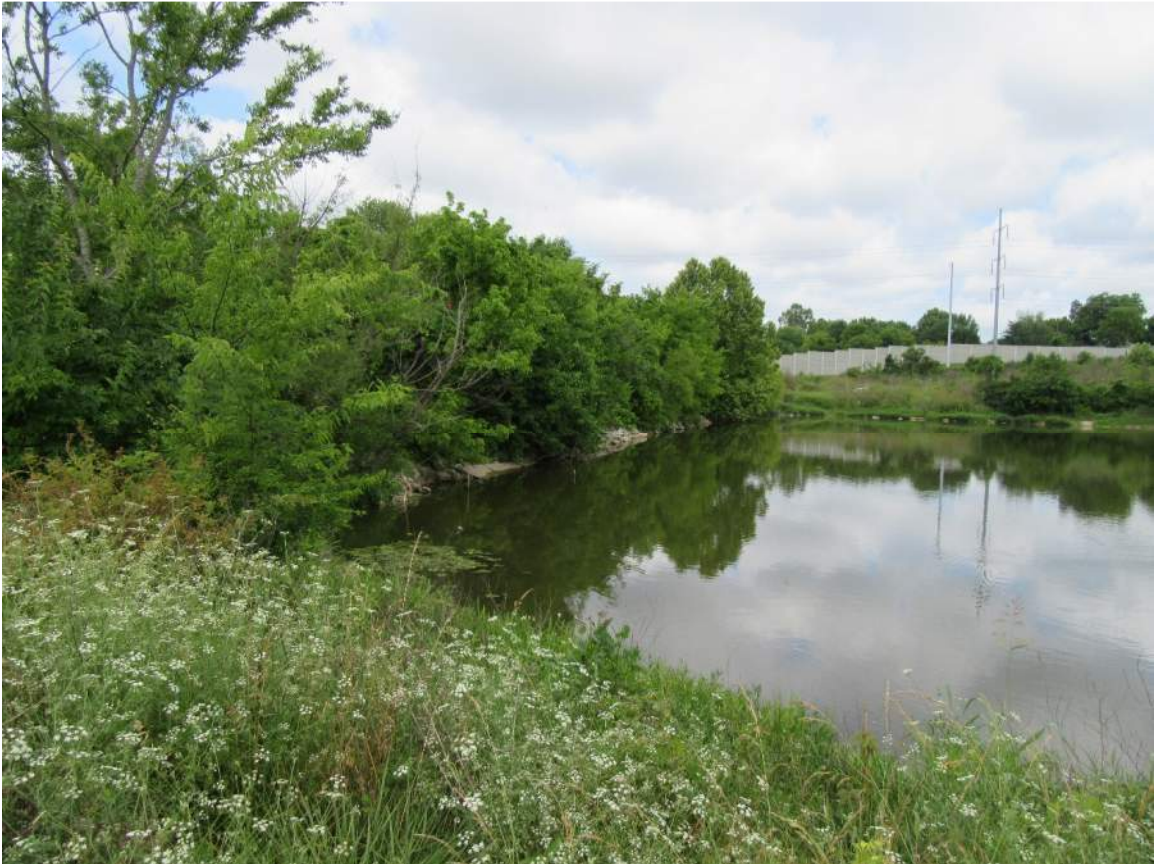
The upstream slope is covered with trees, brush, and tall weeds (Photos 5 and 6). The left portion of the slope is partially covered with riprap and concrete fragments (Photo 7). The trees are up to 12 inches in diameter (Photo 8). The slope is very steep, ranging from 1.5 horizontal to 1 vertical (1.5H:1V) to near vertical.

Photo No. 5: Upstream slope viewed from left abutment.

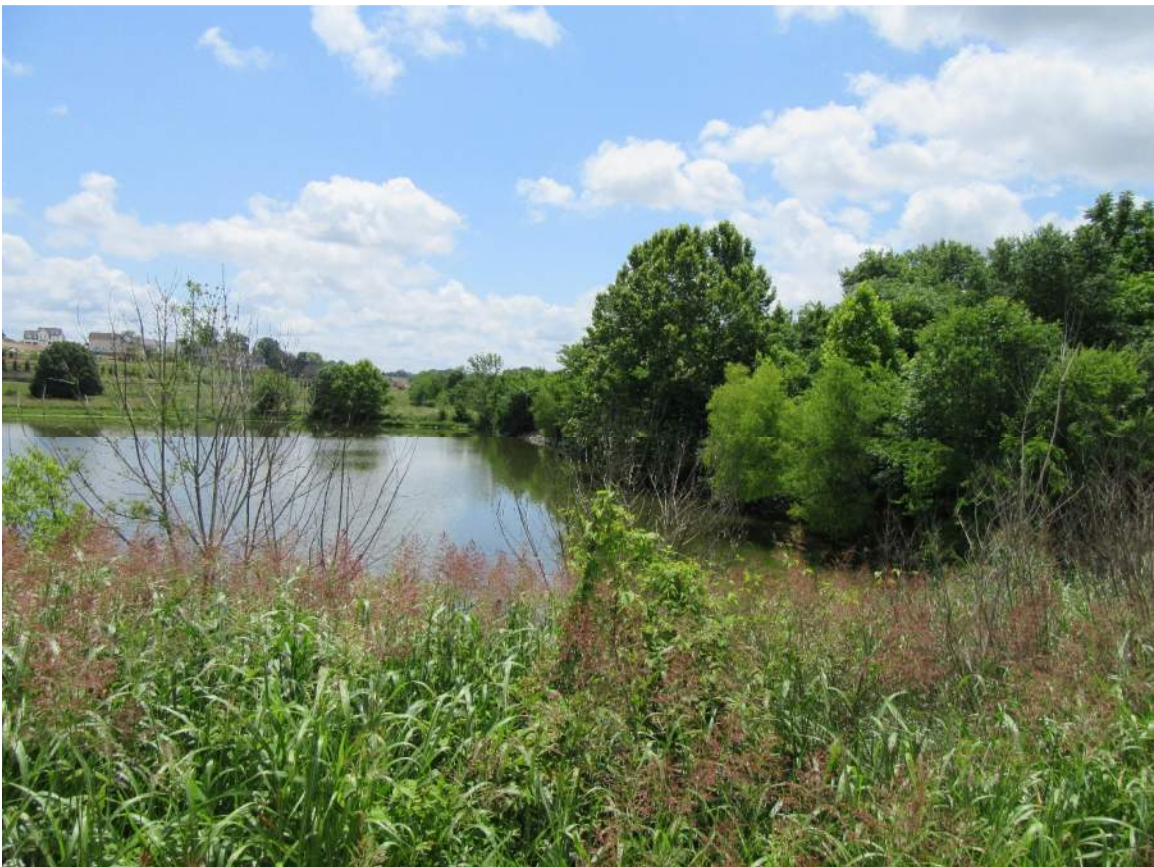
Photo No. 6: Upstream slope viewed from right abutment.

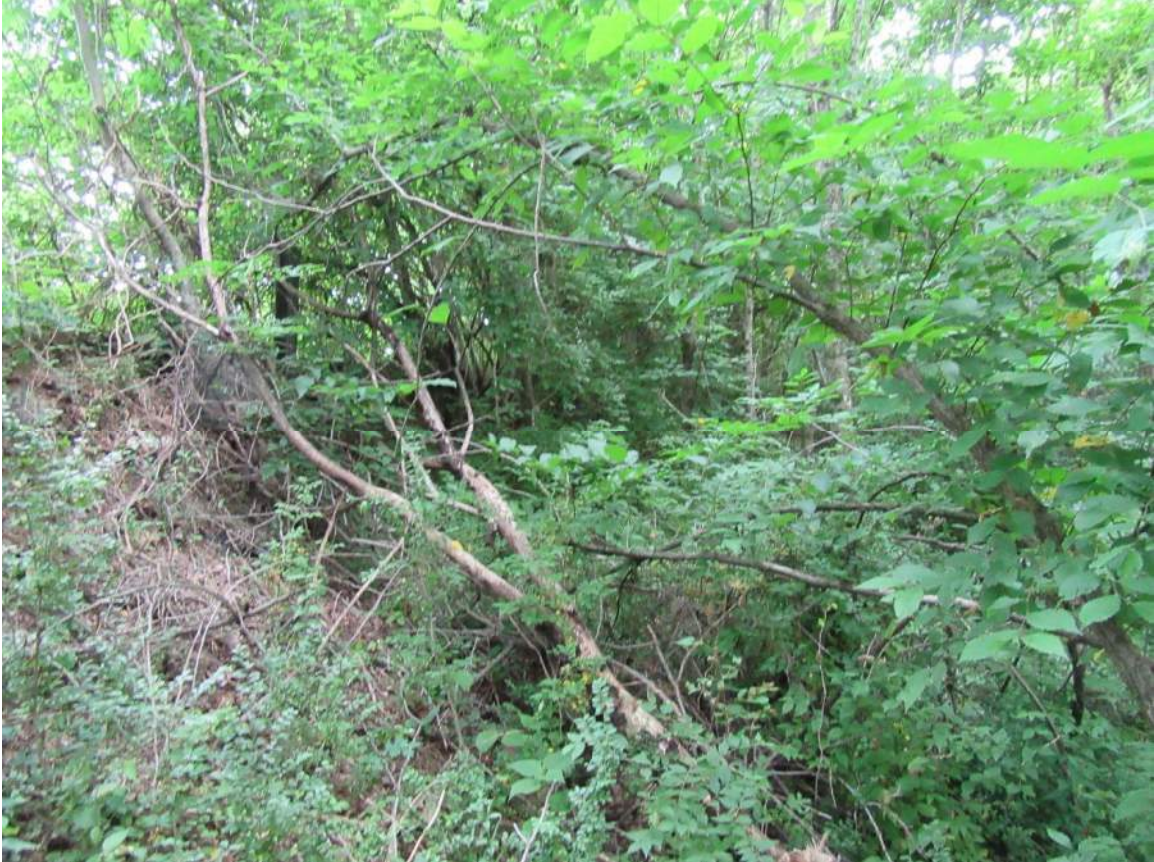
The downstream slope and downstream area are covered with leaves, vines, brush, and trees up to 12 inches in diameter (Photos 9 through 11). The downstream slope is steep, typically about 1.5H:1V. Photo 12 shows the bare, eroded area that may be due to a previous overtopping event.

Photo No. 9: Downstream slope viewed from right abutment.

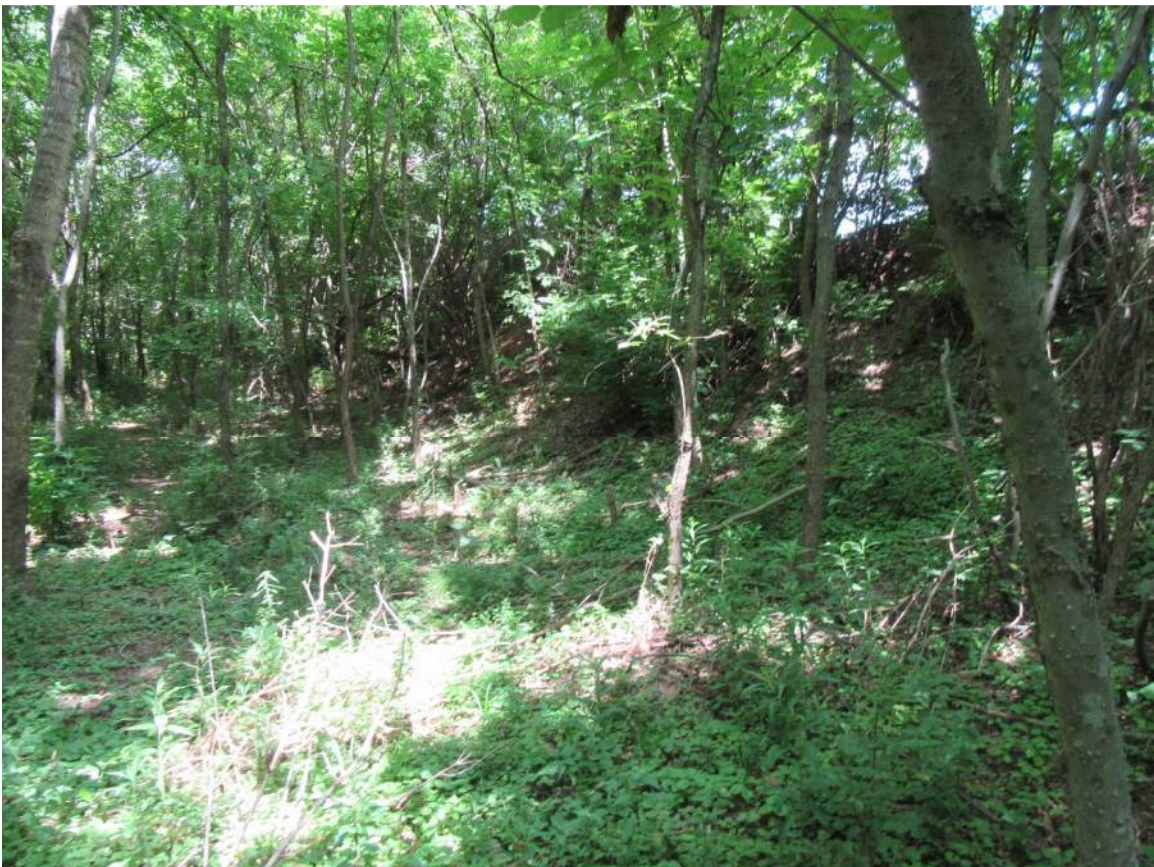
Photo No. 10: Downstream slope and downstream area viewed from left abutment.

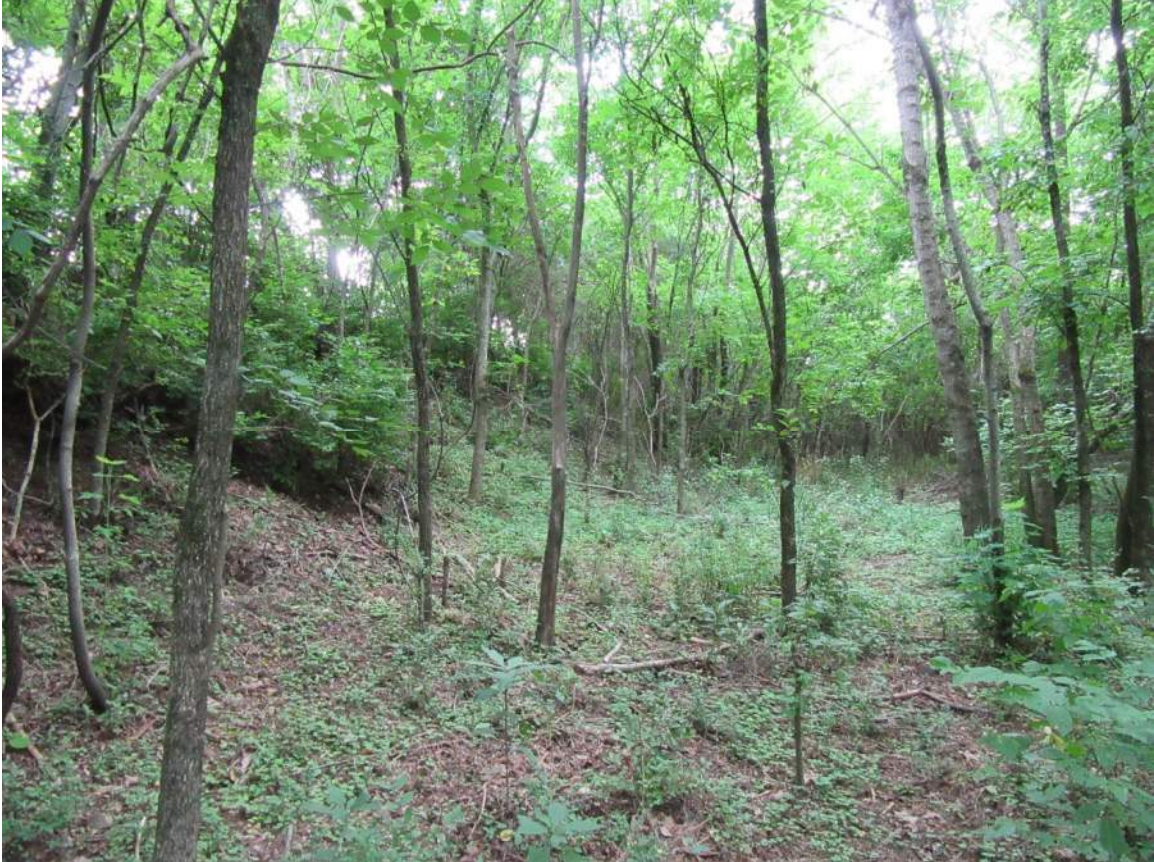
Photo No. 11: Downstream slope and downstream area viewed from right abutment.

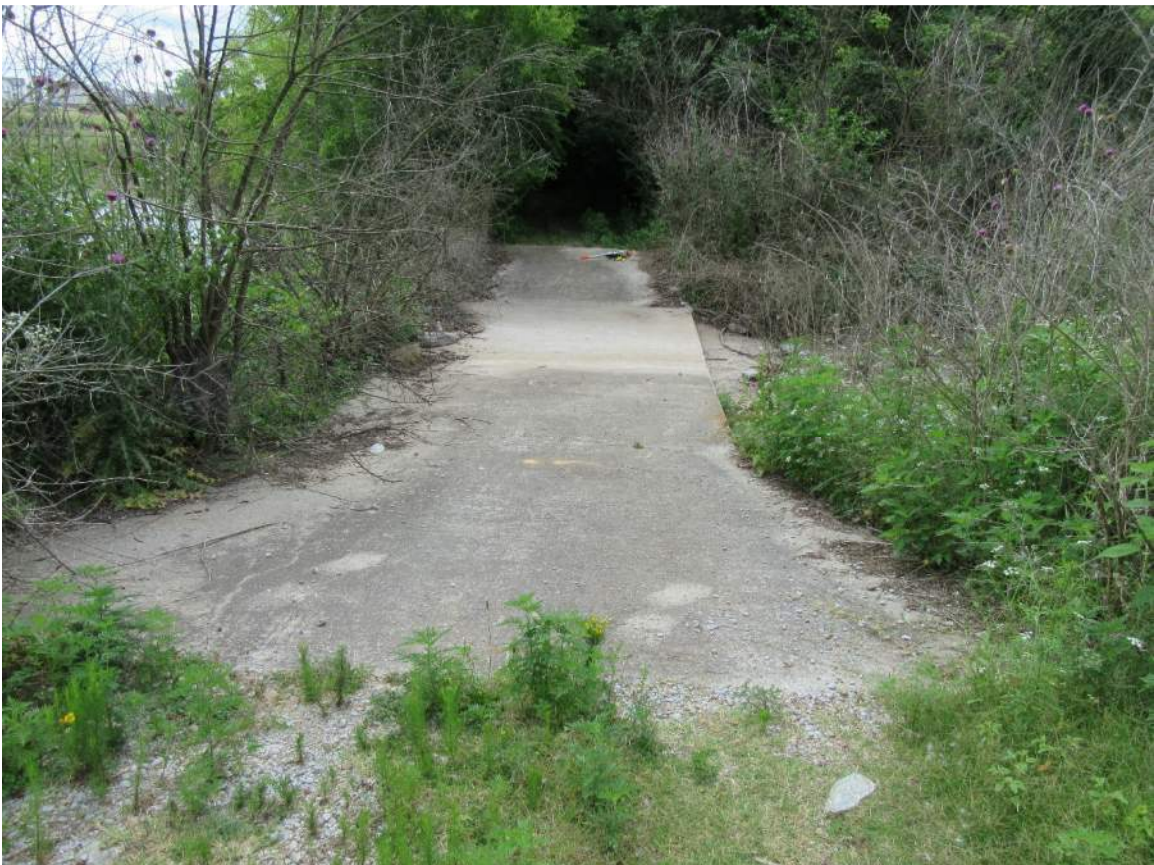
The spillway is located in the right abutment and consists of a trapezoidal concrete weir and discharge channel. The weir is about 46.5 wide with a 25-foot bottom width (Photo16). There is a partially intact fence along the upstream side of the weir that apparently serves as a trash guard (Photo 17). There are small trees and brush in the approach channel upstream of the fence.

Photo No. 16: Spillway weir viewed from right abutment.

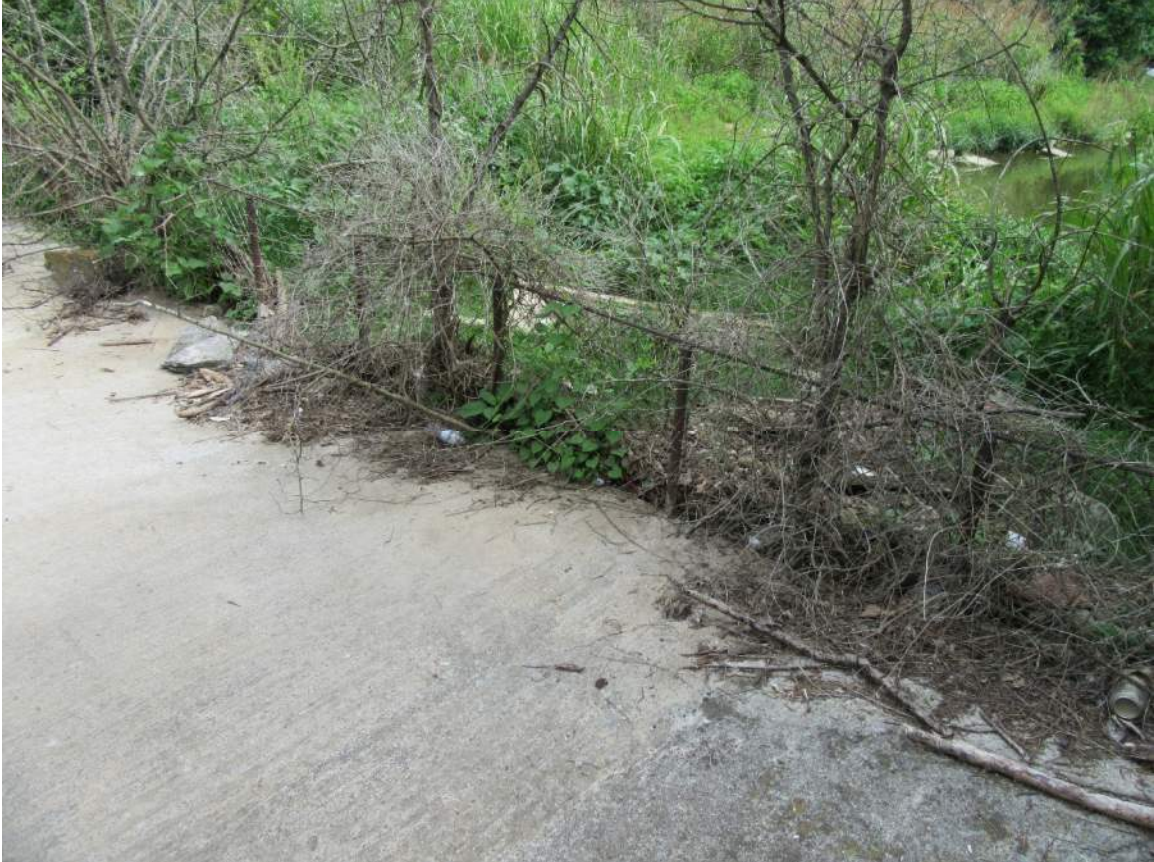
Photo No. 17: Fence (trash guard) on upstream side of spillway weir.

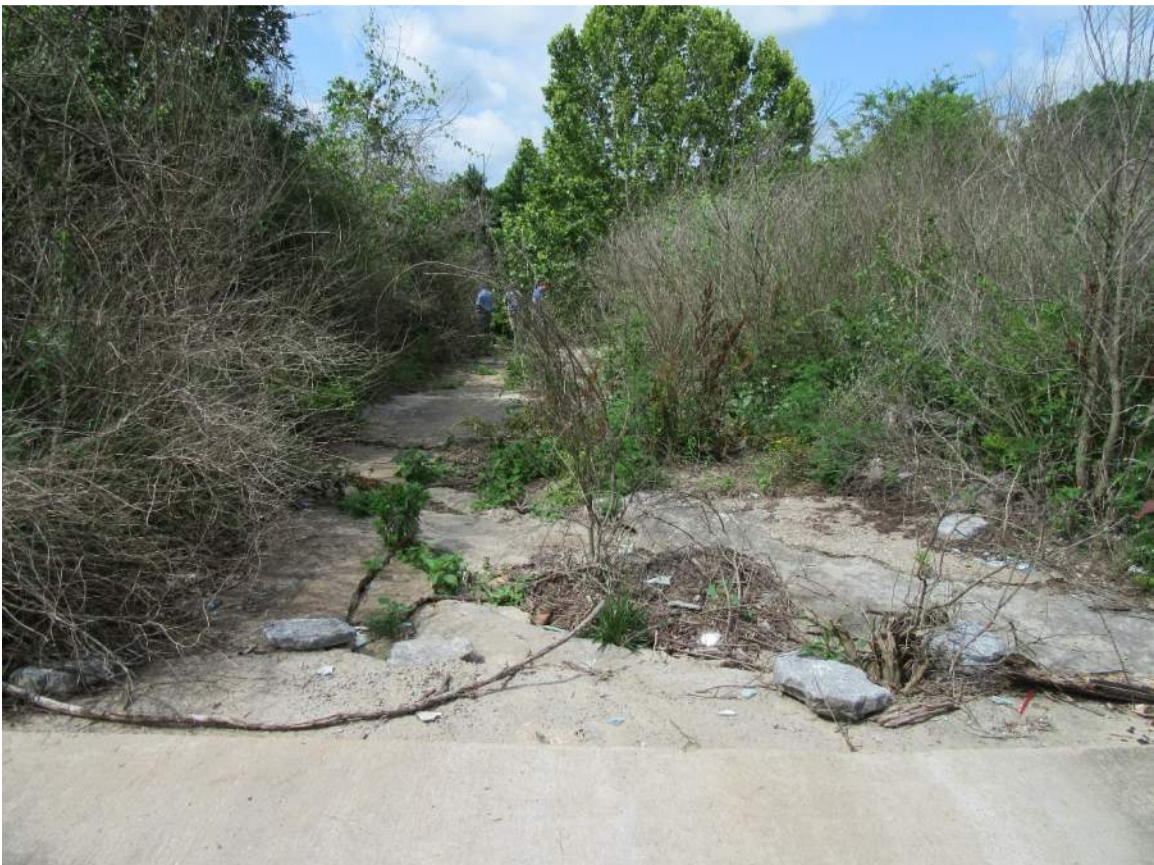
The concrete discharge channel is heavily cracked and has brush growing in the channel bottom and sloped walls (Photos 18 and 19). The channel ends at limestone bedrock (Photo 20) where there is a 15-foot-high drop-off down to the river. Seepage was flowing through the limestone face (Photo 21). In addition, seepage was flowing from the river bank to the left of the limestone face (Photos 22 and 23). Total seepage flow was about 100 to 200 gpm. There was erosion in the seepage area, but the seepage flow appeared to be clear.

Photo No. 18: Spillway discharge channel viewed looking downstream.

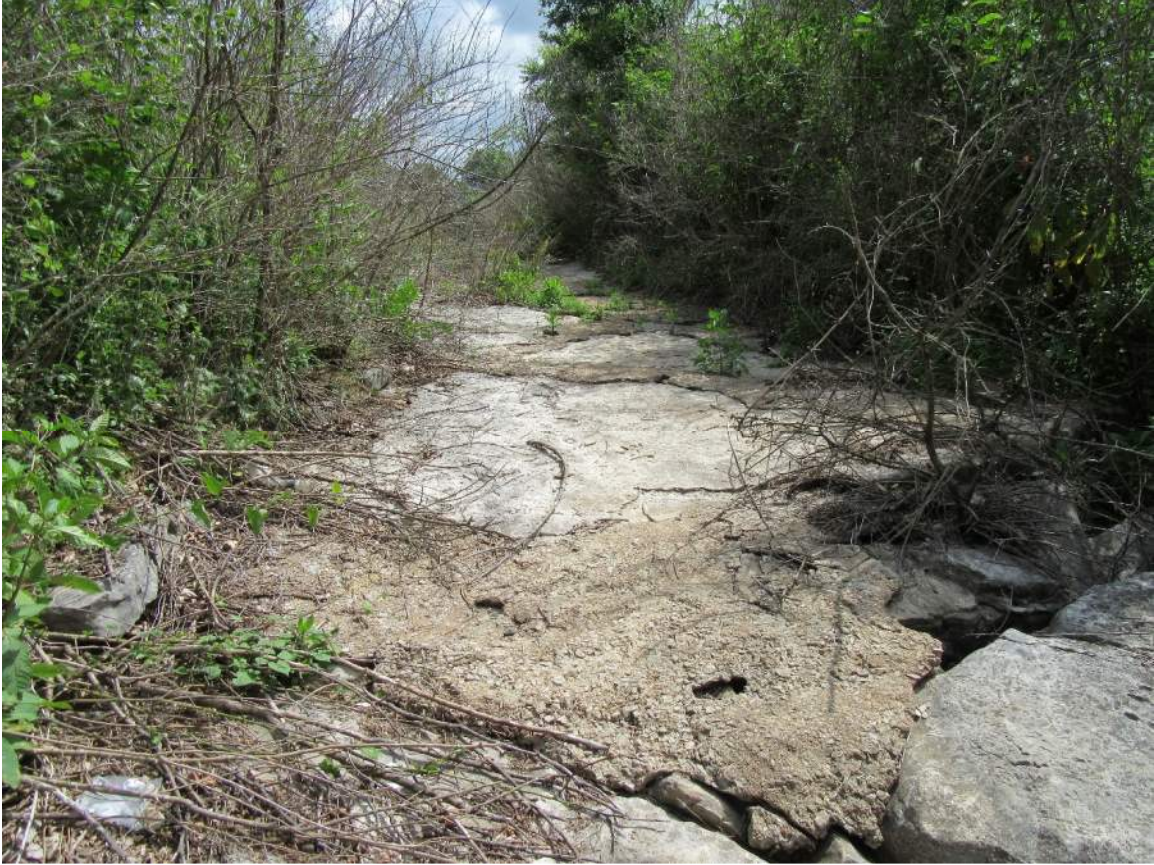
Photo No. 19: Spillway discharge channel viewed looking upstream.

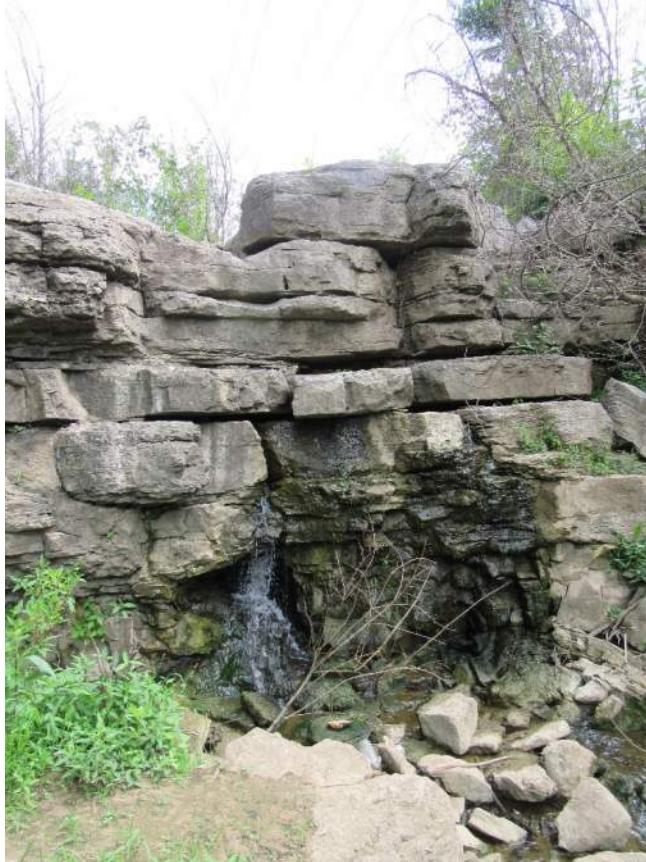
Photo No. 21: Seepage through bedrock at downstream end of spillway discharge channel.
